**AGENDA & NOTICE FOR REGION 4 BOARD OF EDUCATION
GROUNDS and BUILDINGS MAINTENANCE & OVERSIGHT COMMITTEE
MEETING**

Athletic Facilities Master Plan

Regional School District No.4

March 2021

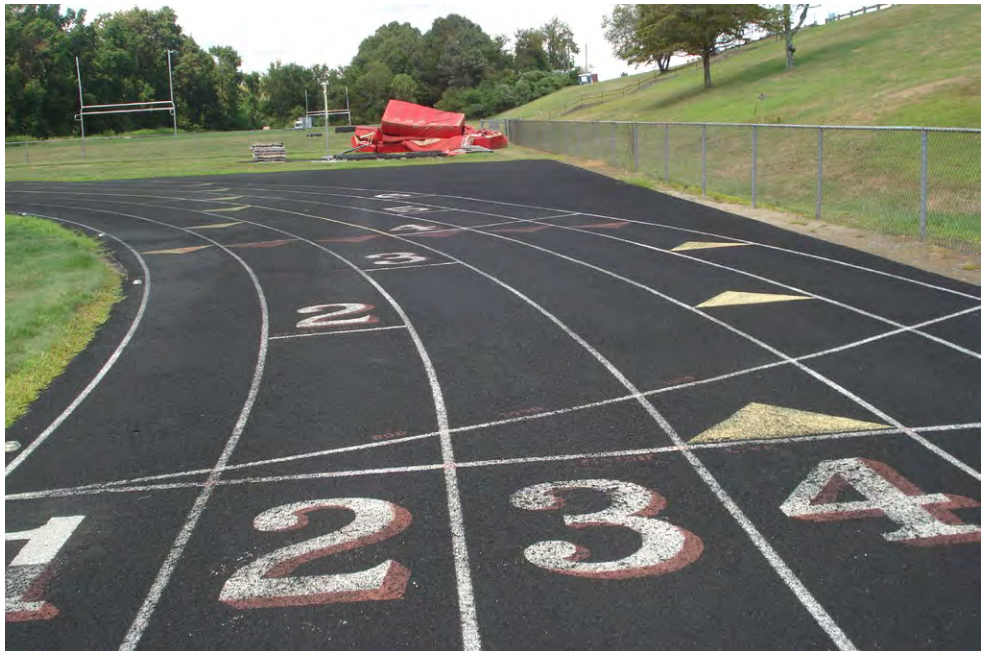
Existing Track

The existing track was constructed in 1995. It is in poor condition and appears to not have much resiliency left and should be resurfaced or replaced in the next couple of years. It is used by the track and field teams and the public. There is a steep slope down to the track on the east and a moderate wooded slope to the west.

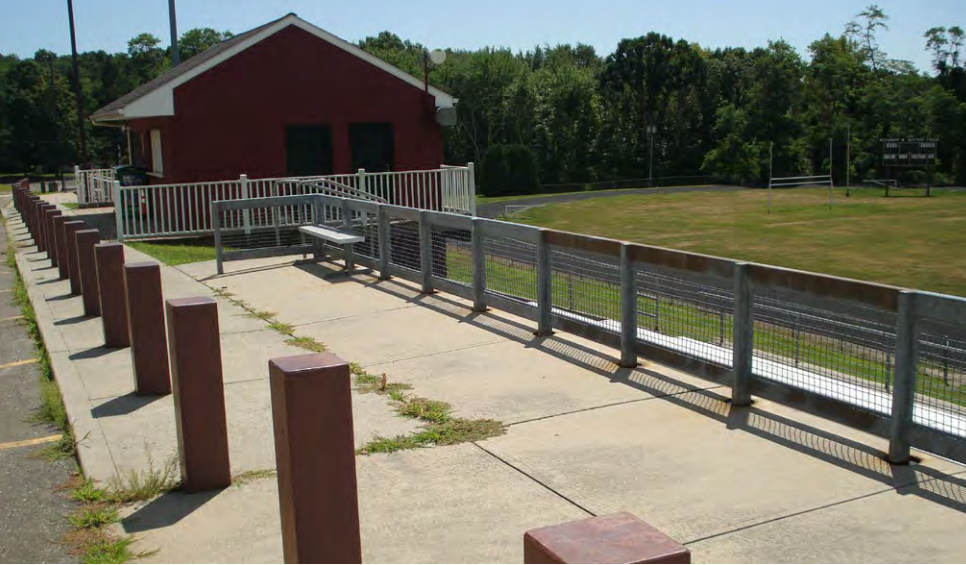
Spectator Seating

Spectator seating is accommodated at the top of the slope to the east of the stadium field. Our observations noted many code and accessibility deficiencies, Hand rails and rail attachments show signs of deterioration and missing posts. The press box/concession building was not part of the assessment. We recommend that the District hire an architectural consultant to perform an assessment of the building.

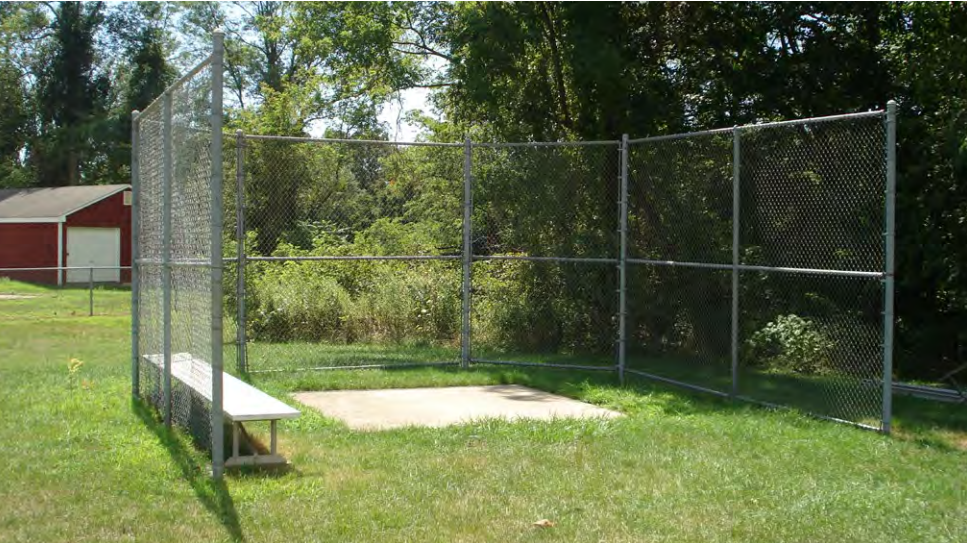
Existing Field Events

The interior field is in fair to good condition with evidence of turf grass deterioration in the high use areas in the center and end zones of the field. Due to the pandemic, spring, summer and fall use has been limited giving the field much needed rest to reestablish turf cover. There doesn’t appear that the field has the proper crown which impedes drainage off the field to the edges. This has led to reserving this field for game football and varsity soccer games use. Additionally, it has required the District cancel or reschedule games because of poor field conditions. The field events (long/triple jump, pole vault, discus, shot put and javelin) are located to the north and outside the running track. The runways are in poor condition and should be replaced in conjunction with the track.

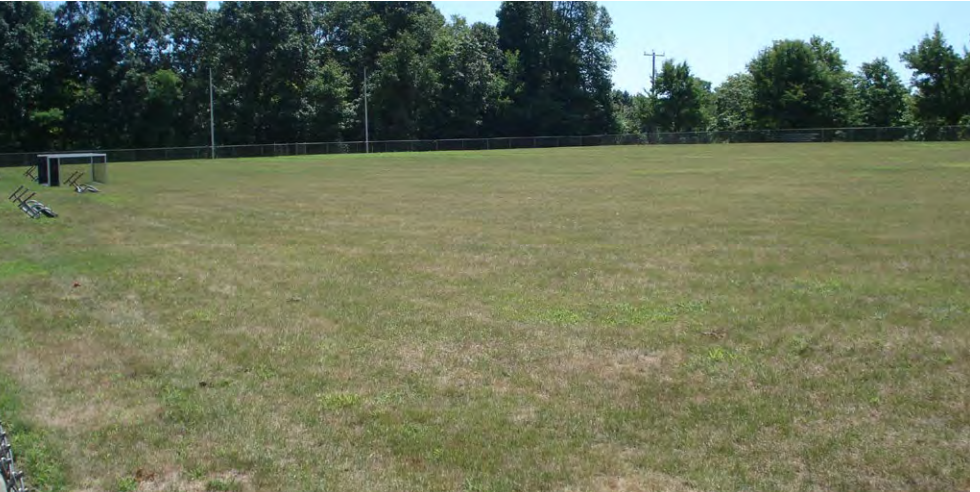
Existing Conditions at Upper Field

The upper field is utilized for a multitude of uses including field hockey practice and games, boy’s lacrosse practice and games as well as non-athletic events such as graduation. The current field configuration is confined by a 4-foot perimeter fence which prohibits the ability to shift the field from one side or the other, reducing wear in the high use areas. There is 10-foot high ball netting along the north end of field. The turf condition is poor. Spectator seating is provided on the west side of the field but lacks an accessible route to and from the parking lot.

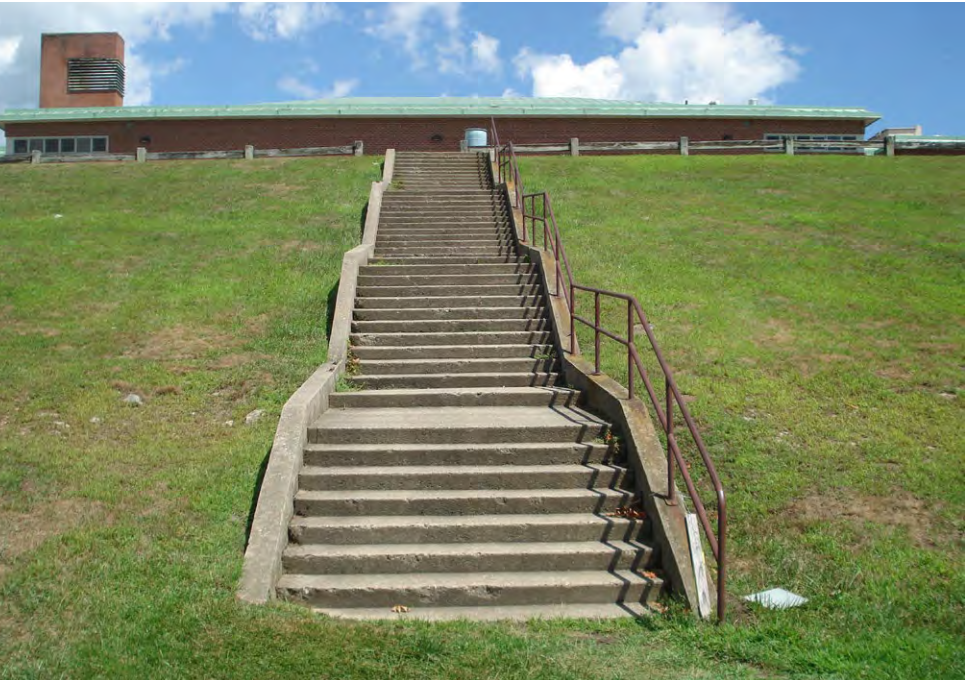
Stairs to Practice Field

The current field configuration allows for a 60-yard field. There is potential for expansion to the west. The field’s playing surface is uneven with bare spots in the turf coverage. It appears that the field lacks the proper crown for a field with natural grass surface leading to poor drainage condition. The goal posts are an “H” frame style, football/soccer goal combination. The goals are in fair to good condition. The field is irrigated by a self-propelled sprinkler. There is no spectator seating and a lack of accessible walkways. Concrete stairs descend the slope to the east, providing access from the school down to the field. The handrail does not meet code for extension at the top and bottom, and only provided on one side. Spalling of concrete along the nosing of the stairs treads with exposed reinforcing bar was noted.

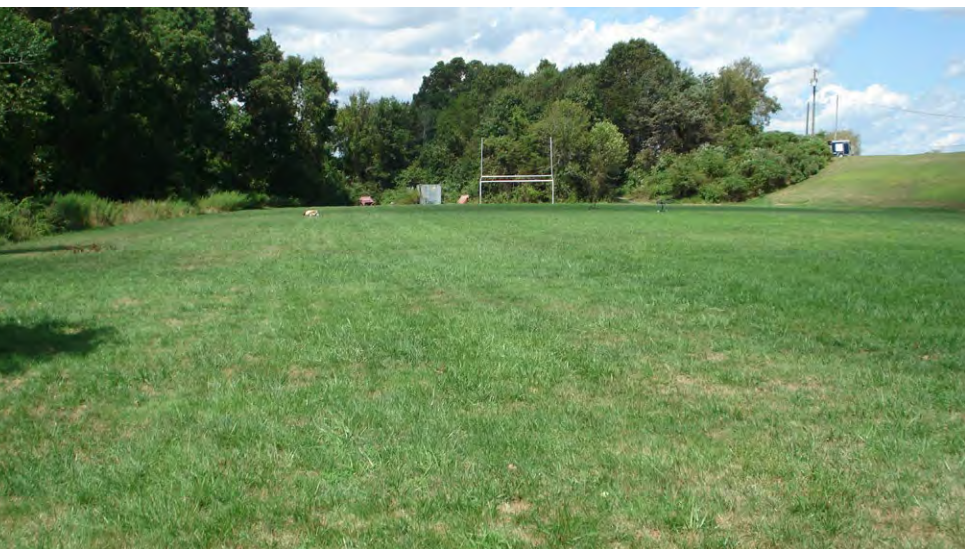
Existing Conditions at Practice Field

The practice field is located to the north of the stadium field and is utilized for football and lacrosse practice, occasional JV soccer in the fall and track and field events in the spring and conditioning in the summer. Track and field events such as shot put, discus and javelin are located at the south end of the field with their throwing sectors in to the field. The putting circle is missing a 2-inch painted circle. Fencing around the discus circle is in good condition but does not meet today’s standards for height, setback from the circle or opening. The circle lacks a 2-inch wide painted circle and projecting lines.

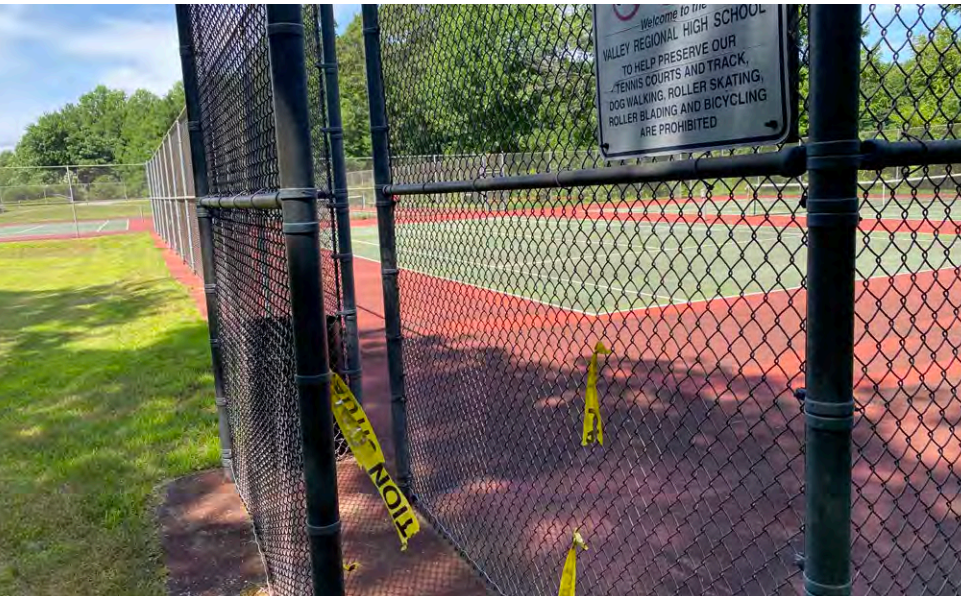
There are currently 6 courts utilized by the District and the public located in the southeast corner of the high school campus. They are lined for single and doubles play. No pickleball markings were noted. The overall condition of the courts is poor. The court surfacing is faded with numerous cracks, some over 1-inch in width, representing a safety hazard. The courts are accessed through "baffles" in the fence at a couple locations which are not accessible. There is an overall lack of spectator seating and access to and within the facility. Additionally, players accessing the two center courts must walk behind other players creating a distraction and potential safety hazard. There are a few wooden player benches that are in poor condition and newer metal benches that are in good condition.

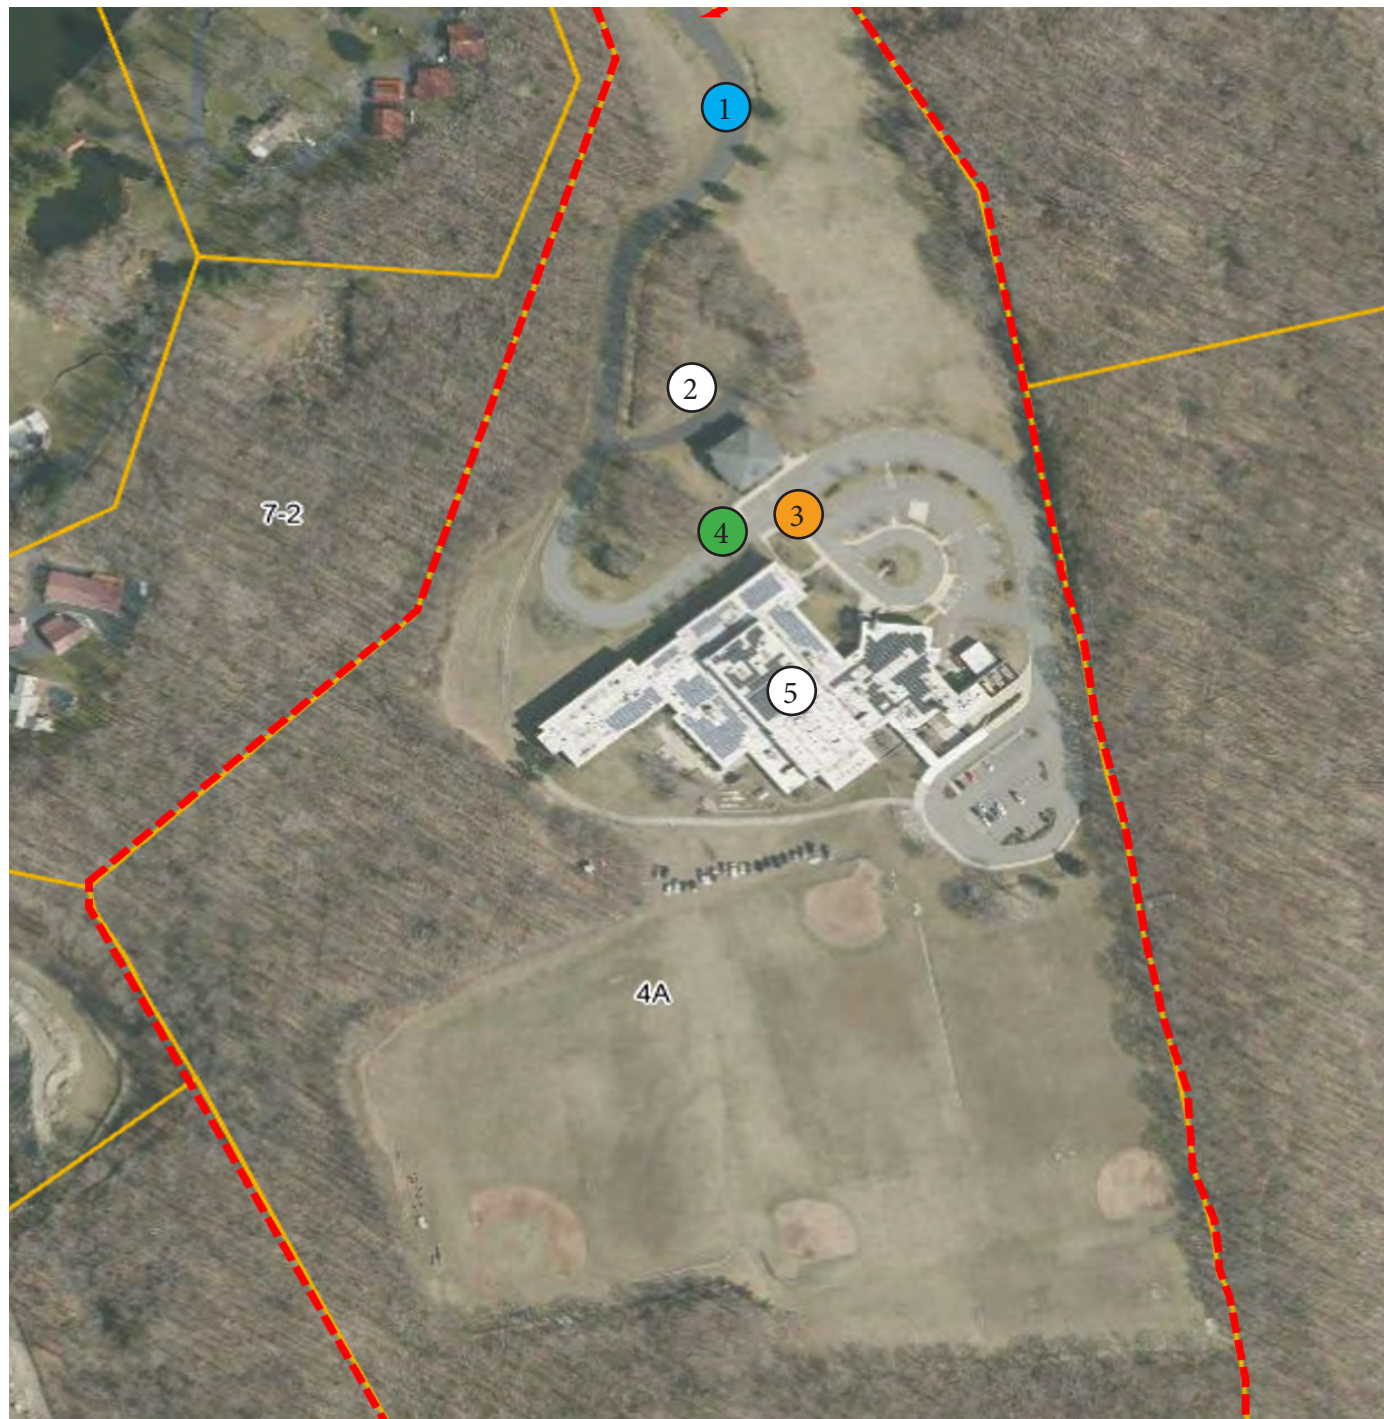
Curbs in the parking lot are deteriorating in places. The sidewalks at building are also beginning to deteriorate. The accessible route across the driveway is lacking the tactile warning strips required where the sidewalk meets the driveway.

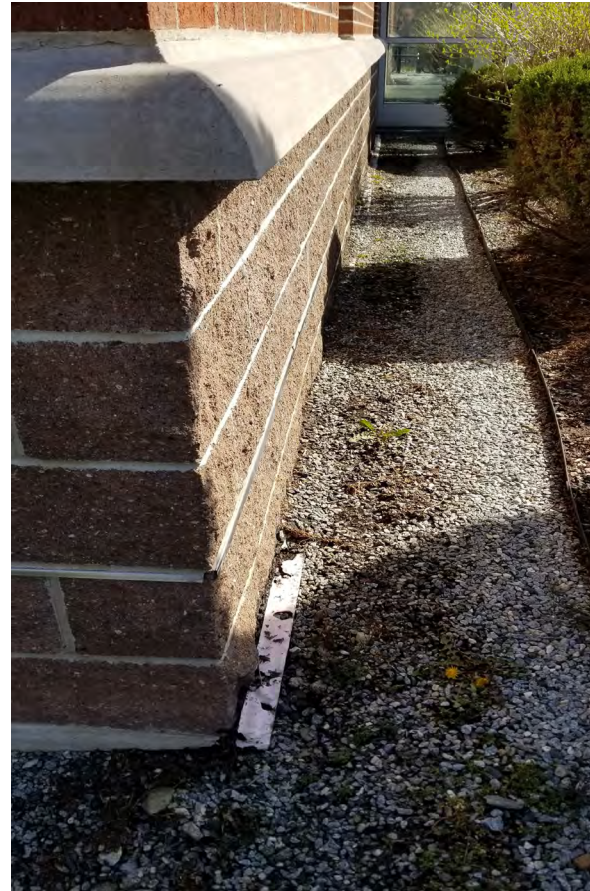
The masonry is showing signs of what might be efflorescence as well as areas of mold and lichen growth. Some areas of mortar have been repaired. The building would look better if it were power-washed to remove the dirt and growth.

The windows are double pane insulated and are aging well. The aluminum entry doors are in good condition. Sealant around the windows is aging well, replacement should be planned for in the next two to five years.

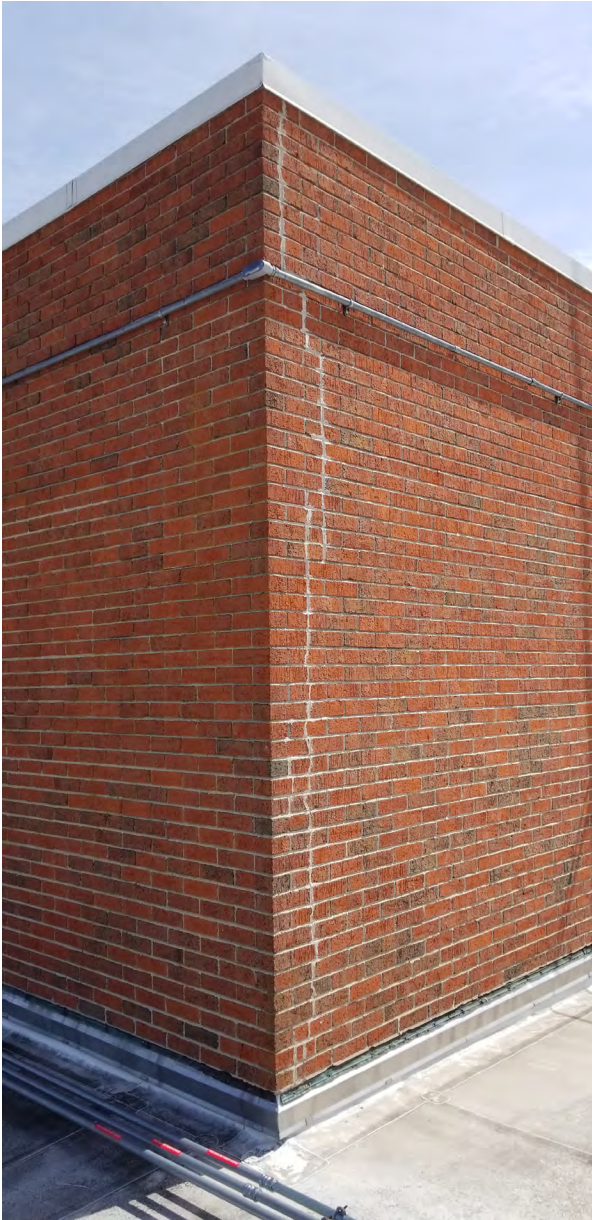
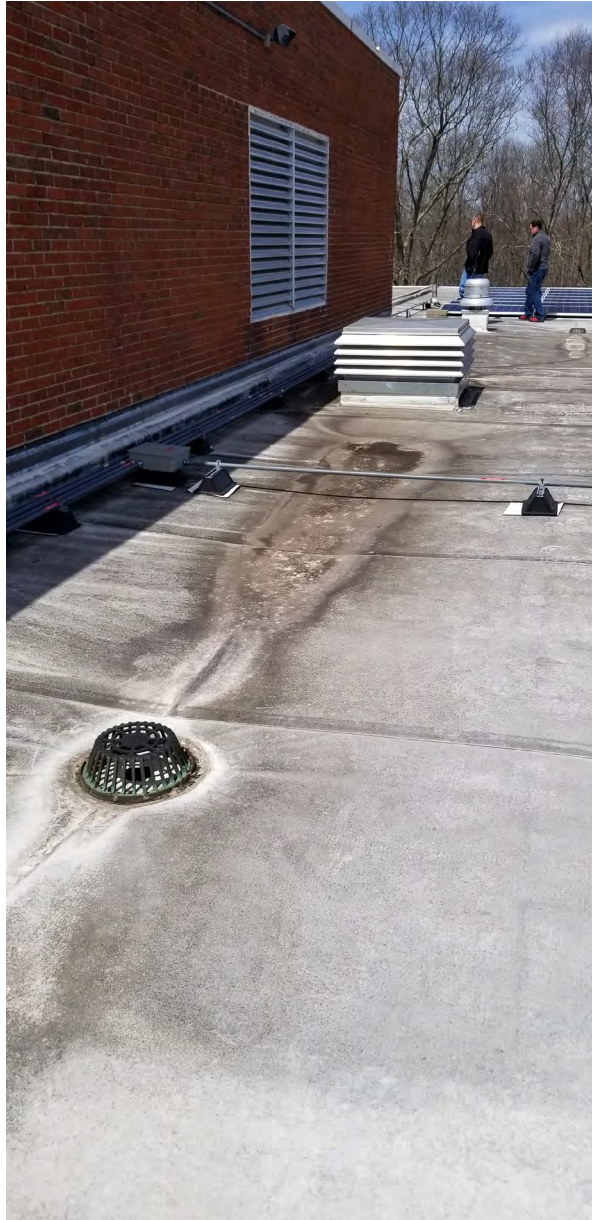
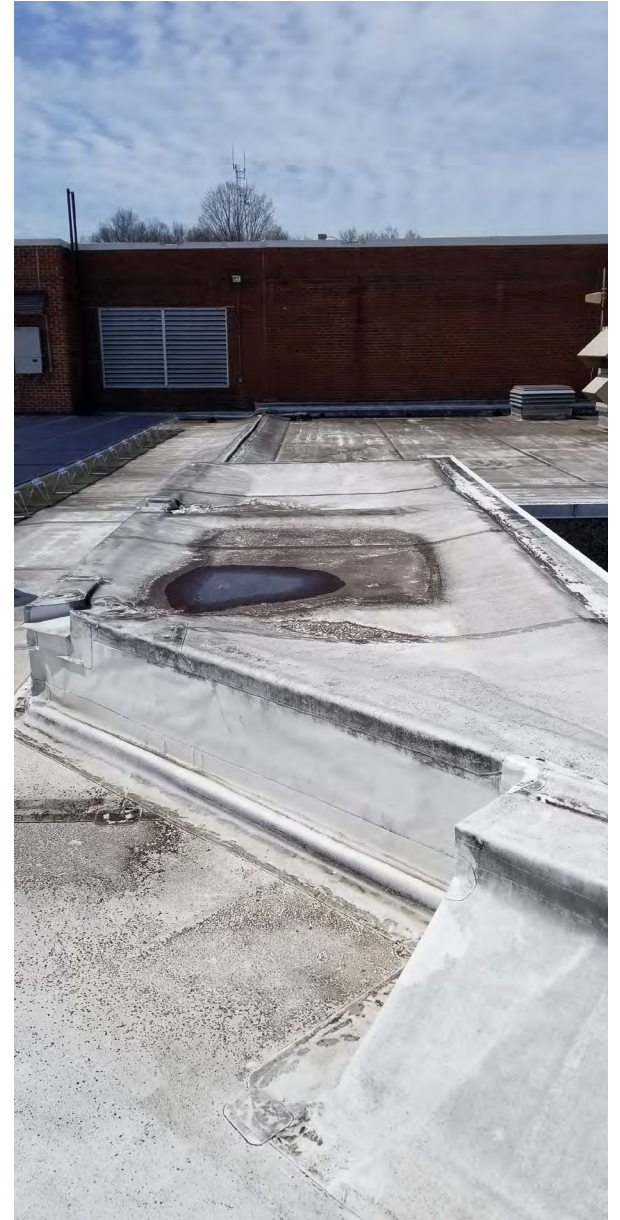
The building is clad in brick with corrugated metal and precast exposed stone panels. The brick walls show spalling, some cracking, loss of mortar, and efflorescence. The extent of this condition in some areas is concerning and it is recommended that potential causes and resolution be investigated to assure continued structural and environmental integrity of the building.

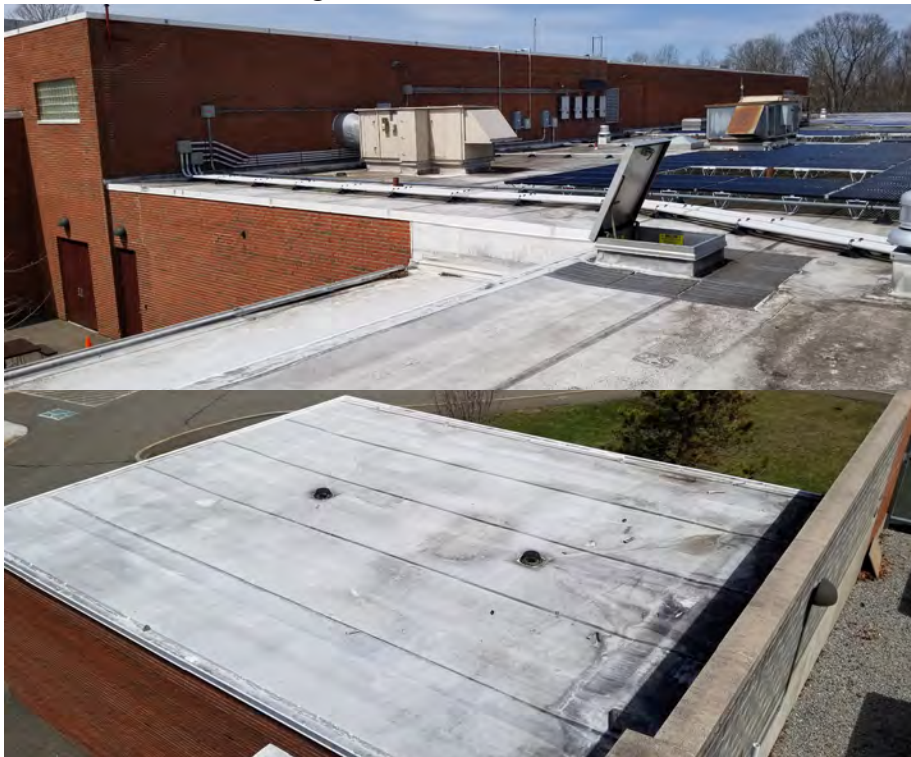
leak or point of water ingress along the north side of the roof. This shows on the interior as rot, dampness, and mold on the wall near the nurse's office. This roof should be further investigated to determine what life expectancy might be left. Roof drains need to be cleaned in various locations on the roof, and secondary scuppers are needed in many areas. It is recommended that replacement of this roof be planned for sometime in the next three to five years, unless further investigation determines it remains a sound roof and drain system.

Photos on this and the facing page give an idea of the conditions on the roof relative to effluorescence in the brick, deterioration of the chimney caps, water ponding on the roof, and the overall condition of the roofing membrane itself.

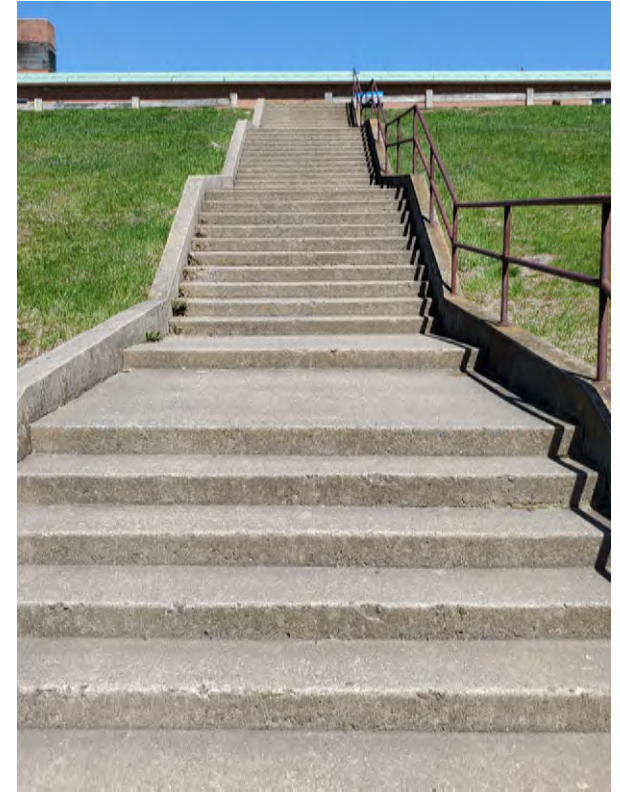
There is a long, multiple-flight concrete stair that connects the western driveway with the football practice field. This staircase has a railing on just one side, the other having apparently broken off. This stairway has differing tread and riser dimensions and could be considered a hazard.

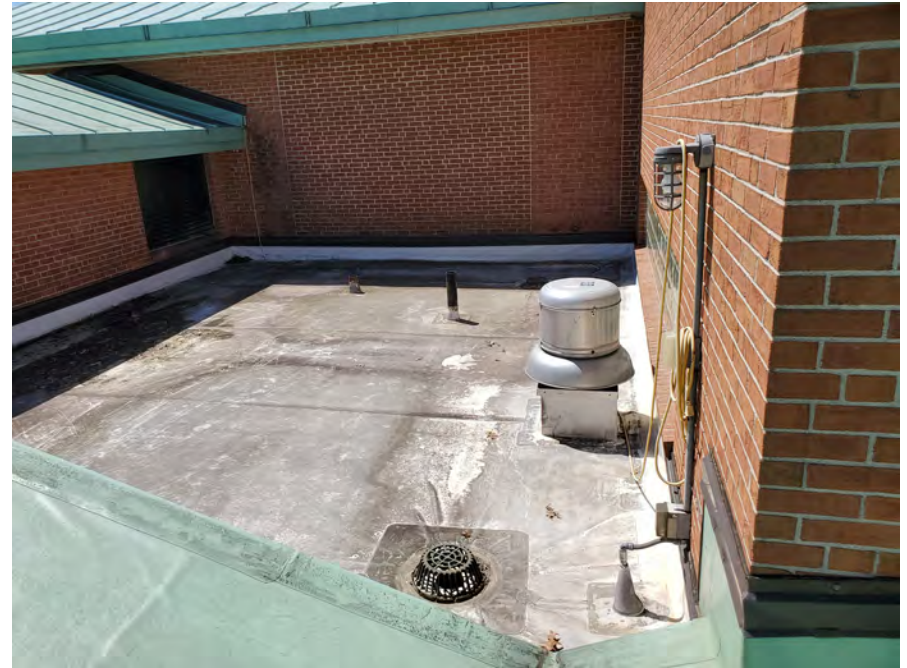
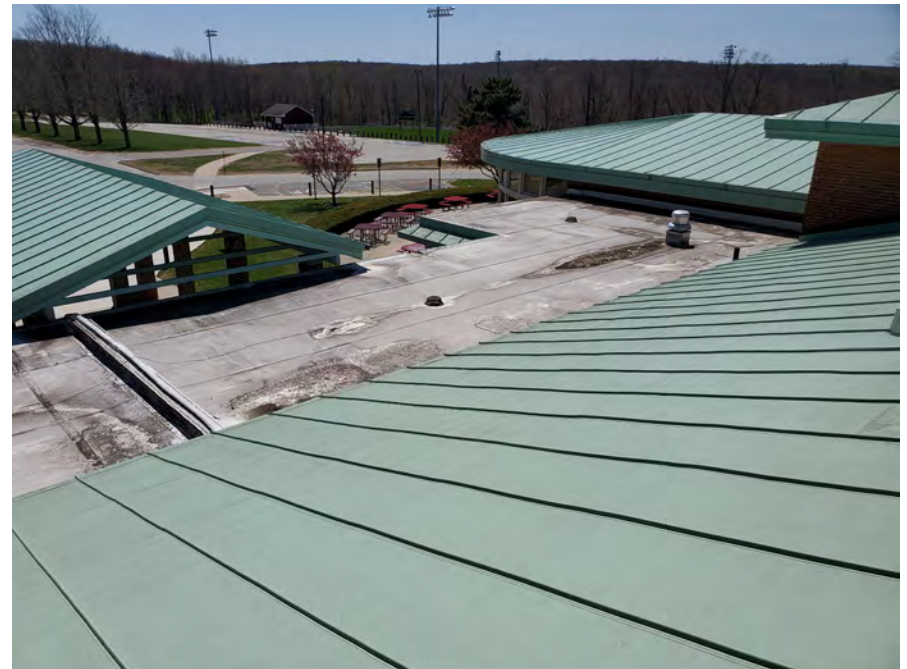
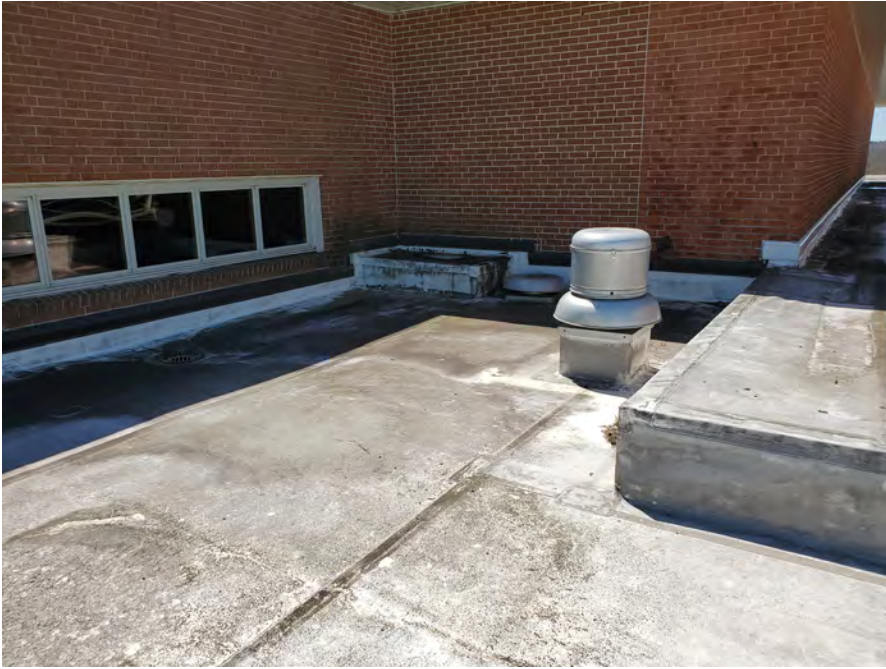
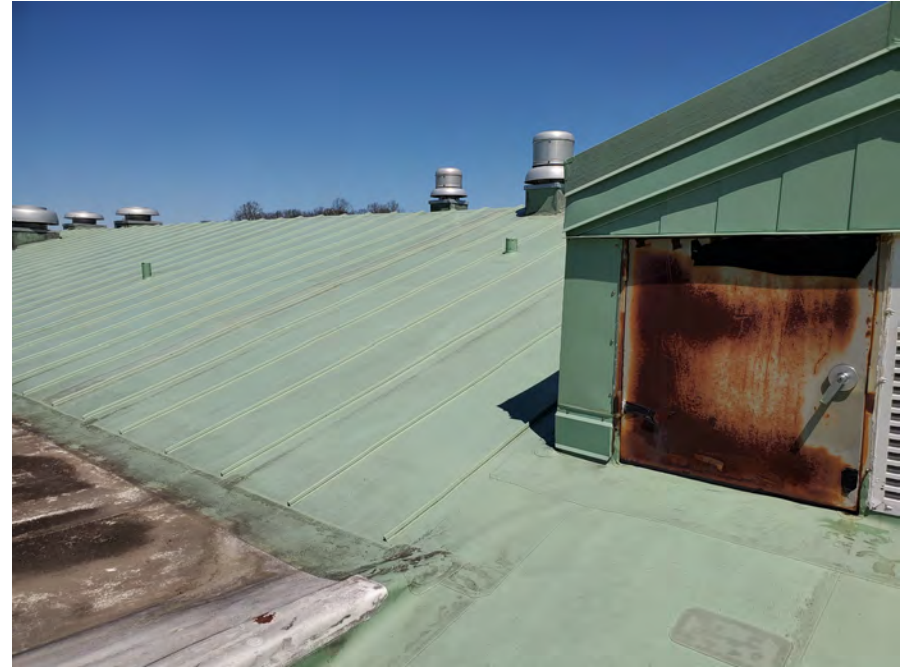
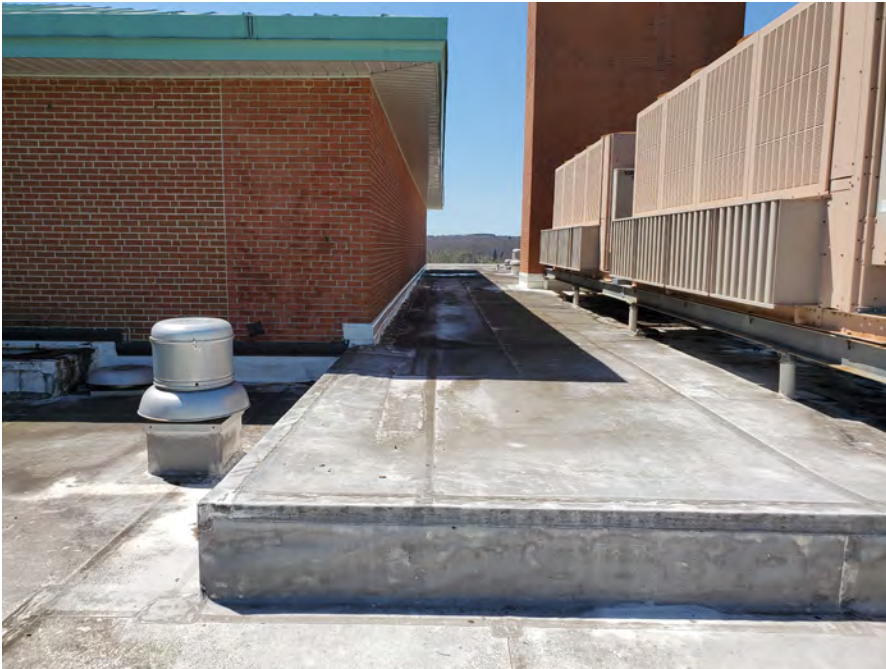
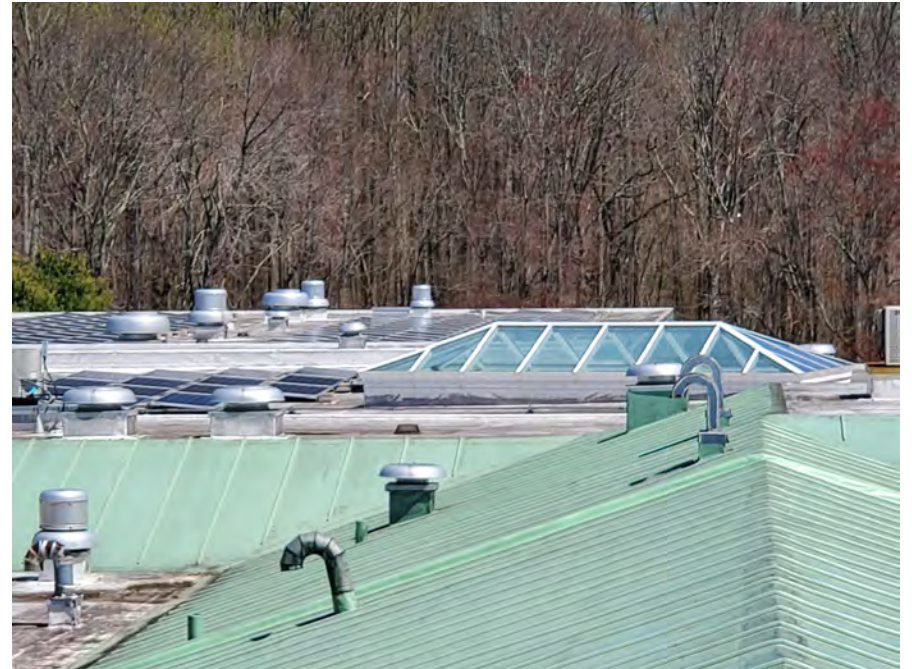
The access doors, some louvers, and roof hardware need to be painted or replaced. See photo upper right of the opposite page.
