**AGENDA & NOTICE FOR REGION 4 BOARD OF EDUCATION
GROUNDS and BUILDINGS MAINTENANCE & OVERSIGHT COMMITTEE
MEETING**

Athletic Facilities Master Plan

Regional School District No.4

March 2021

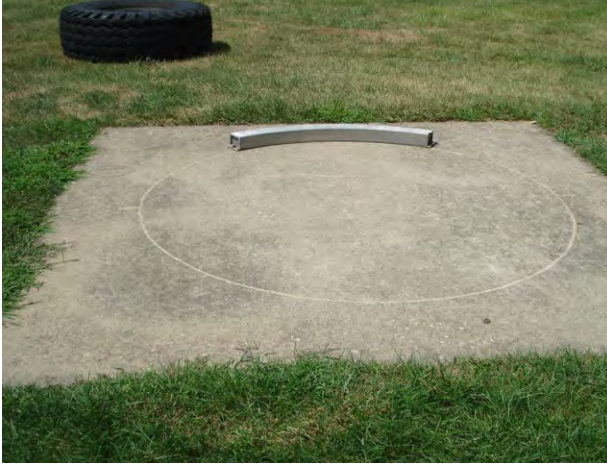
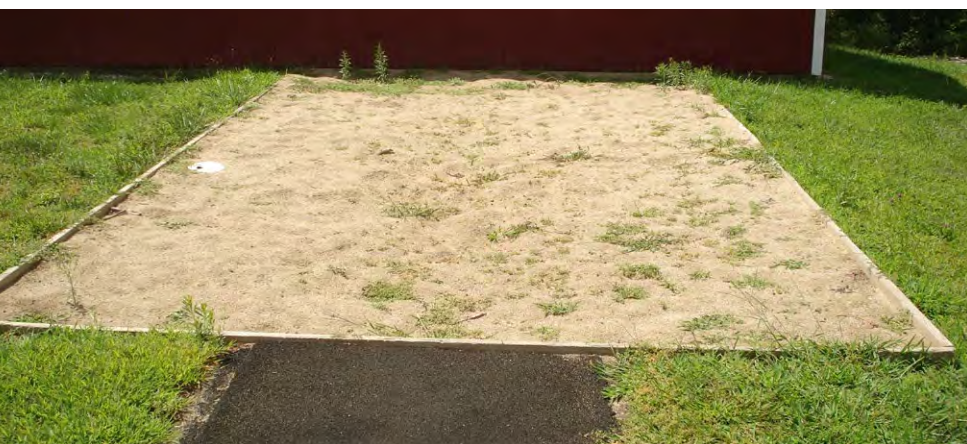
Existing Field Events

The interior field is in fair to good condition with evidence of turf grass deterioration in the high use areas in the center and end zones of the field. Due to the pandemic, spring, summer and fall use has been limited giving the field much needed rest to reestablish turf cover. There doesn’t appear that the field has the proper crown which impedes drainage off the field to the edges. This has led to reserving this field for game football and varsity soccer games use. Additionally, it has required the District cancel or reschedule games because of poor field conditions. The field events (long/triple jump, pole vault, discus, shot put and javelin) are located to the north and outside the running track. The runways are in poor condition and should be replaced in conjunction with the track.

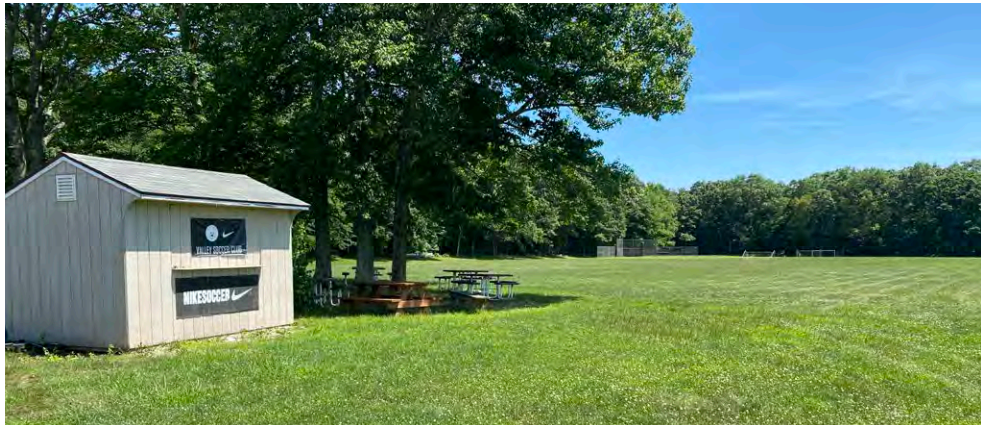
Concessions and Seating Area

The athletic fields at John Winthrop Middle School are one contiguous open space with four diamond fields, the two southern fields are discontinued. There are bleachers located in the field area and around the wood line as well as numerous player benches and soccer and lacrosse goals. These items and are in fair condition however, most of the nets are in poor condition and should be replaced. The fields are accessed via openings in a 4-foot fence at the edge of the parking with a vehicle gate and access road adjacent to the school building. The entire facility lacks irrigation infrastructure and is further constrained by allocation of staffing to deploy sprinklers. There is a grove of tree to the north of soccer field 1 with a few picnic tables and small concession shed.

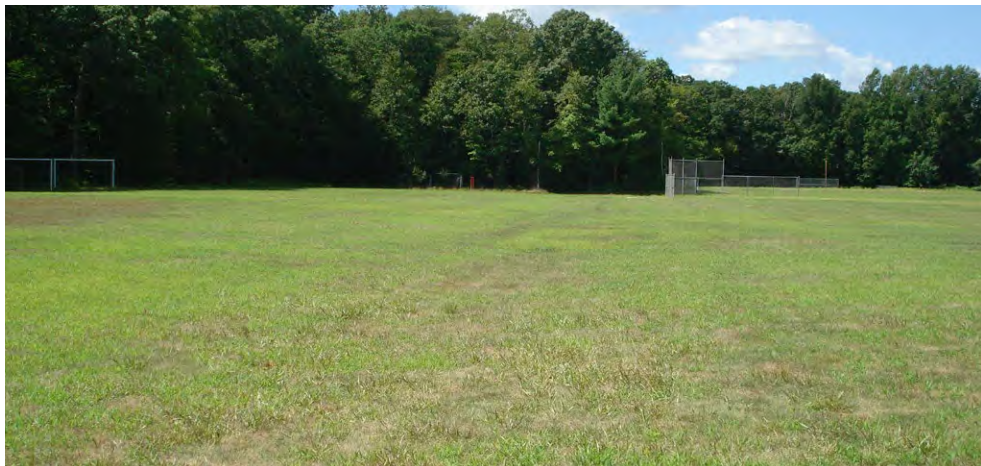
Condition of Existing Fields

Soccer field 3 shares the outfield of the baseball field and is primarily used for soccer and field hockey. This creates a scheduling conflict with spring sports. The turf grass is in poor condition and suffers from lack of irrigation. There are no permanent accommodations for players or spectators and an overall lack of accessibility.

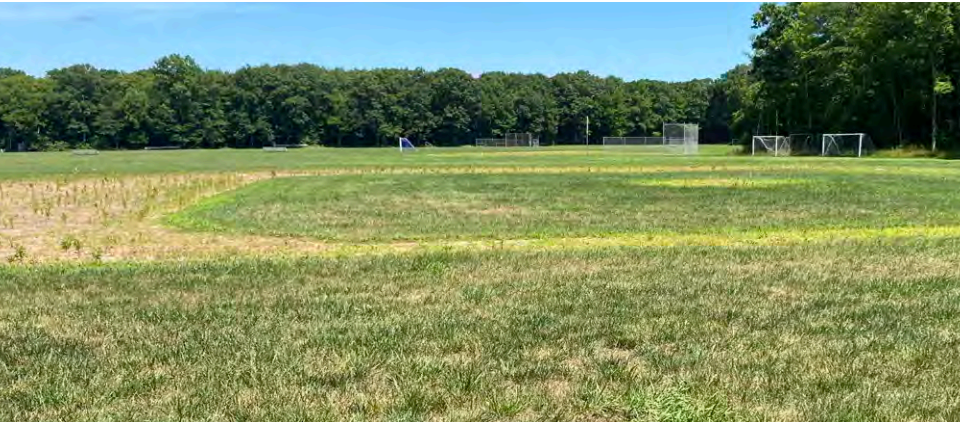
Condition of Baseball Field

The baseball field is in the southwest corner of the facility and has proper northeast orientation. The outfield is shared with soccer field 3. The turf grass has a high percentage of weeds, bare spots from overuse with shared soccer field 3, compaction and is not irrigated. The backstop is in fair condition but short and the distance to home plate should be increased. There is no defined players area and no fencing. The infield is full of weeds, compacted and the material is course. Foul poles are present but need to be repainted and there is no foul ball protection for spectators.

Field surface drainage is collected by a couple french and areas drains located between soccer field 2 and along right field foul line. The stone surface is silted in and covered with crabgrass, severely impacting its function. The field's location is far from parking with no accessible route.

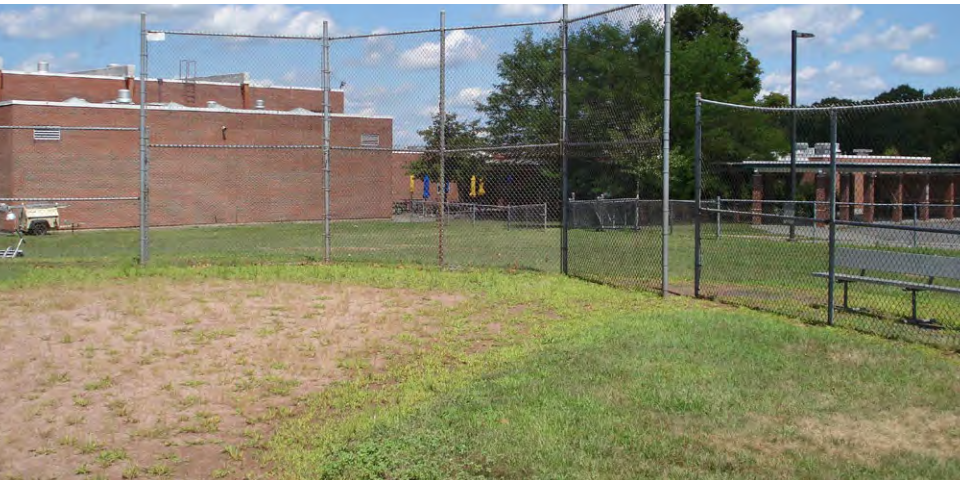
Condition of Softball Field

The field, located in the center of the facility is not irrigated and in poor condition. The turf grass has a high percentage of weeds, bare spots from overuse with shared soccer field 2 and compaction. The backstop is in fair condition but short and the distance to home plate should be increased. There is 6-foot fence in front of the players areas which is in fair condition. The infield is full of weeds, compacted and the material is course. The field lacks foul poles and foul ball protection of spectators. There is no accessible route form the parking lot to the field.

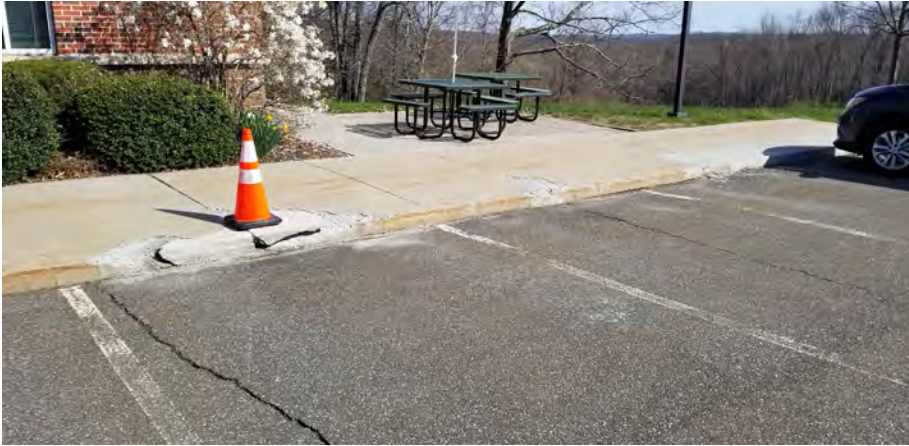
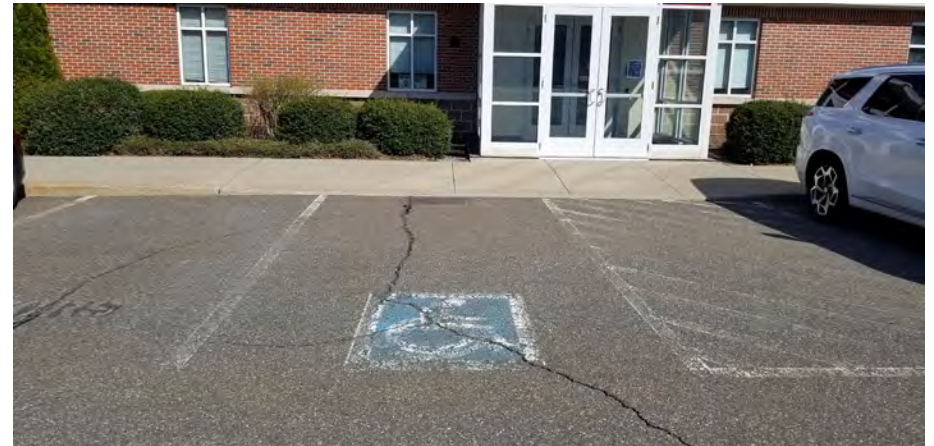
Curbs in the parking lot are deteriorating in places. The sidewalks at building are also beginning to deteriorate. The accessible route across the driveway is lacking the tactile warning strips required where the sidewalk meets the driveway.

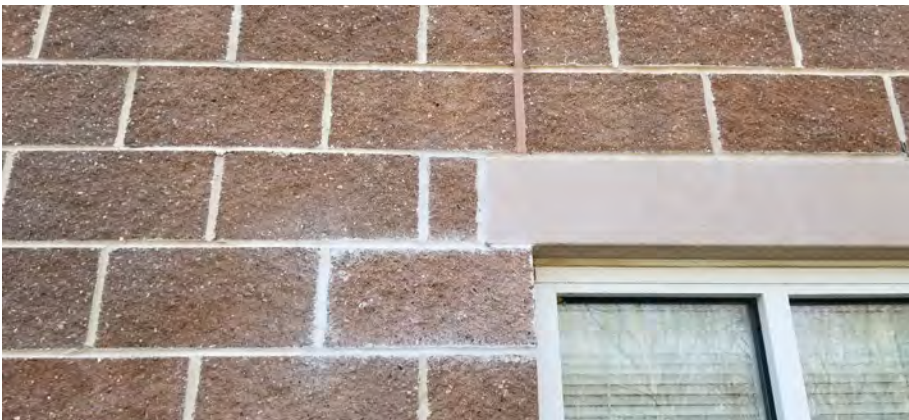
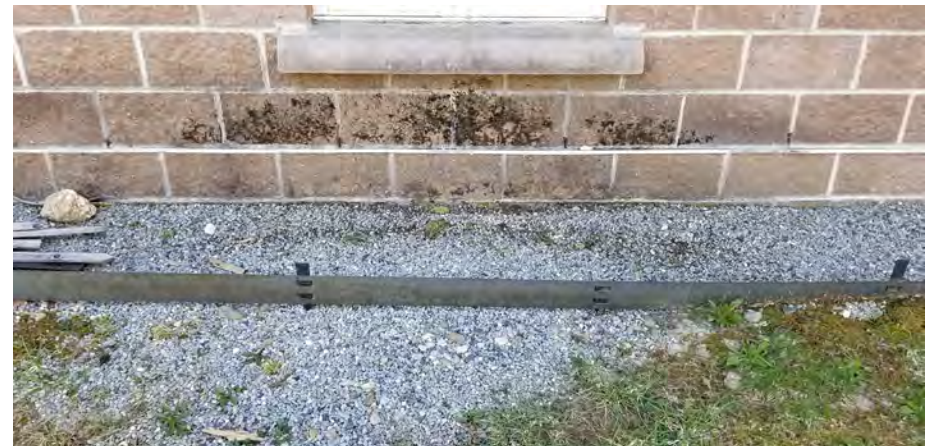
The masonry is showing signs of what might be efflorescence as well as areas of mold and lichen growth. Some areas of mortar have been repaired. The building would look better if it were power-washed to remove the dirt and growth.

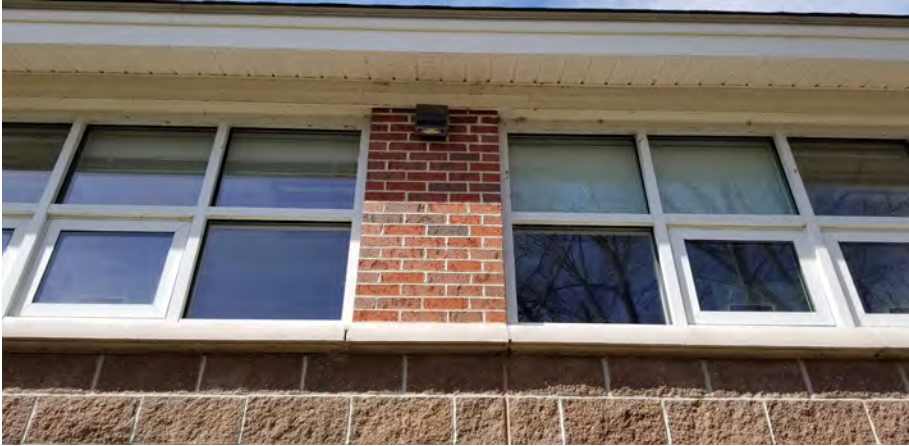
The windows are double pane insulated and are aging well. The aluminum entry doors are in good condition. Sealant around the windows is aging well, replacement should be planned for in the next two to five years.

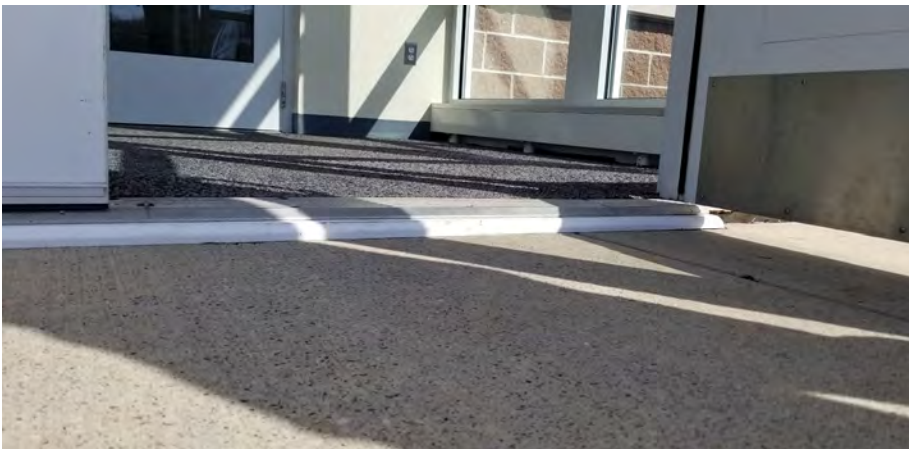
The threshold at the outer door of the vestibule does not appear to seal, which could allow water to enter during a storm or when snow melts. It appears that the sweep on the bottom of the east (main operating) leaf is missing. This should be replaced to prevent water and insects from entering the vestibule.

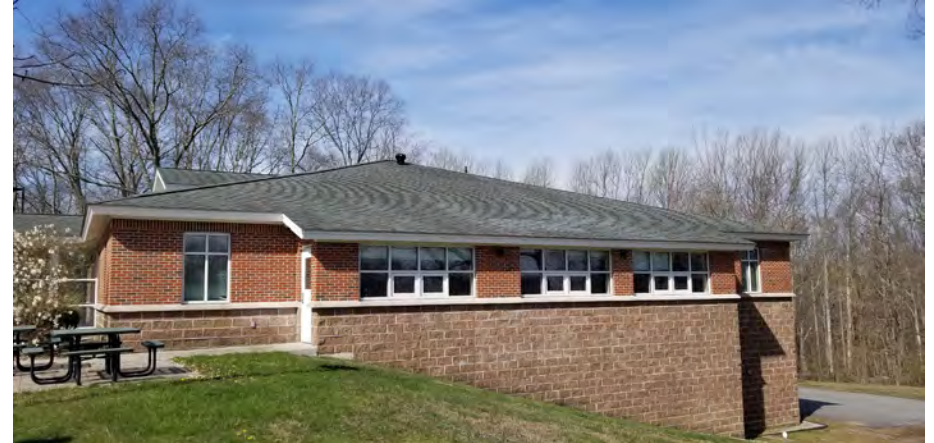
Soffits, fascia, and other exterior trimwork is in good condition and showing no signs of deterioration. The roof is reported to have suffered some leaking a few years ago. It is approaching the end of its life expectancy and replacement should be undertaken within the next two to five years.

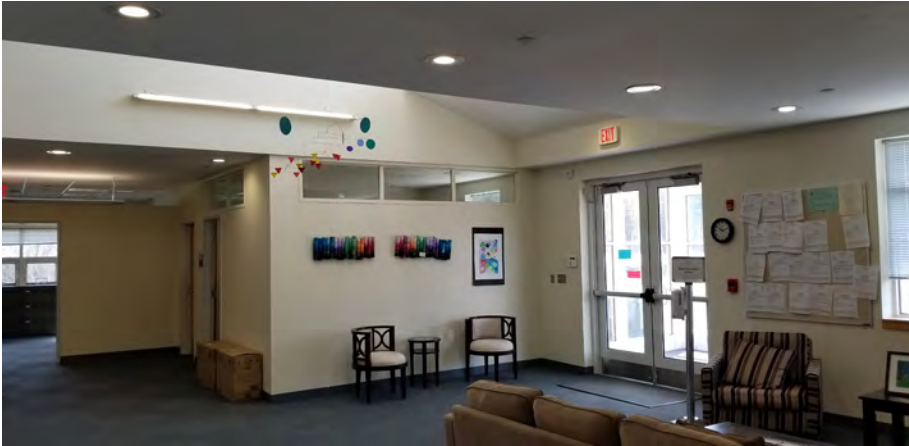
The reception area has a high ceiling with windows to let sunlight into the space. The walls, ceilings, and floors are in good condition.

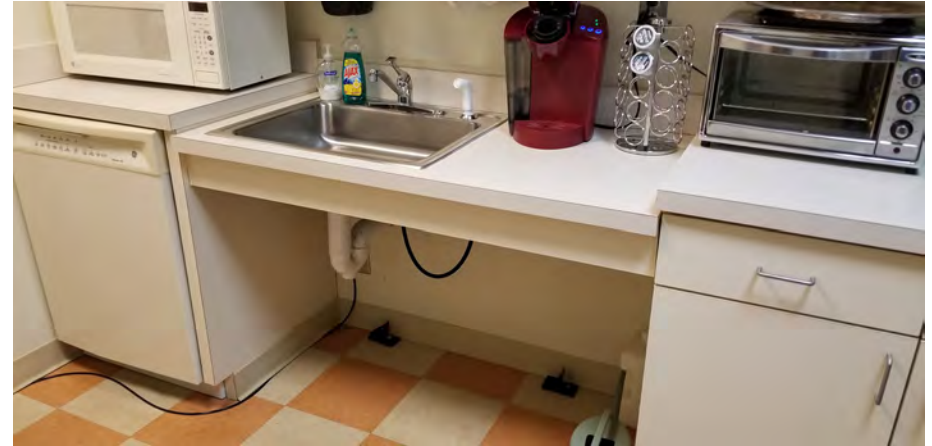
The office spaces are carpeted, with GWB walls and lay-in acoustical ceilings. The rooms are overall in good condition. Windows have operable sashes and blinds to control sunlight entry to the room. Door hardware is ADA compliant throughout. Some workstations are not fully ADA compliant, due mainly to how and where equipment is located.

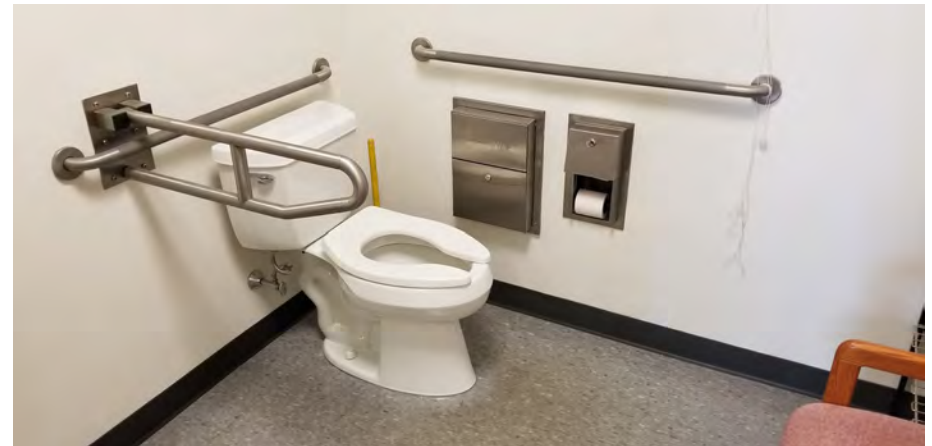
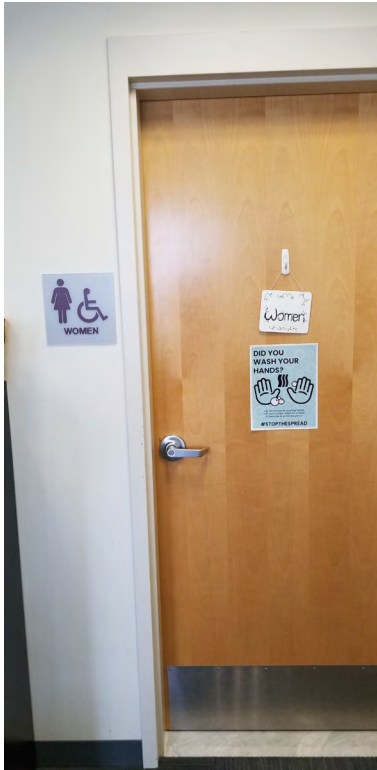
Restrooms and signage all appear to be ADA compliant and in good condition.

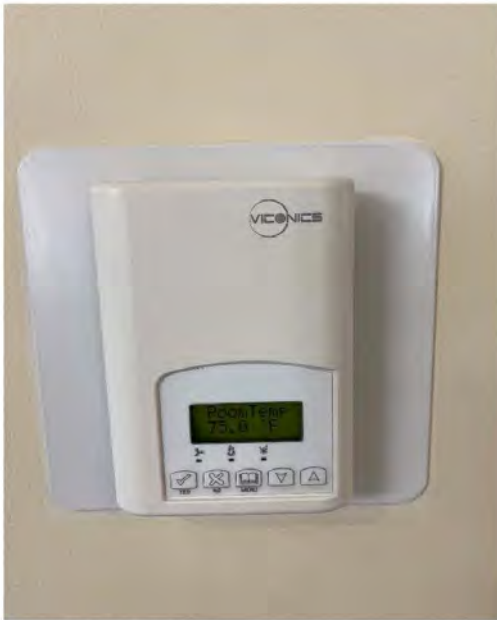
Photo # 1: Typical thermostat.

We would recommend upgrading the existing thermostats to thermostats that have the ability to tie into a central BMS (building management system). The BMS system will help improve system efficiency, help troubleshoot any issues with the equipment as well as help stay up to date on all preventive maintenance items.

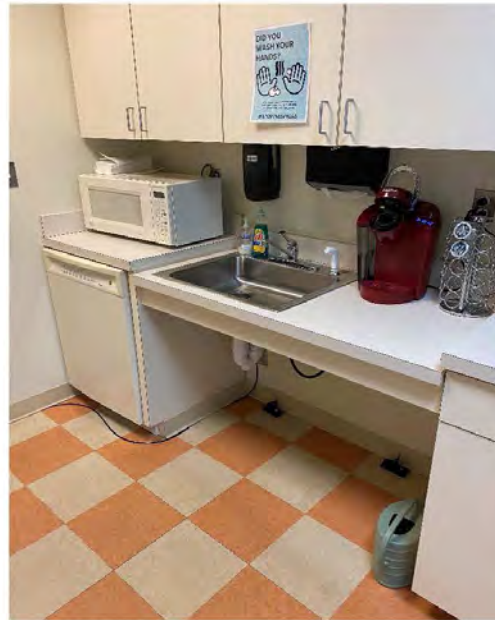
Photo # 2: Kitchenette area

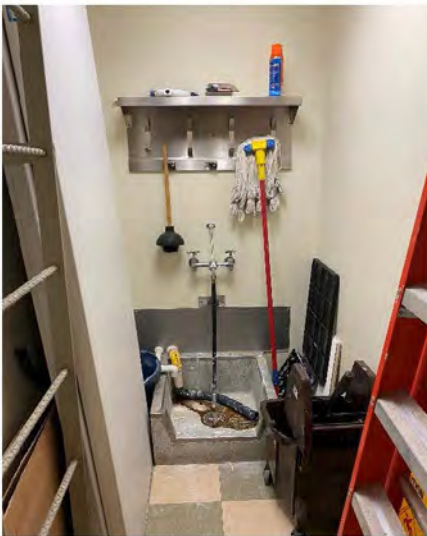
Photo # 3: Mop sink

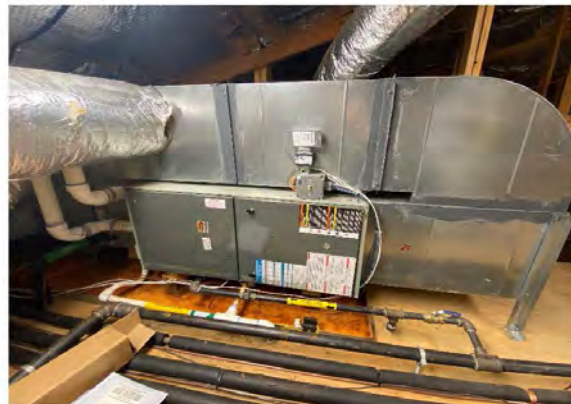
Photo # 4: Gas fire furnace located in attic space.

The gas fired furnaces and air cooled condensing units providing the heating and cooling for the building appear to be in good to fair condition and are operating as designed. The units are roughly 18 years old and are starting to near the end of their useful life. The useful life of these units is roughly 20-25 years. It would be recommended to replace these units over the next 5-10 years to more energy efficient units. These units also did not appear to bring in outside air into the spaces. It would be recommended that if the HVAC system is upgraded, a ventilation system be added to the cooling and heating units.

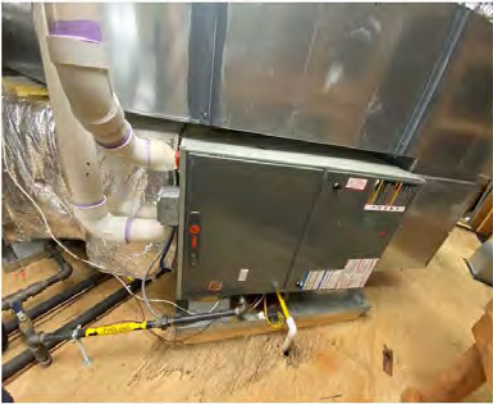
Photo # 6: Gas fired furnace.

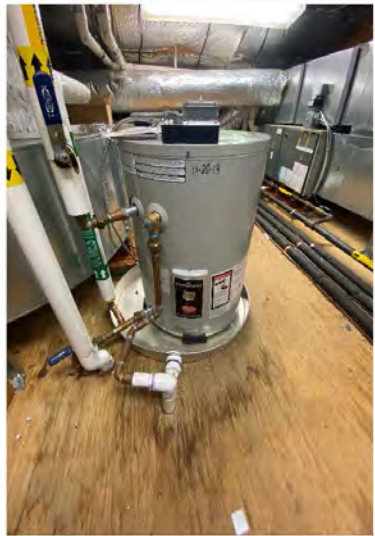
1. Domestic hot water is provided by an electric water heater located in the attic space. The water heater is manufactured by Bradford White and has a capacity of 19 gallons. The water heater appears to be 208V, single phase with an input of 2500 Watts. The disconnect for the water heater is mounted to the top of the tank. The water heater is mounted in a drain pipe which is piped to a drain pipe. The water heater appears to be installed in 2019 and appears to be in new to good condition. Hot water from the water heater serves a mixing valve located adjacent to the water heater in the attic before serving the fixtures throughout the building such as the kitchenette sink and lavatory sinks. The mixing valve appears to be in good condition and operating correctly.

Photo # 7: Domestic hot water heater.

F. MEP SYSTEMS CONCLUSION:
Overall, the plumbing system in the building appears to be in good condition. The electric water heater was installed in 2019 and is in new condition.

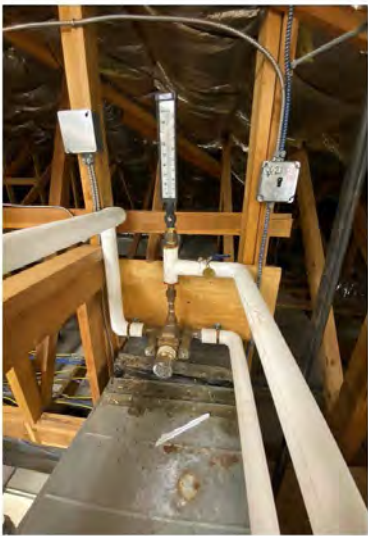
Photo # 8: Domestic water mixing valve.

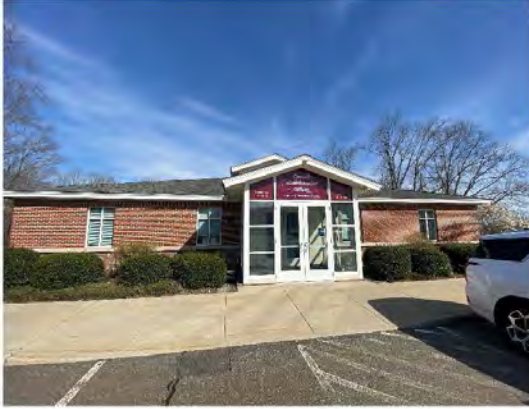
Photo # 9: Front exterior of superintendents office building

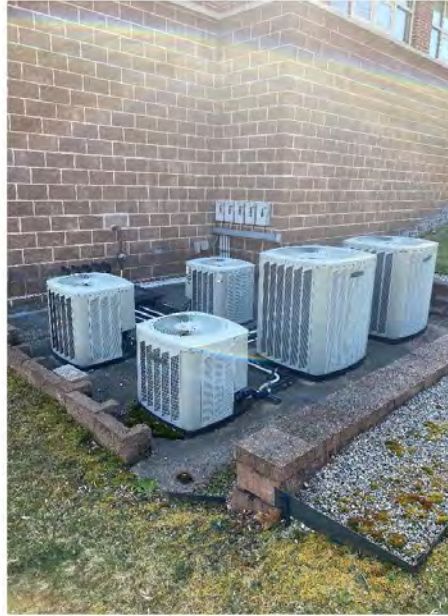
Photo # 10: Air cooled condensing units serving gas fired furnaces in attic space.

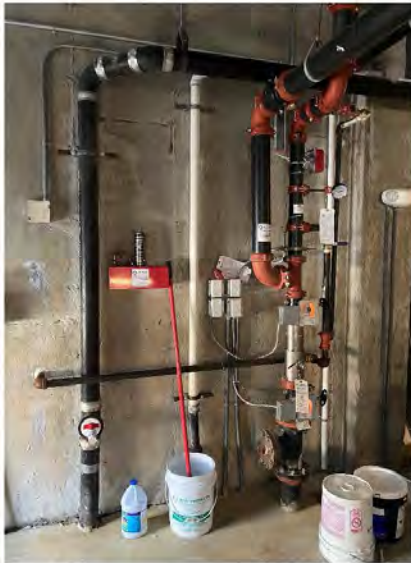
1. The Fire protection service for the building enters through the basement floor and comes in at 4" diameter. The service reduces to 3" before entering a backflow preventer and serves the entire building. Sprinklers are located throughout the basement, first floor and attic space. The wet system serves the attic space with upright sprinkler heads extended from the main serving the main floor below. The service appears to be in good condition.

Photo # 11: Fire Protection service entering through basement.

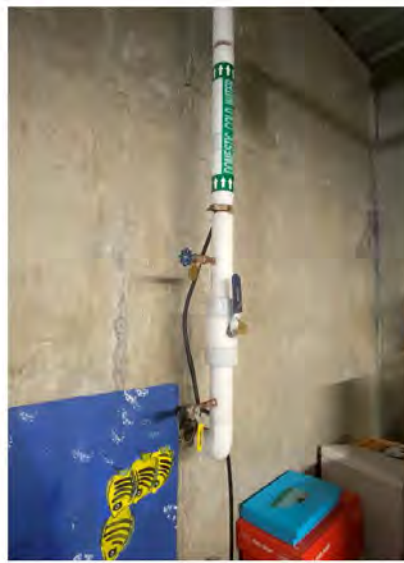
Photo # 12: Domestic water service entering through basement.

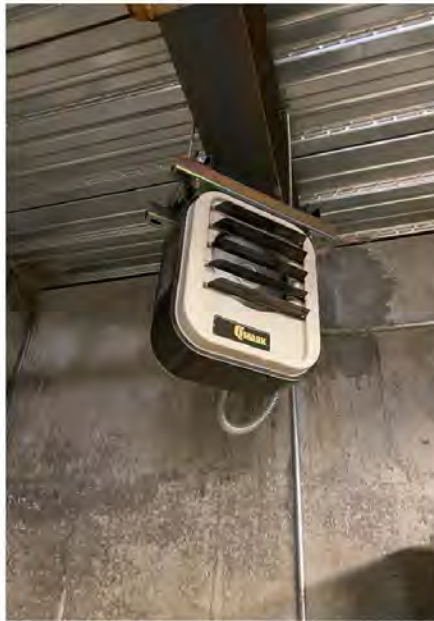
2. Electrical unit heaters are provided in the basement space for freeze protection of the sprinkler and domestic water systems. The unit heaters are manufactured by QMark and are suspended from the structure. The unit heaters appeared to be in good condition and operating correctly at the time of the site visit.

Photo # 13: Electric unit heater for freeze protection of basement area.

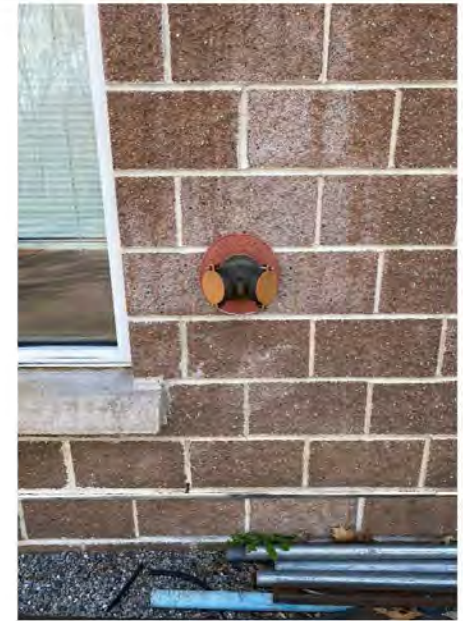
Photo # 14: Fire department connection.

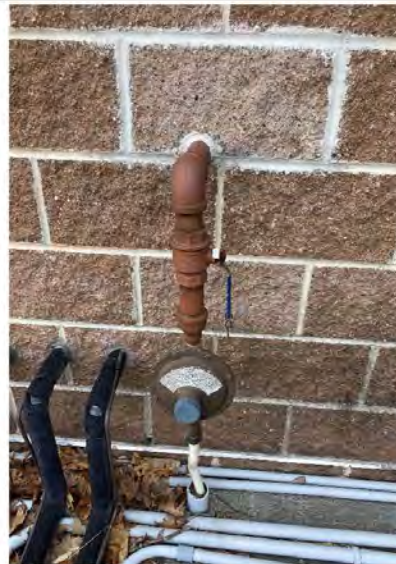
2. Gas: Gas for the building is provided through a buried propane tank near the rear of the building. It is believed that the tank is roughly 500-1000 gallons. The propane system is provided with a regulator and shut off valve at the exterior of the building before it enters to serve the gas fired furnaces located in the attic space.

Photo # 15: Propane gas service into building.

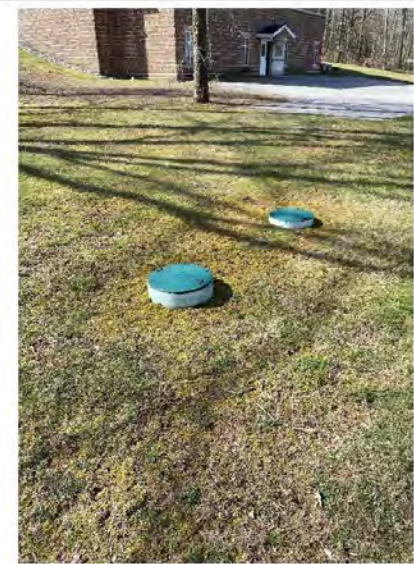
Photo # 16: Buried propane tank access covers.

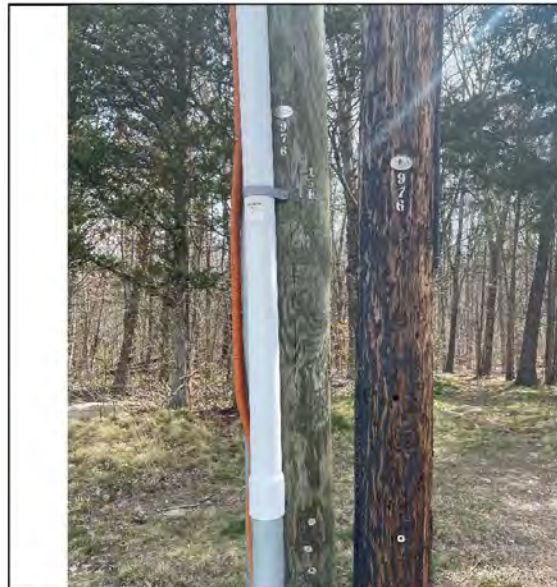
Photo # 17: - Utility Service Pole with Power and Telecommunications

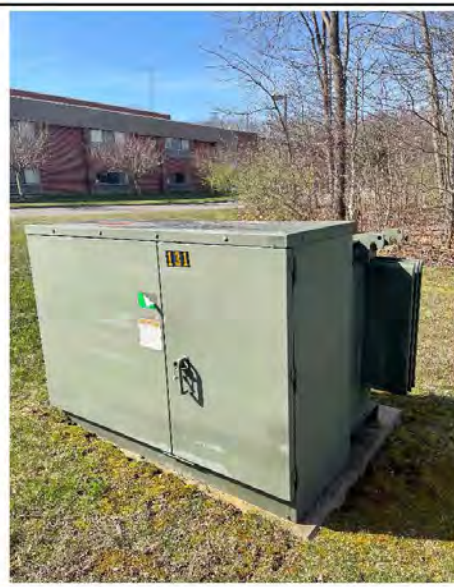
Photo # 18: - Utility Pad Mounted Transformer

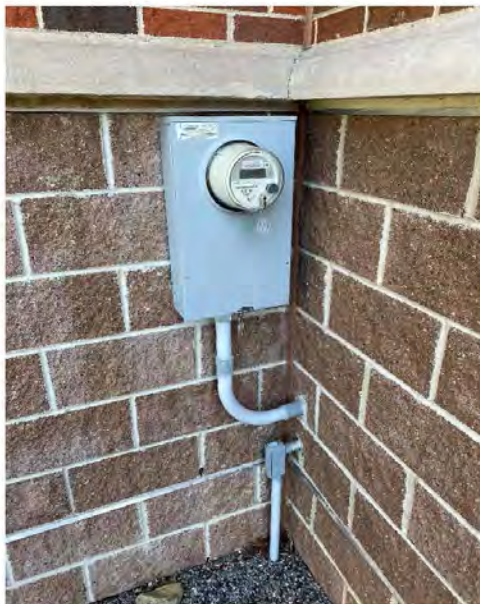
Photo # 19: - Utility Meter

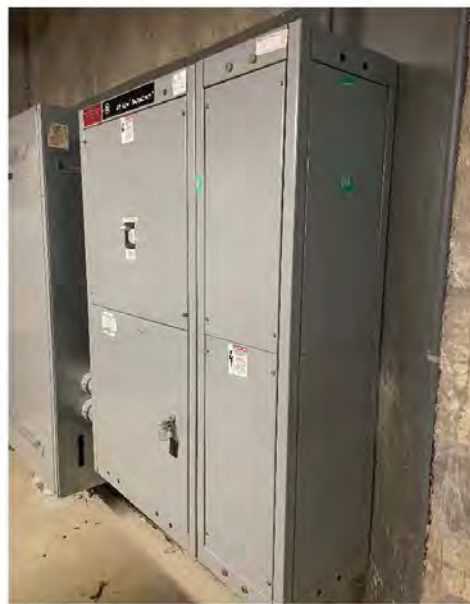
2. Electric Service Switchboard - The service entrance equipment is located in the basement of the building and consists of a 208Y/120volt, 3-phase, 4-wire main switch and CT cabinet, manufactured by General Electric and rated for 600 amperes. The metering cubicle is arranged cold sequence with the meter mounted on the exterior of the building. The main switch and CT section feeds a 600A, 208Y/120V, 3-phase, 4-wire MLO distribution panel “MDP”, which contains circuit breakers that feed lights and equipment in the basement. “MDP-2” is a 208Y/120V, 3-phase, 4-wire MLO distribution panel, rated at 600A and fed off the lugs of panel “MDP”. “MDP-2” feeds HVAC equipment and panels located in the basement and ground level. All this equipment dates from 2004, when the building was constructed. It is in excellent condition and should serve the facility for another 15-20 years.

Photo # 20: - Service Entrance Main Switch and CT Cabinet in Basement

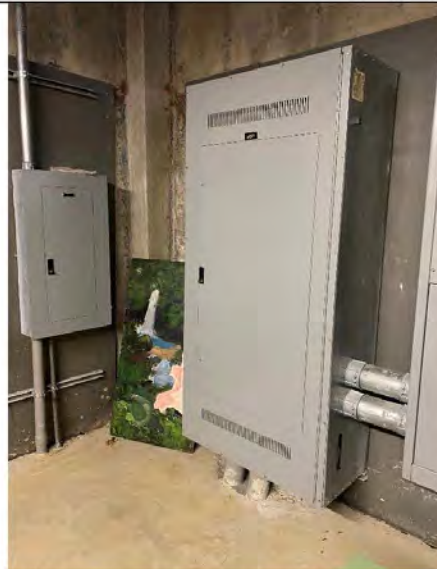
Photo # 21: - Service Entrance Equipment – Main Distribution Panel “MDP”

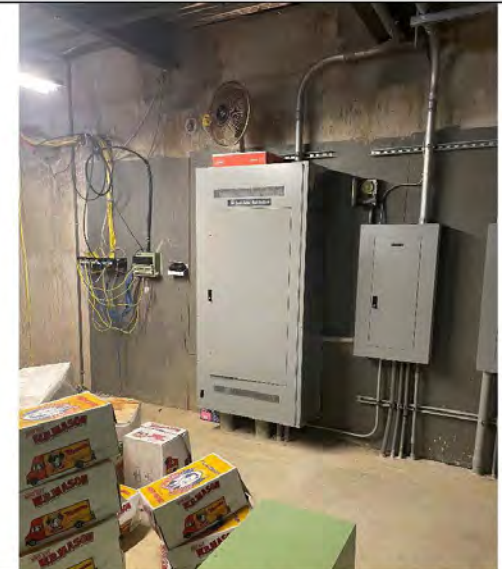
Photo # 22: - Distribution Panel “MDP-2”

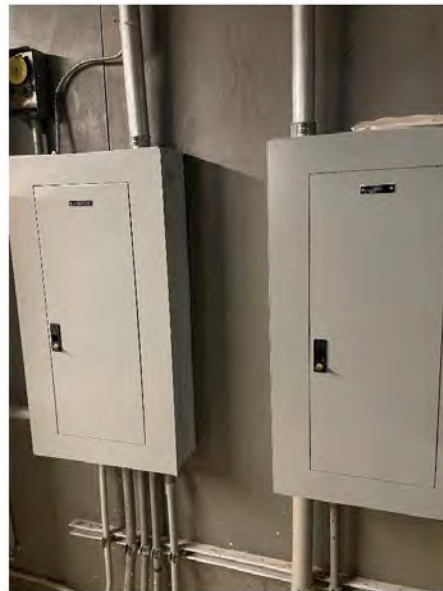
3. Electric Panelboards – Branch circuit panelboards are by General Electric and are original to the building. As observed, panelboards appear to be in excellent condition and should be in service for another 15-20 years. Available spare/bus space appears adequate.

Photo # 23: - Branch Panelboards in Basement

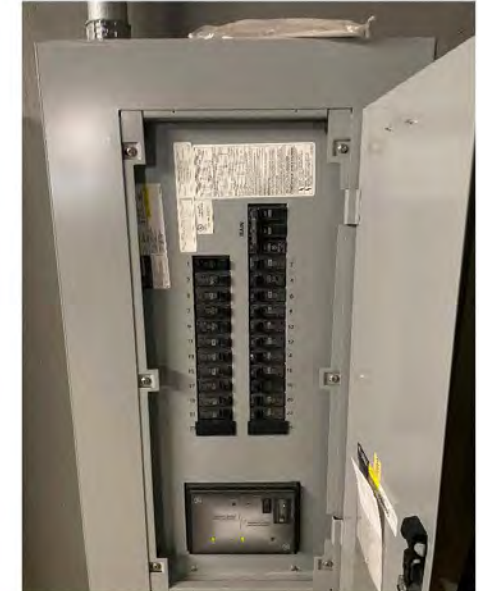
Photo # 24: - Branch Panelboard Interior

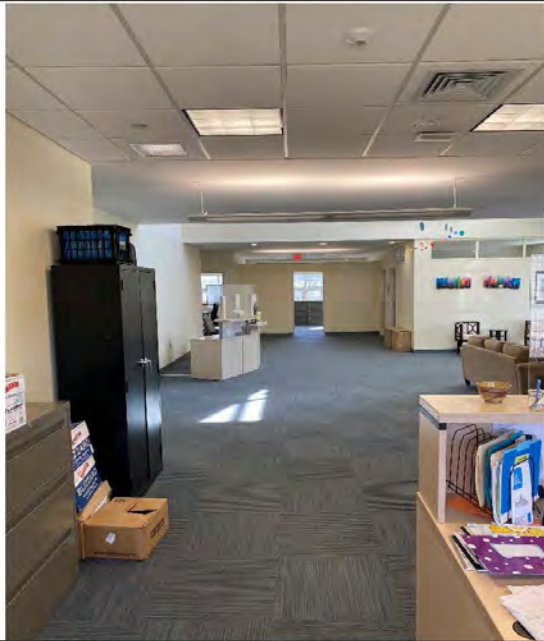
Photo # 25: - Reception Area Lighting

Most lighting systems have been retrofitted with newer technology, more energy efficient LED lamps. Emergency lighting and exit signage are battery powered and of recent vintage. It is suggested that the remaining lighting systems that have not been upgraded, be replaced with new LED fixtures, or retrofitted with LED lamps and drivers.

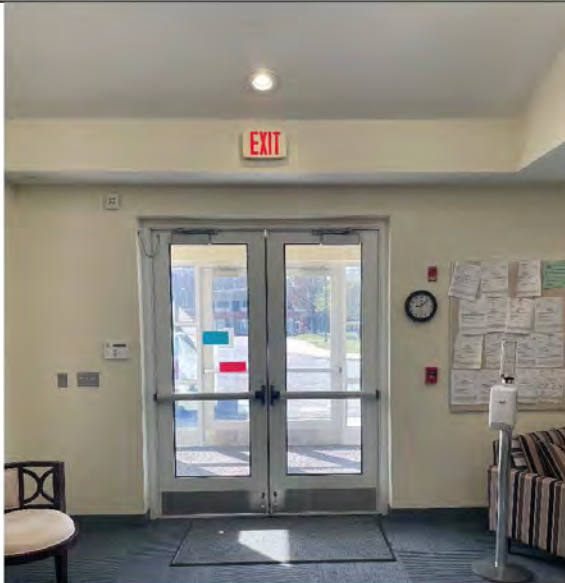
Photo # 27: - Interior Entry Lighting

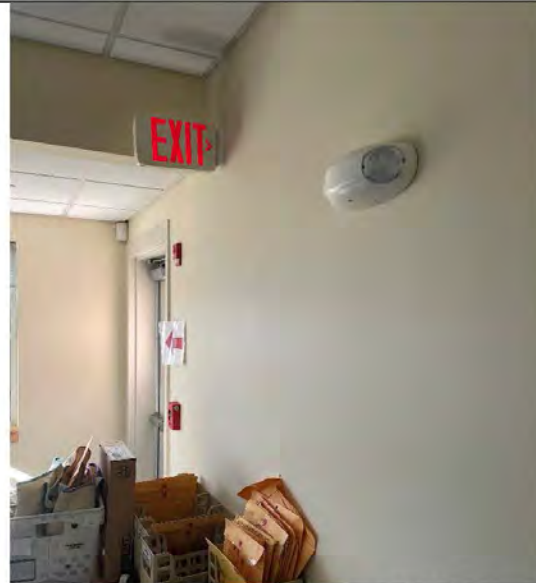
7. Battery operated emergency lights and remote emergency light heads are used to light egress paths in corridors and above exterior doors. Emergency lighting fixtures were not tested for operation, but appear correctly installed and in good condition. Exit signs are LED with battery backup. Exit signage in all areas of the building appears in compliance with current codes. All signage appears operational and in good condition.

Photo # 28: - Exit and Emergency Lighting

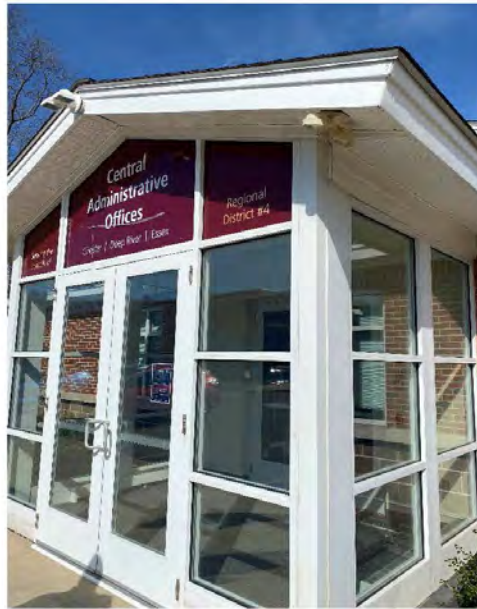
Photo # 29: - Exterior and Emergency Lighting at Front Entrance

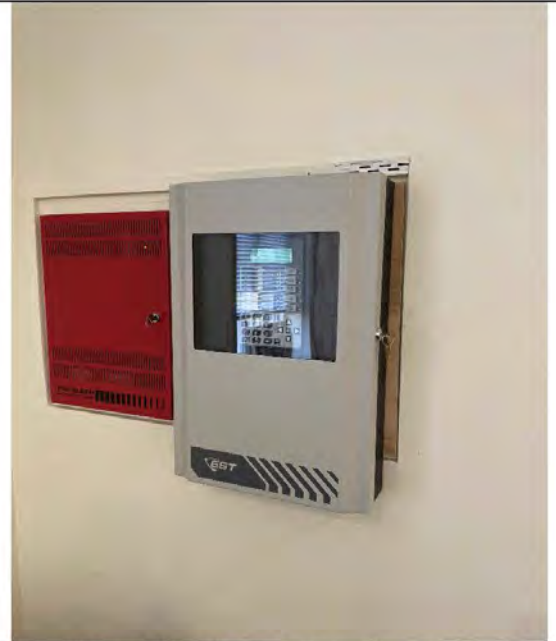
Photo # 30: - Fire Alarm Service Control Panel and Booster Cabinet at Main Entry

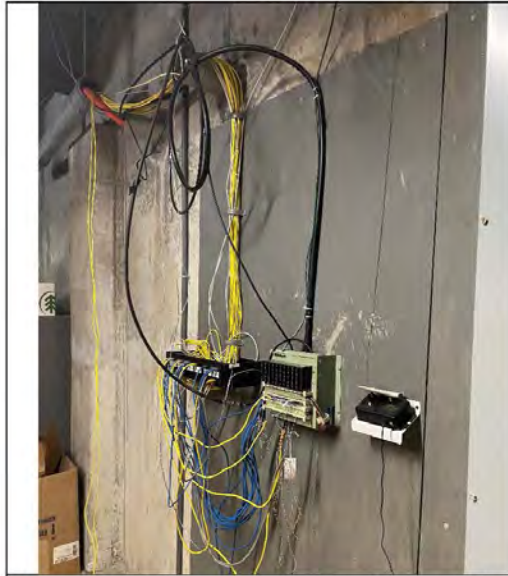
Photo # 33: Telecommunications Demarc with Fiber in Basement

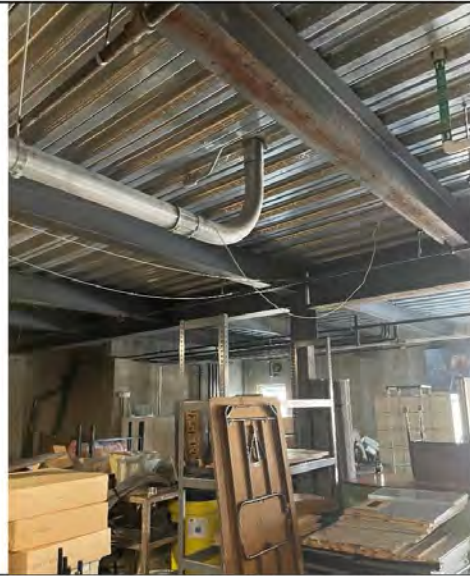
Photo # 34: - Conduit for Telecommunications Cabling up to Main Floor

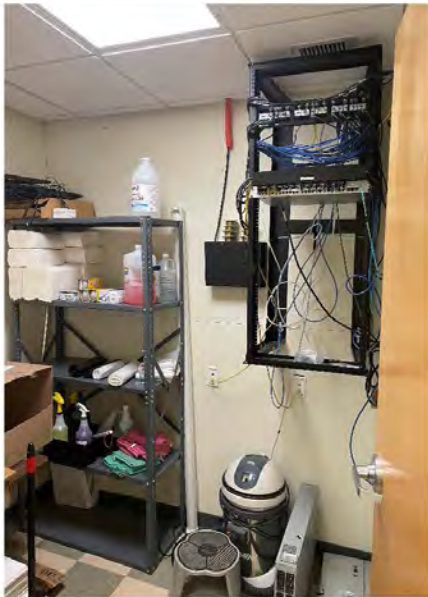
Photo # 35: - Telecommunications Rack with Fiber in Main Floor Storage Closet

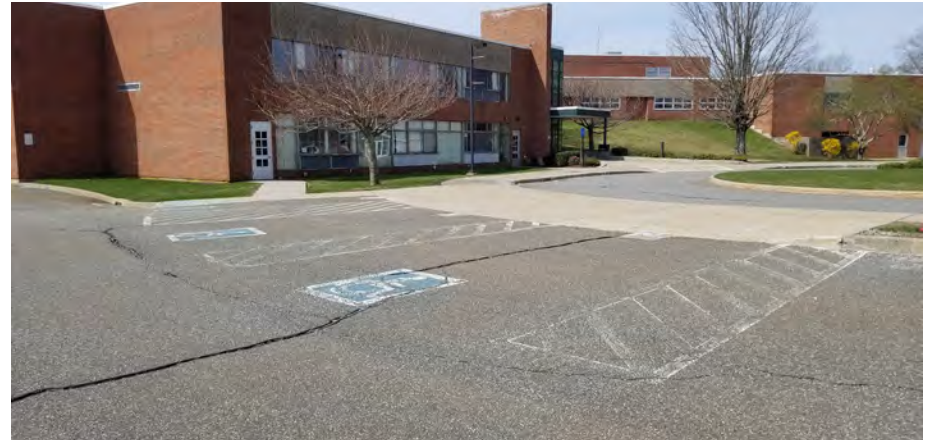
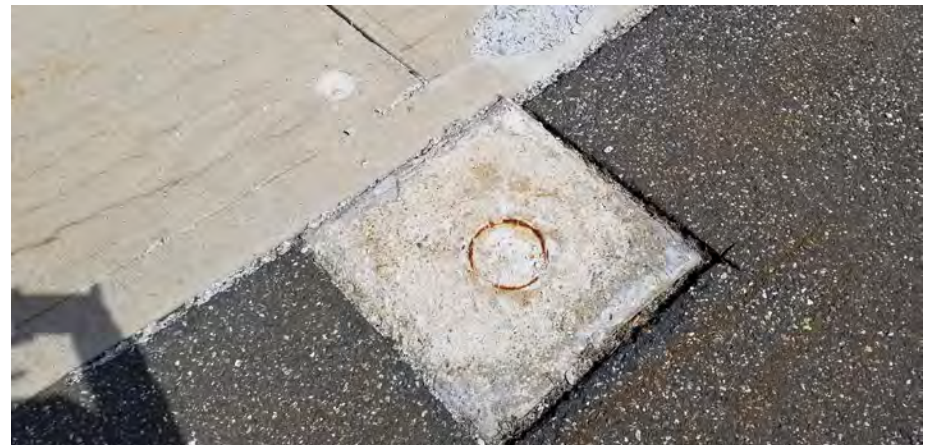
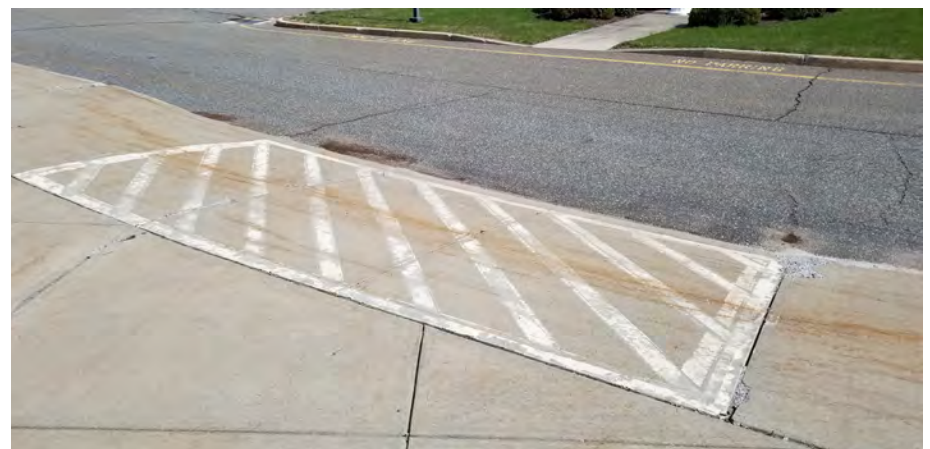
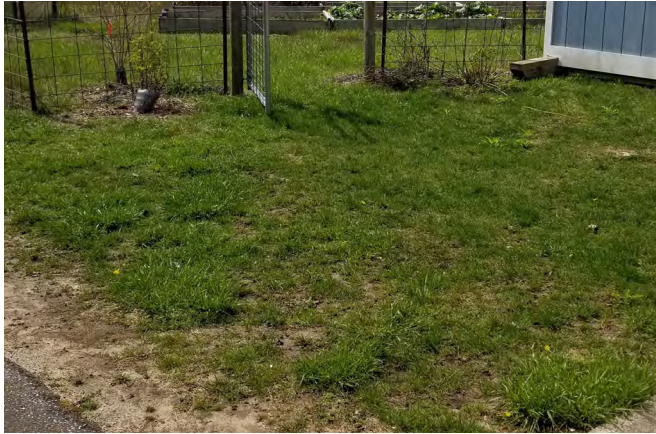
The accessible routes are not properly constructed or marked. There are designated ADA spaces on the east and south sides of the building. These appear to be properly sized for van loading and car use. However, the required crosswalks, signs, markings, and tactile warning strips are either faded, missing, or broken, taking these spaces out of compliance. This should be addressed as a first order item. Most of the corrections are straight-forward to implement.

The curbing and sidewalks immediately the north of the building entrance are concrete. Deterioration is spreading quickly in some areas and some of the walks are becoming unsafe. Deterioration will typically accelerate once it has begun. Remedial work should be scheduled in the next two years.
