**AGENDA & NOTICE FOR REGION 4 BOARD OF EDUCATION
GROUNDS and BUILDINGS MAINTENANCE & OVERSIGHT COMMITTEE
MEETING**

Athletic Facilities Master Plan

Regional School District No.4

March 2021

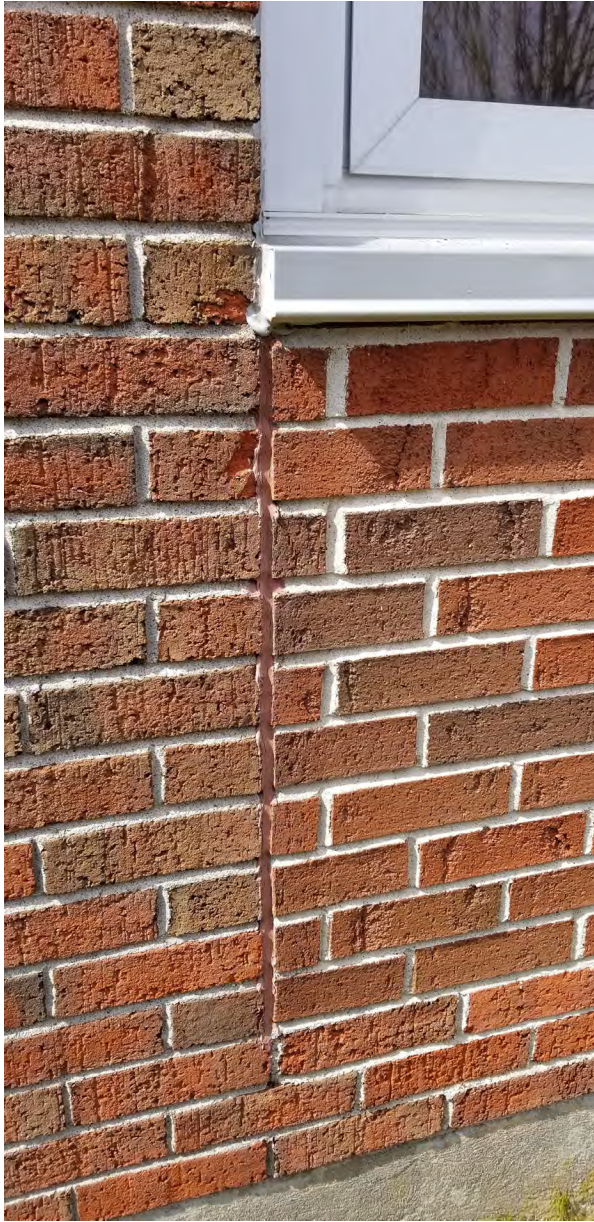
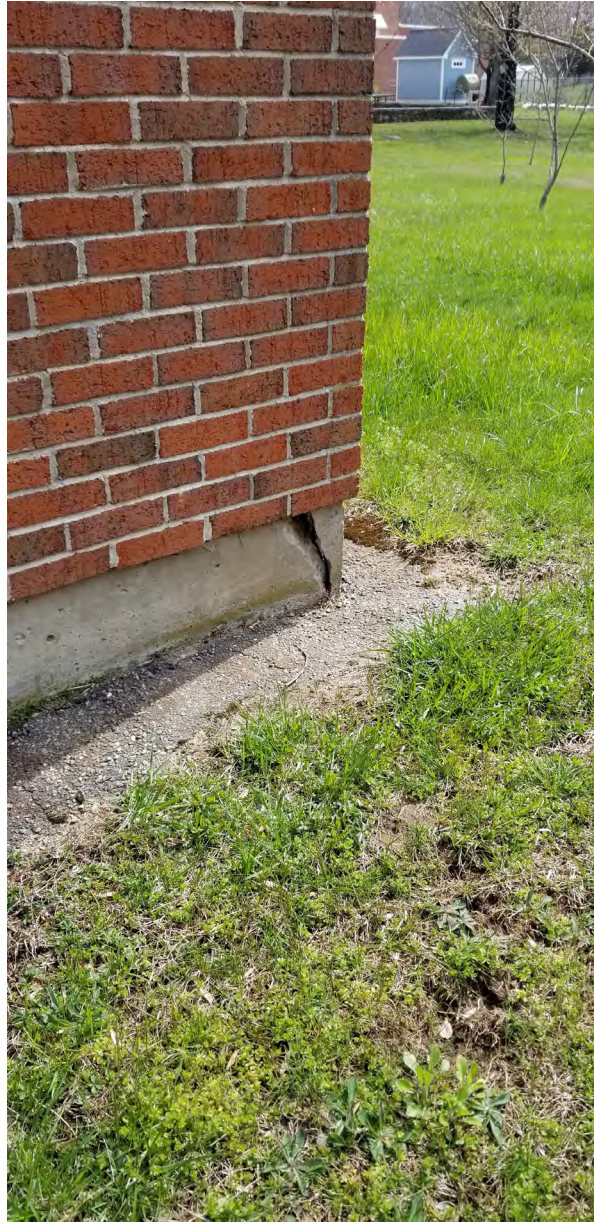
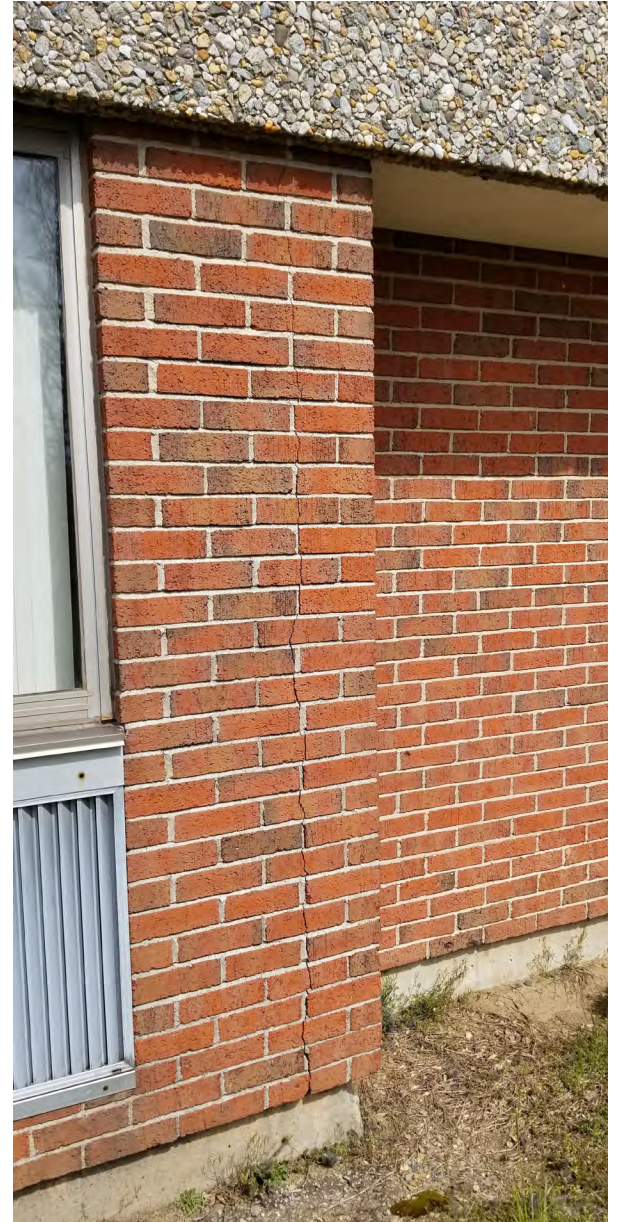
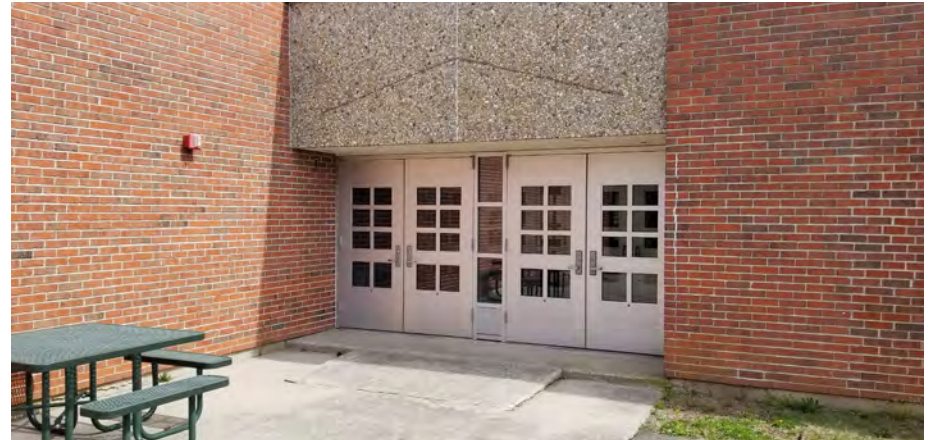
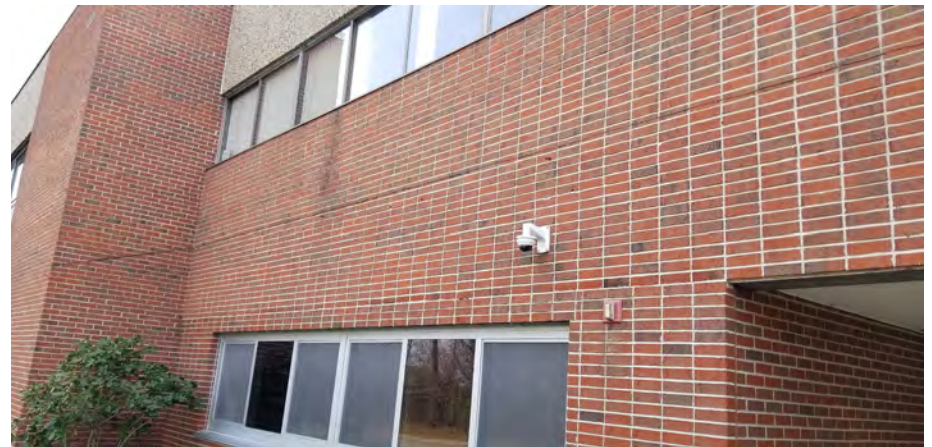
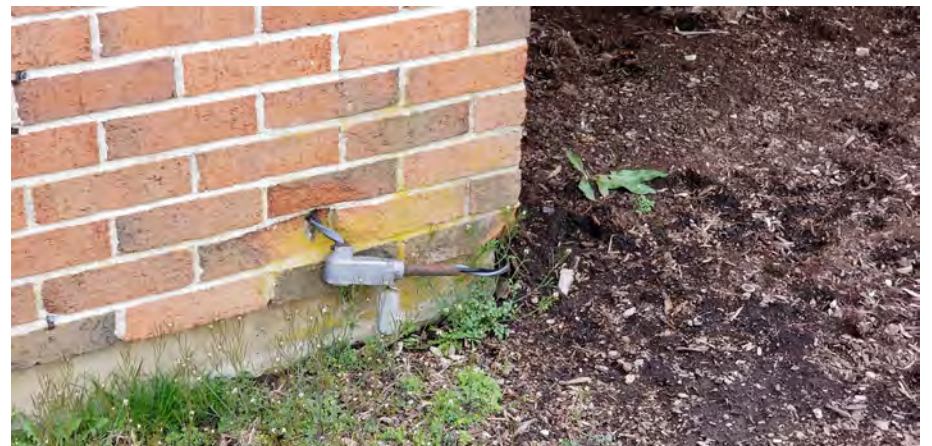
The building is clad in brick with corrugated metal and precast exposed stone panels. The brick walls show spalling, some cracking, loss of mortar, and efflorescence. The extent of this condition in some areas is concerning and it is recommended that potential causes and resolution be investigated to assure continued structural and environmental integrity of the building.

The deterioration of the brick is especially evident on some of the building corners, the chimney, and other areas both at ground level and above the roofline. Given.

The photos on this and the facing page illustrate some of the areas observed during our assessment.

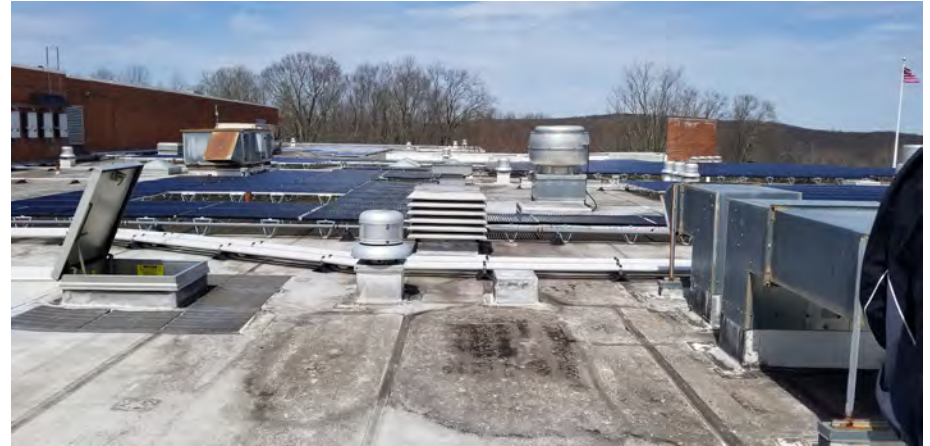
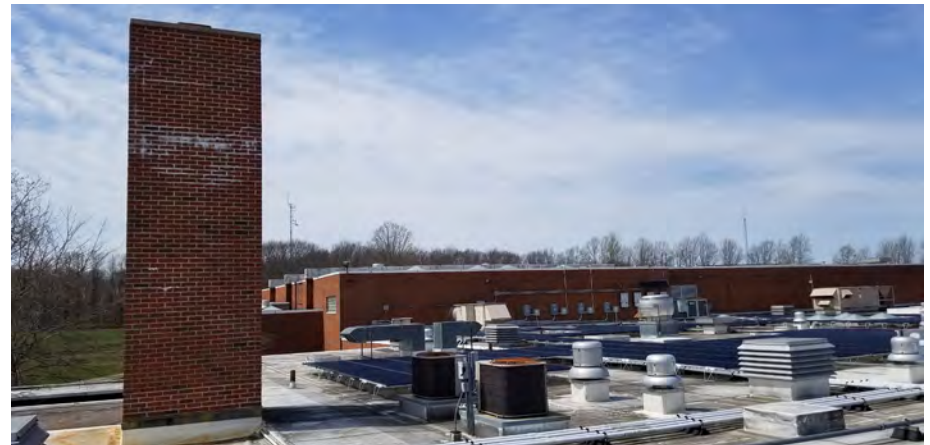
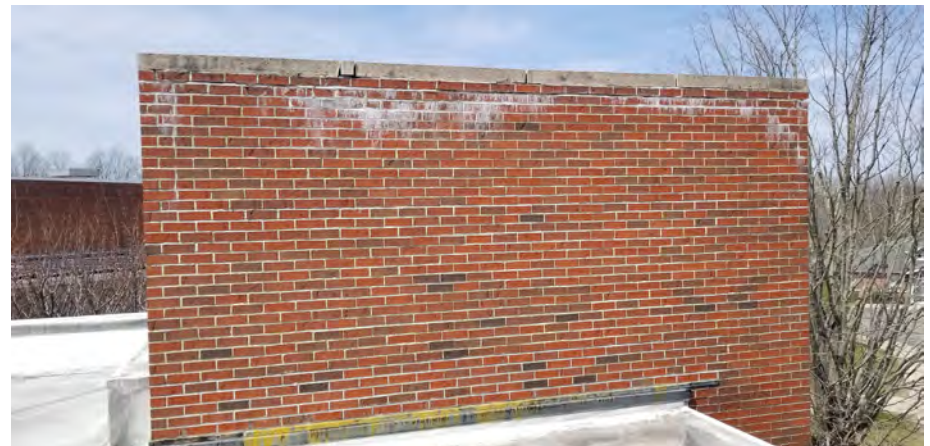
leak or point of water ingress along the north side of the roof. This shows on the interior as rot, dampness, and mold on the wall near the nurse's office. This roof should be further investigated to determine what life expectancy might be left. Roof drains need to be cleaned in various locations on the roof, and secondary scuppers are needed in many areas. It is recommended that replacement of this roof be planned for sometime in the next three to five years, unless further investigation determines it remains a sound roof and drain system.

Photos on this and the facing page give an idea of the conditions on the roof relative to effluorescence in the brick, deterioration of the chimney caps, water ponding on the roof, and the overall condition of the roofing membrane itself.

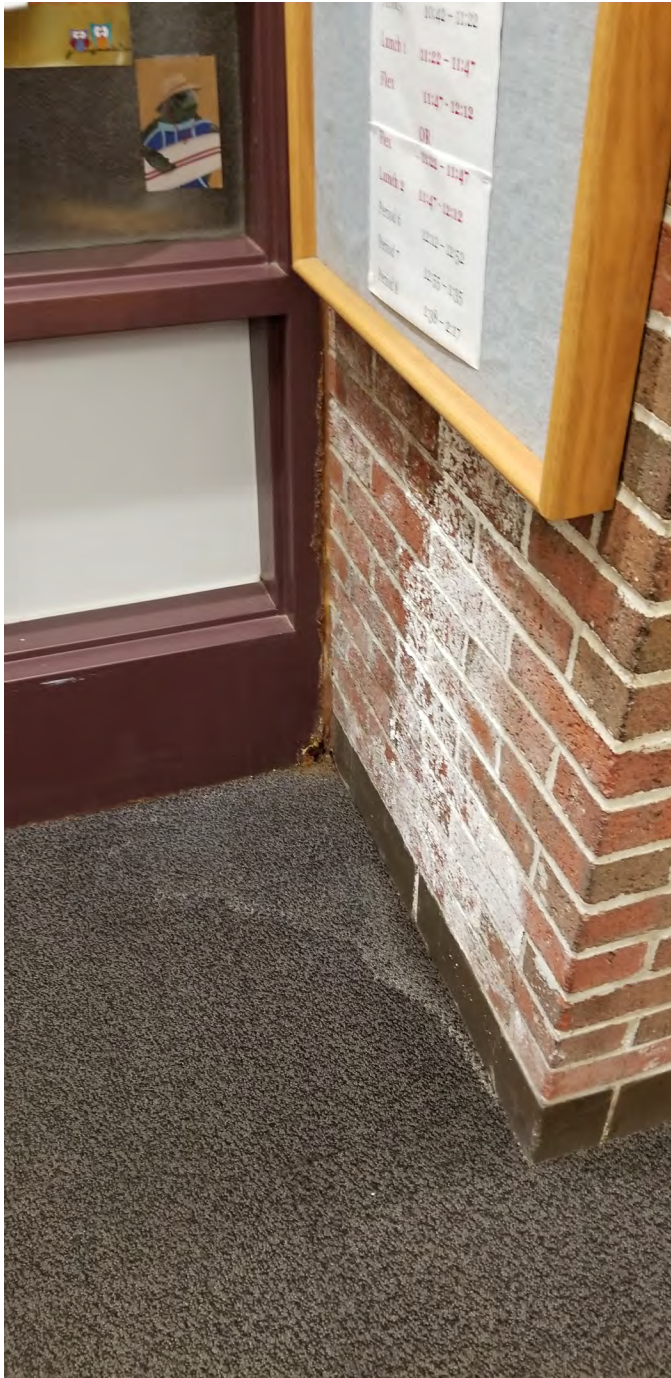
An area of concern is seen in the large photo on the facing page. This shows the damage caused by a persistent roof leak. Water has traveled beneath the roof membrane to an opening in the roof deck at one of the walls. Water has made its way down the wall near the door to the Nurse's office, where it has rotted the door frame and caused efflorescence of the brick.

It is unclear if the cause of this water infiltration has been found. This is cause for concern on a number of fronts and should be addressed as quickly as possible.

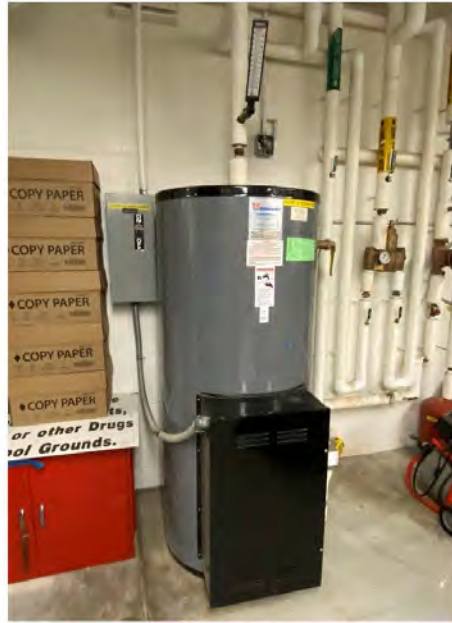
Photo # 1: Electric water heater with mixing valves.

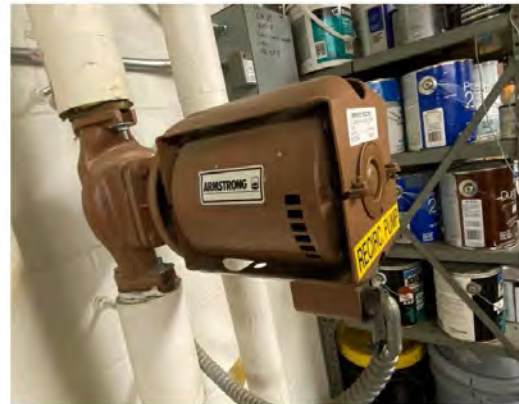
Photo # 3: Domestic hot water re-circulation pump.

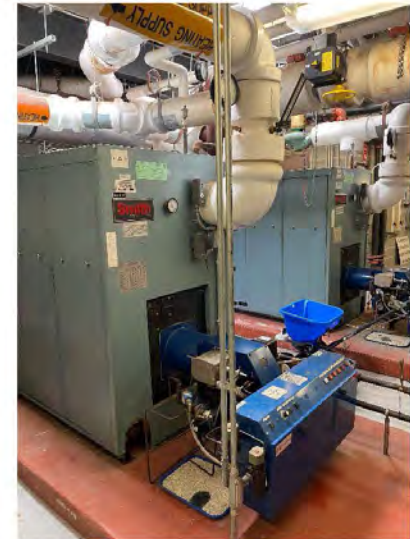
Photo # 4: Existing boiler plant.

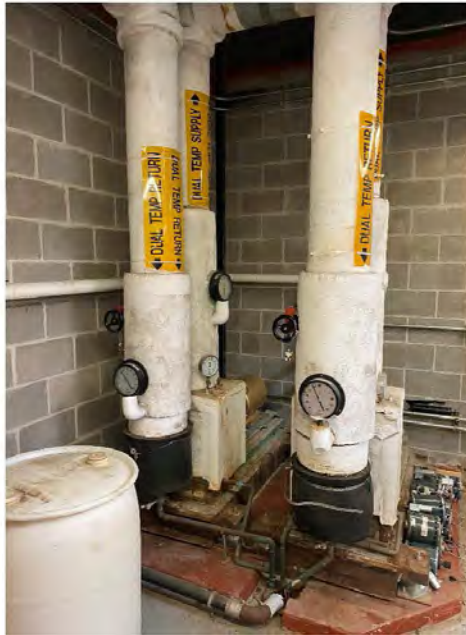
Photo # 5: Dual temp base mounted pumps.

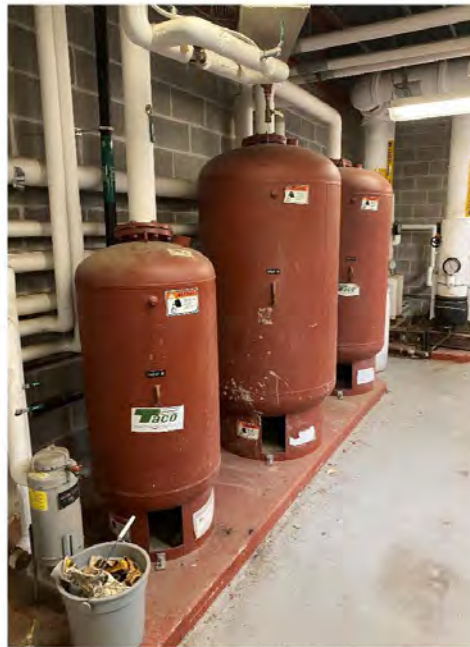
Photo # 6: Expansion tanks for hydronic systems.

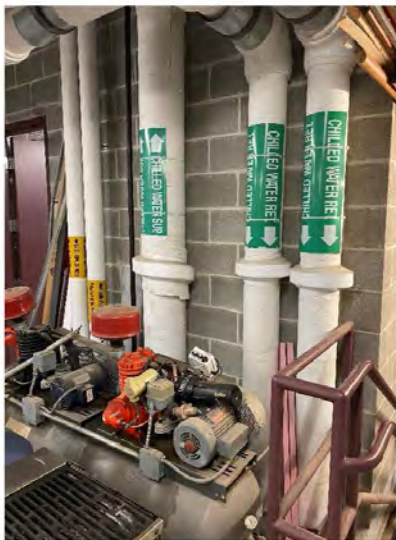
Photo # 7: Chilled water distribution piping.

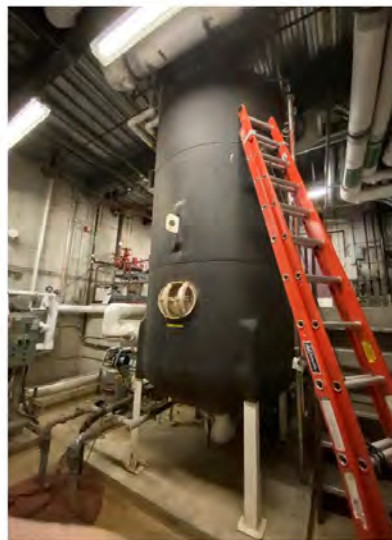
Photo # 8: Water storage tank.

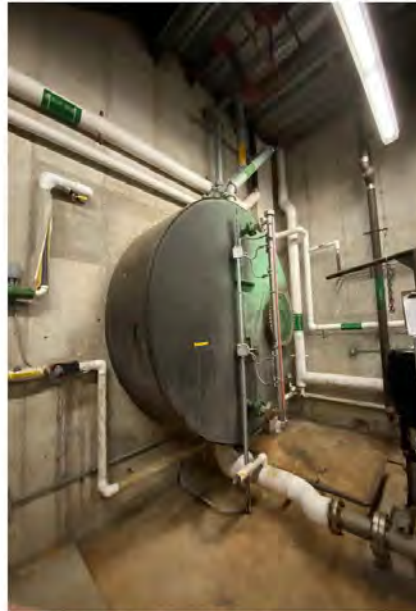
Photo # 9: Buried water storage tank.

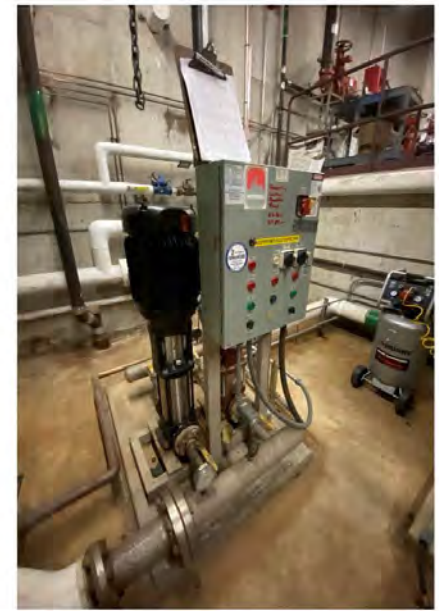
Photo # 10: Domestic water booster pump system.

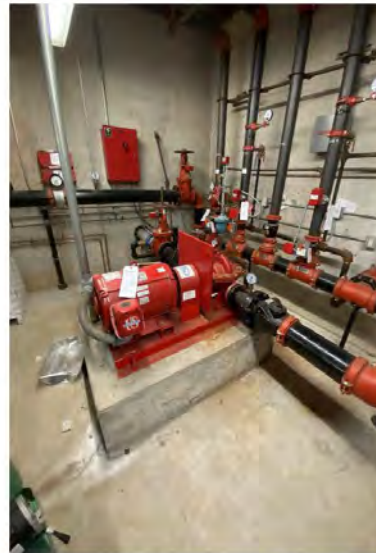
Photo # 11: Fire pump and sprinkler riser assembly.

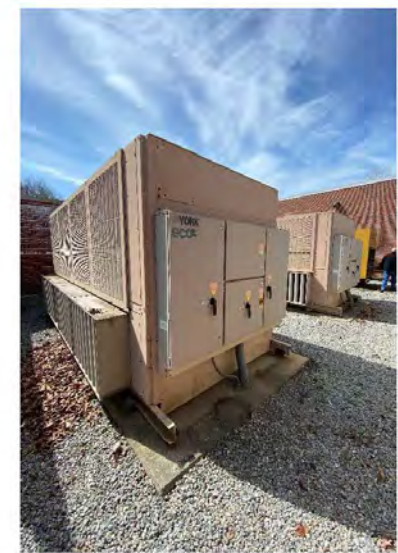
Photo # 12: Existing air cooled chillers.

The air handling units/ roof top units and unit ventilators vary in age, however, the units are operating past their useful life and should be upgraded/ replaced in the near future. Chilled water is provided to the air handling units, rooftop units and unit ventilators via (2) 130 ton air cooled chillers, located on grade next to the building. The chillers are manufactured by York and are model YCAS0138EB46YFA. The chillers appear to be operating correctly, however, as the rest of the air handling equipment, the chillers are exceeding their useful life and should be replaced in the near future.

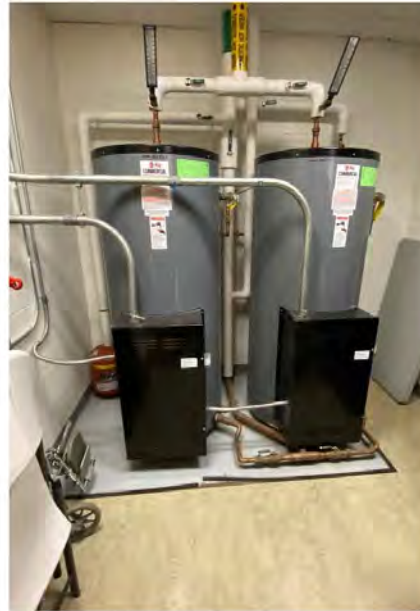
Photo # 14: Existing electric domestic water heaters.

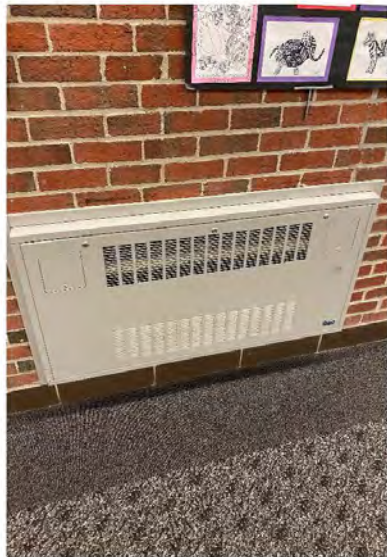
Photo # 15: Semi recessed cabinet unit heater.

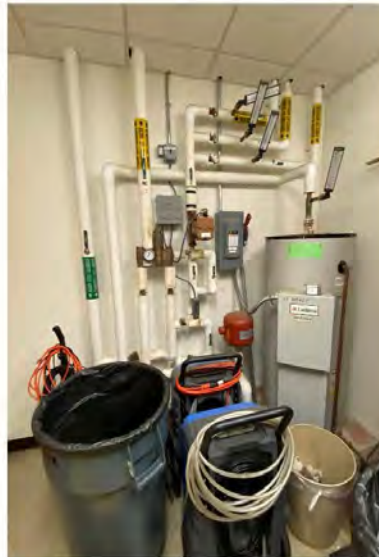
Photo # 16: Additional electric water heater in storage room.

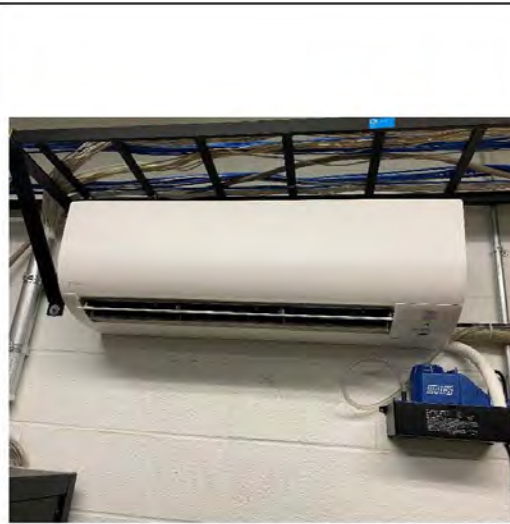
Photo # 17: AC split unit with condensate pump.

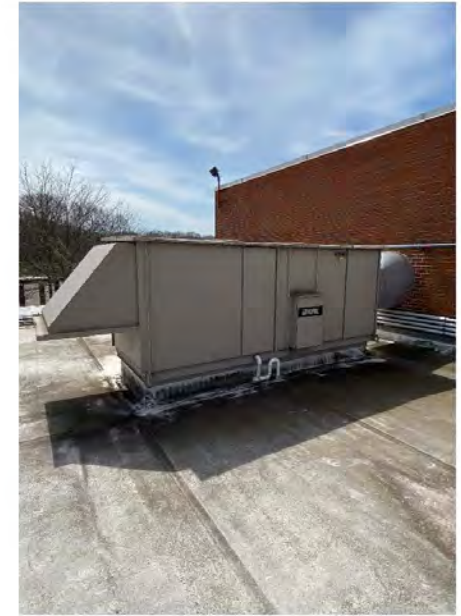
Photo # 18: Existing air handling unit.

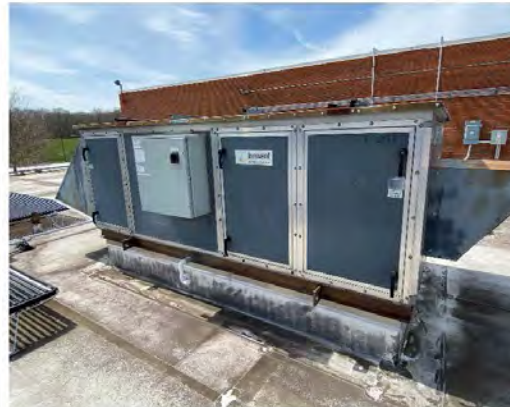
Photo # 19: Gas fired heat pumps- installed in 2017.

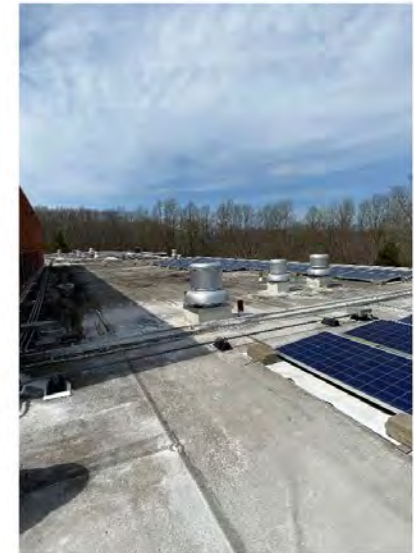
Photo # 20: Typical roof mounted exhaust fans.

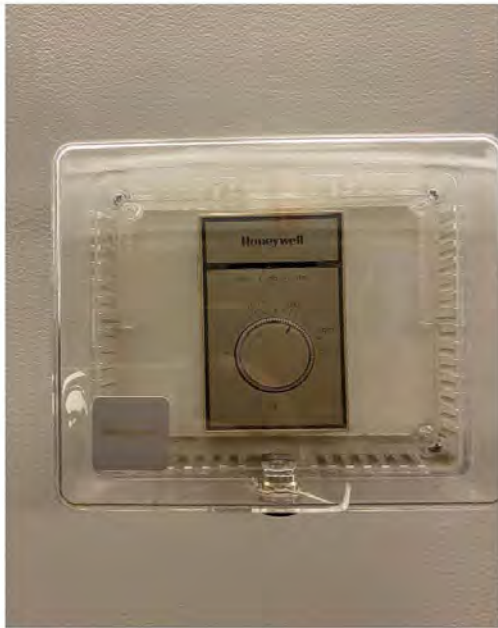
Photo # 21: Honeywell thermostat.

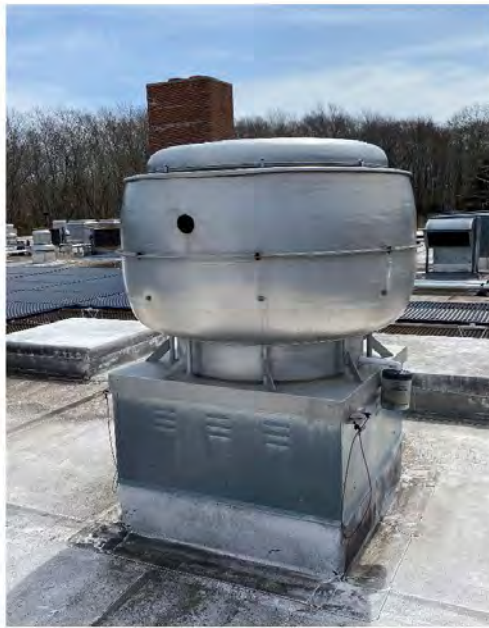
Photo # 22: Kitchen exhaust fan

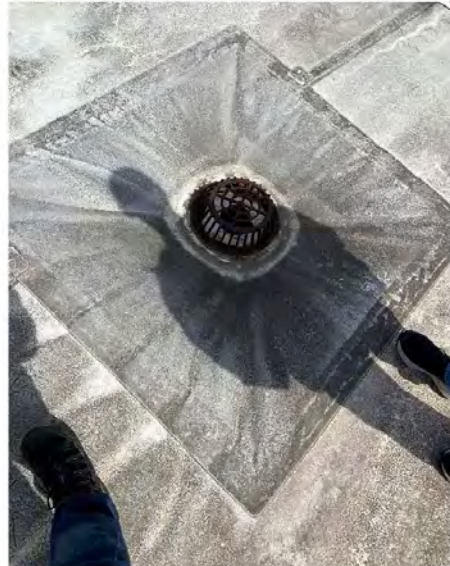
Photo # 24: Roof drain.

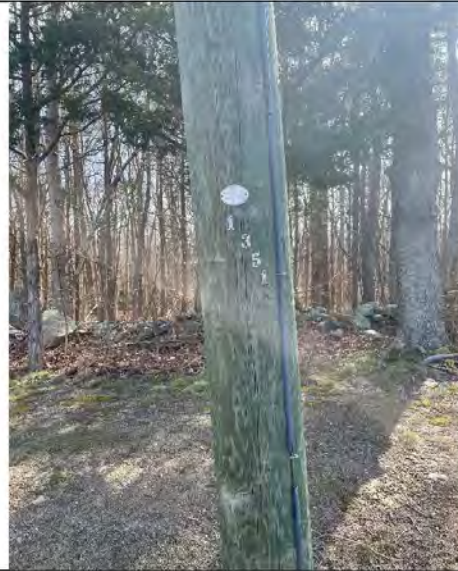
Photo # 25: - Utility Service Pole #1351

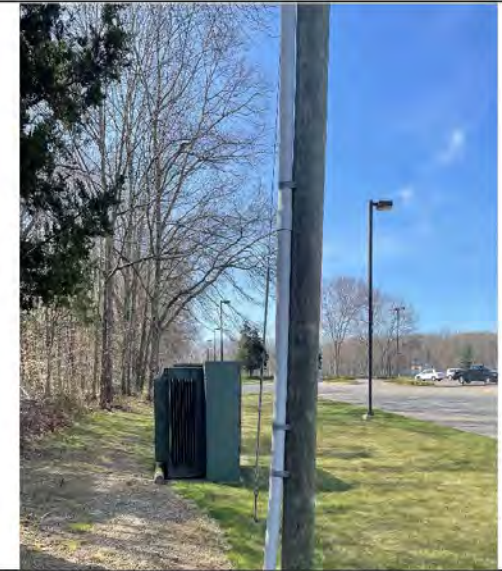
Photo # 26: - Utility Service Pole Primary and Telecommunications with Utility Transformer

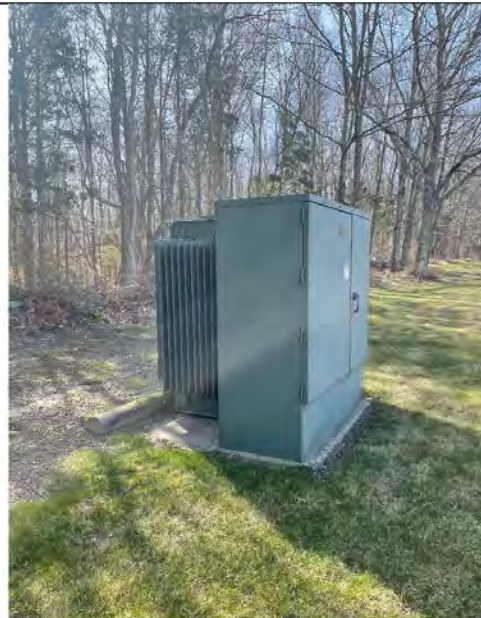
Photo # 27: - Utility Pad Mounted Transformer

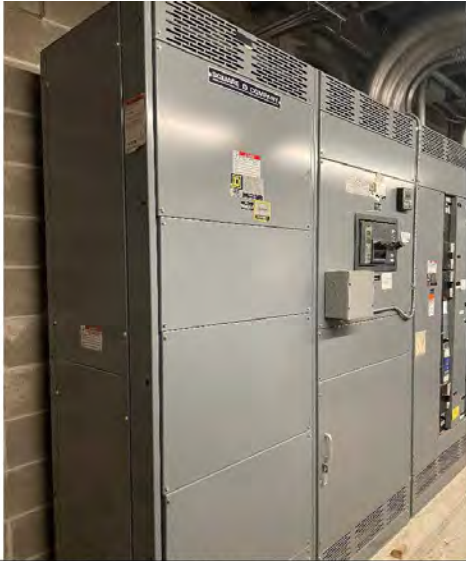
Photo # 29: - Service Entrance Switchboard in Main Electric Room

The Main Electric Service Switchboard and distribution system were installed as part of additions and renovations that were made 2005. This equipment is in excellent condition with no reported issues and should remain in service for another 15-20 years. Branch panelboards and feeders appeared in good condition with no issues reported.

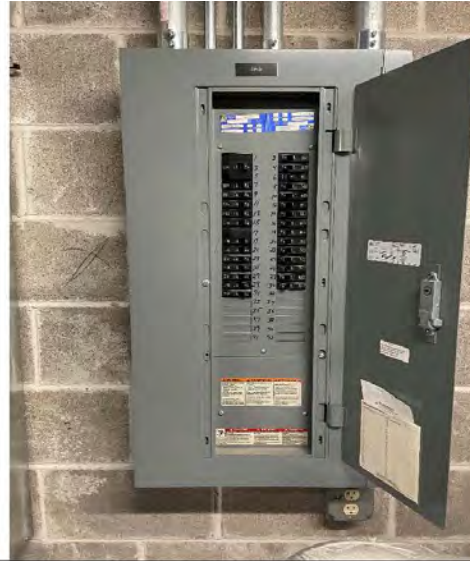
Photo # 30: - Typical "CP" for Mechanical Equipment

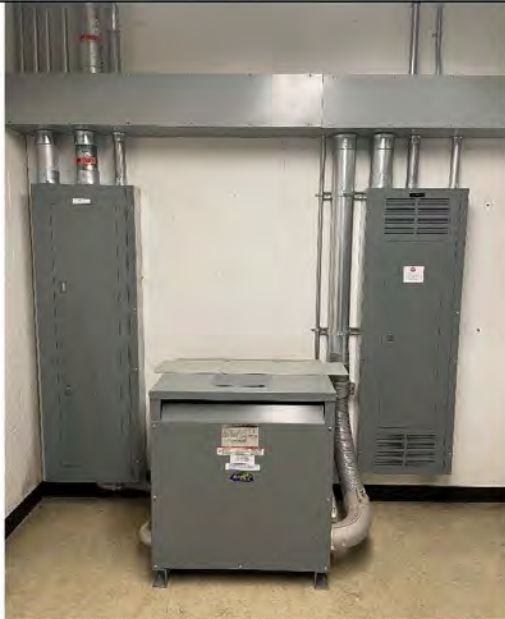
Photo # 31: - Typical Electrical Closet Panels and Distribution Transformer

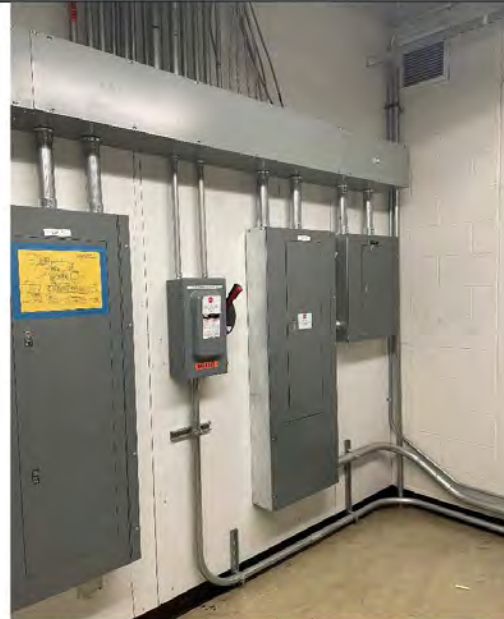
Photo # 32: - Typical Branch Panelboards – Square D (2005)

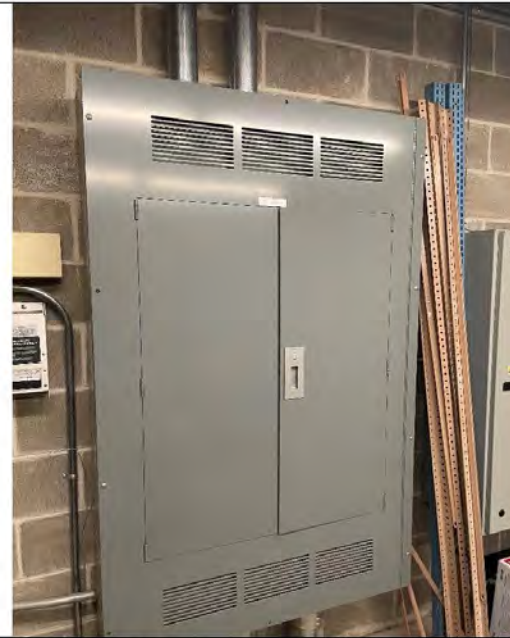
Photo # 33: - Emergency Distribution Panel “EDP”

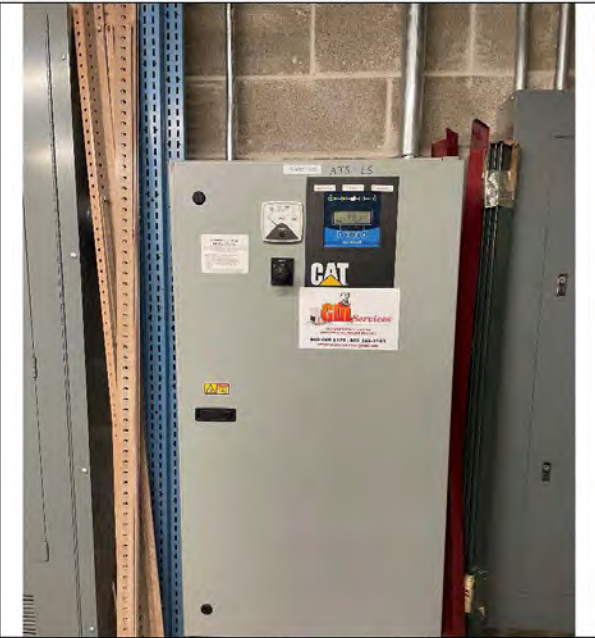
Photo # 34: - Automatic Transfer Switch – 150A “ATS-LS” (Life Safety)

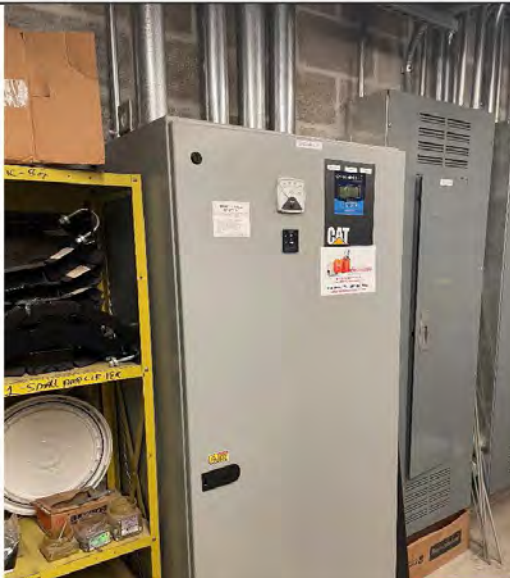
Photo # 35: - Automatic Transfer Switch – 600A (Optional Standby)

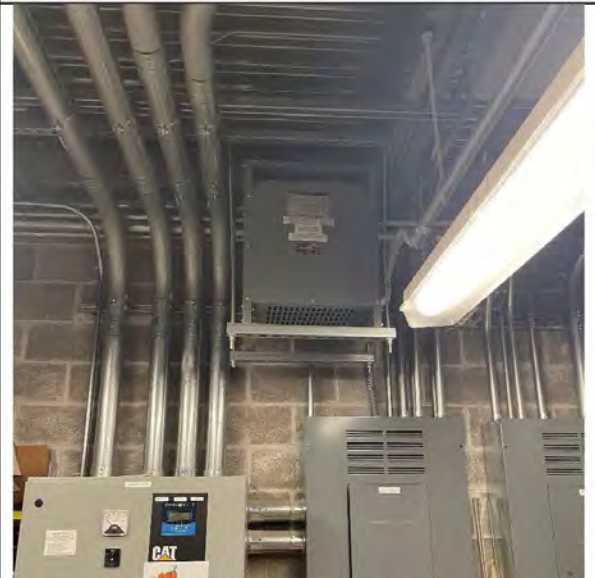
Photo # 36: - Standby ATS with Distribution Panel “ESB-1” and Transformer for Panel “EOP”

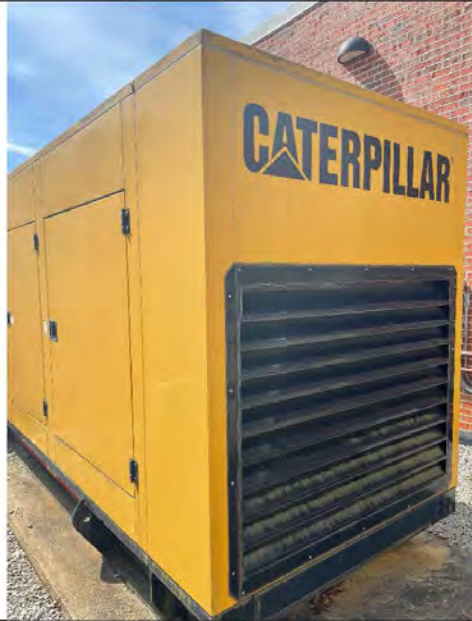
5. Emergency and Optional Standby Power – Emergency and Stand-by power to the building is provided by a 400kW/500kVA, 480/277V, 3-phase, 4-wire diesel-fired standby generator with sub-base fuel tank, manufactured by Caterpillar. A 600A generator mounted circuit breaker is fed from a 600A MCB, 480/277V Emergency Distribution Panel “EDP”. Panel “EDP” contains a 150A circuit breaker and a 500A circuit breaker, which feed the Life Safety and Optional Standby transfer switches, respectively. Life Safety transfer switch “ATS-LS” is wired to a 150A MCB, 480/277V Life Safety distribution panel, which feeds branch panels throughout the building for emergency lighting. The Optional Standby transfer switch, marked “600AMP ATS”, is wired to a 500A MCB, 480/277V 2-section distribution panel “ESB-1”. “ESB-1 (SECT. 1)” feeds “CP” branch panels, AHU’s, and various other pieces of mechanical equipment. “ESB-1 (SECT. 2) feeds RTU’s, well pumps, kitchen panel “KP-1” and transformer for panel “EOP”. “EOP” is a 100A, 208/120V panel that feeds various 120V and 208V mechanical equipment loads.

Photo # 37: - 400kW/500kVA Diesel Powered Generator with Sub-Base Fuel Tank

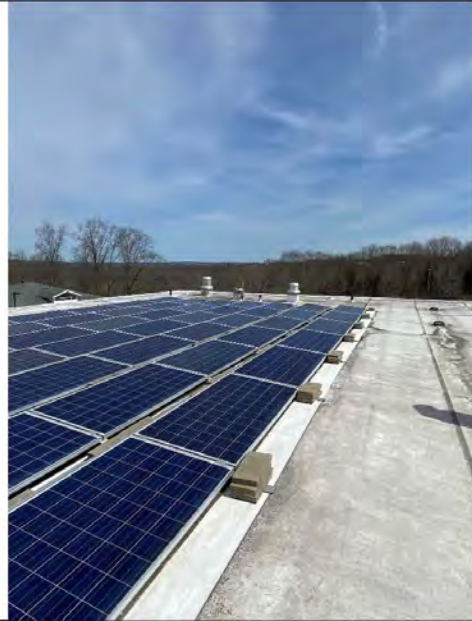
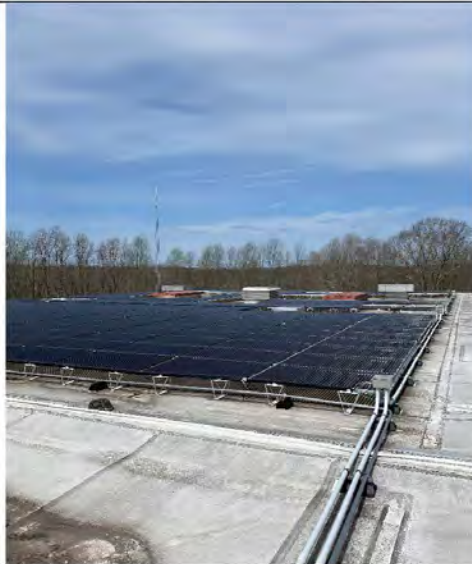
6. Photovoltaic System – The PV system is of the grid-connected type and does not include battery/back-up storage or secondary electrical generation devices. The system utilizes solar arrays, installed on the various roof structures and produces AC power at 480V into local services via inverters mounted on the roof. The system disconnect and meters and are located at the ground level exterior, close to the utility meter. This system appears to be functioning properly with no issues reported.

Photo # 38: - Solar Panels on Roof

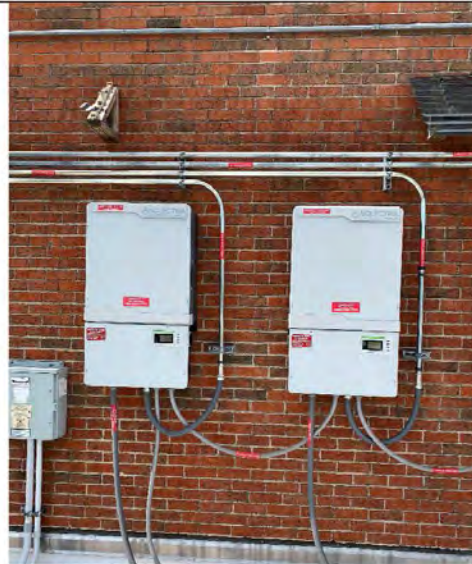
Photo # 40: - Typical Photovoltaic System Inverters on Roof

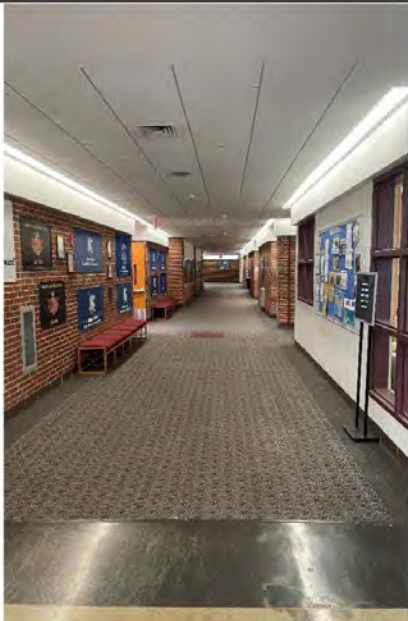
Photo # 44: - Typical Corridor Lighting

Some lighting systems in the corridors have been retrofitted with newer technology, more energy efficient LED lamps. Emergency lighting and exit signage for egress appeared to be operating properly. It is suggested that lights in the classrooms be replaced with new LED equipped fixtures and low voltage controls, for improved light quality and higher efficiency. Any remaining fluorescent fixtures in the corridors should be either retrofitted with new LED lamps, or replaced entirely with new LED designed fixtures and drivers.

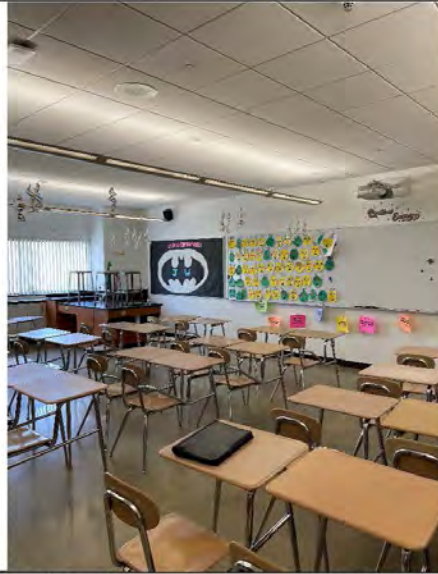
7. Interior lighting throughout the facility is a mix of LED and fluorescent technologies. Corridors are lit with either 2x2 lay-in fixtures with parabolic diffusers, or perimeter mounted linear fluorescents retrofitted with LED lamps. LED downlights are used to light vestibules. All areas are controlled by key switches and ceiling occupancy sensors. Office lighting consists primarily of 2'x2' fluorescent direct/indirect fixtures with wall switches and occupancy sensors for control. Most classrooms use fluorescent direct/indirect pendant mounted light fixtures, controlled with wall switches and ceiling occupancy sensors. No daylighting controls were observed. Suggest replacing the remaining fluorescent troffers with new LED direct/indirect lay-in fixtures and the fluorescent pendants in classrooms with direct/indirect LED pendants for improved light quality. Low voltage wall dimmer switches along with ceiling mounted occupancy/vacancy sensors and daylighting control is recommended in all classrooms and offices to improve efficiency and meet current energy code standards.

Photo # 46: - Typical Classroom Lighting

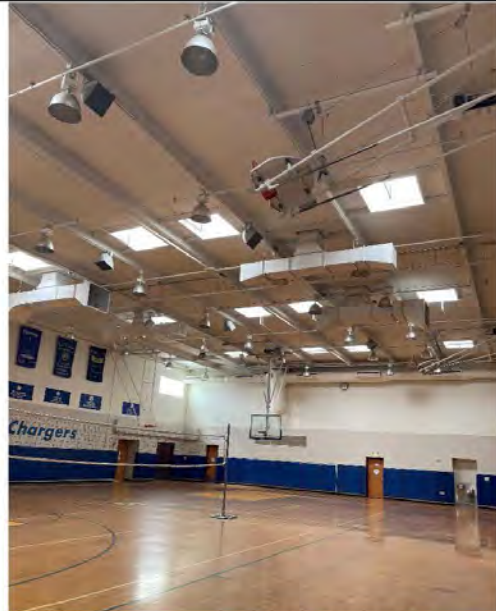
8. Lighting fixtures in the gymnasium are high-bay type with LED lamps controlled by key-operated toggle switches. Light levels appeared to meet the requirements of the space. None of the gymnasium light fixtures are equipped with wire guards and some have been damaged as a result. This is an ongoing safety issue and needs to be resolved.

Photo # 47: - Gymnasium High Bay Lights

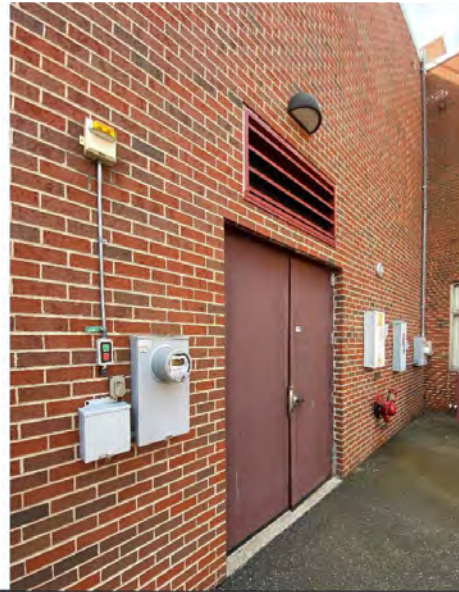
10. Pole and building mounted fixtures, controlled by timeclock and photocells light the walkways, exits and parking areas around the building. The fixtures are new LED replacements of older metal halide, high-pressure sodium or compact fluorescent technologies. Exterior/site lighting throughout the grounds appeared in good working condition.

Photo # 49: - Typical Exterior Egress Light Fixture

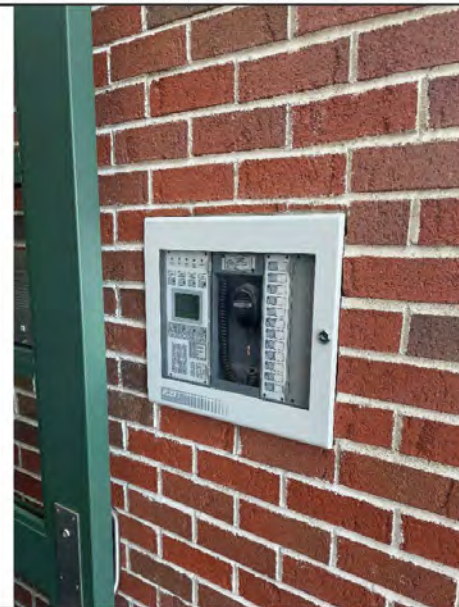
Photo # 51: - Fire Alarm Remote Annunciator Panel in Main Entrance Vestibule

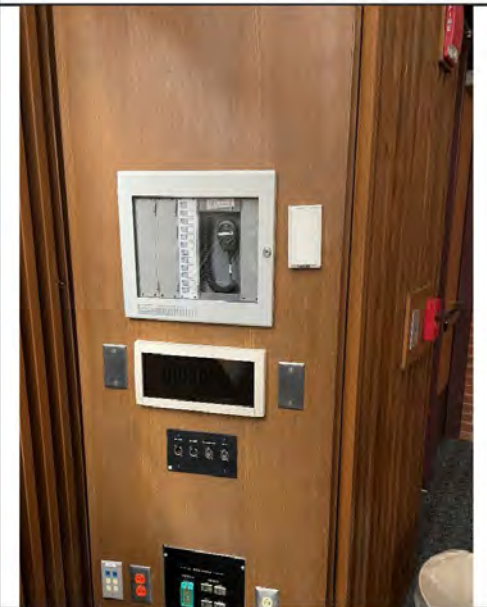
Photo # 52: - Fire Alarm Voice Evac Panel in Auditorium

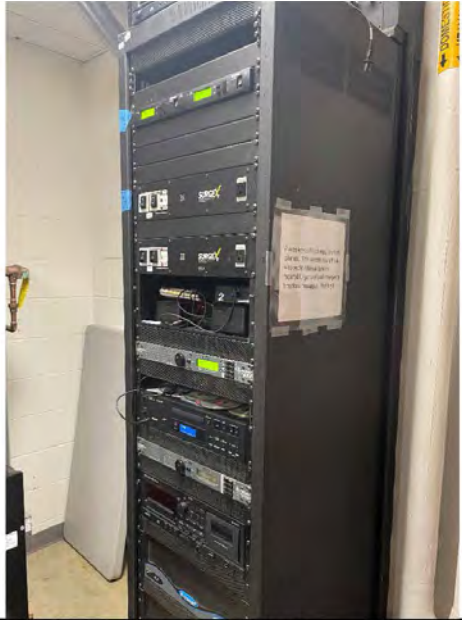
The paging system and speakers currently function with no issues. No improvements are required at present.

Photo # 57: - Audio System Rack

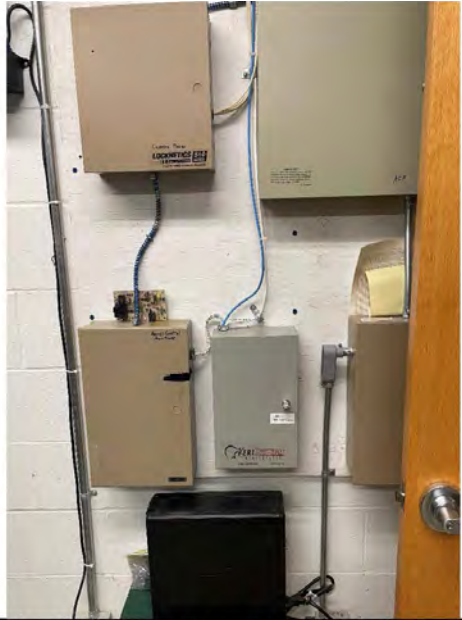
5. Access Control and Surveillance - The building uses an access control system consisting of card readers located at the main points of entry. Headend equipment is by KerriSystems. Surveillance cameras are located at various points around the exterior and interior of the building. The video system is networked with a dedicated HD display located in the Administration area. All systems appear to be operating properly, with no reported issues. No intrusion detection was observed.

Photo # 58: - Access Control System Headend Equipment

The existing access control system is recent with no major issues reported. It is recommended that a review of desired access controlled doors and end-user operations be conducted. A full assessment by a qualified technician is recommended to verify that all devices are connected and tested for proper operation.

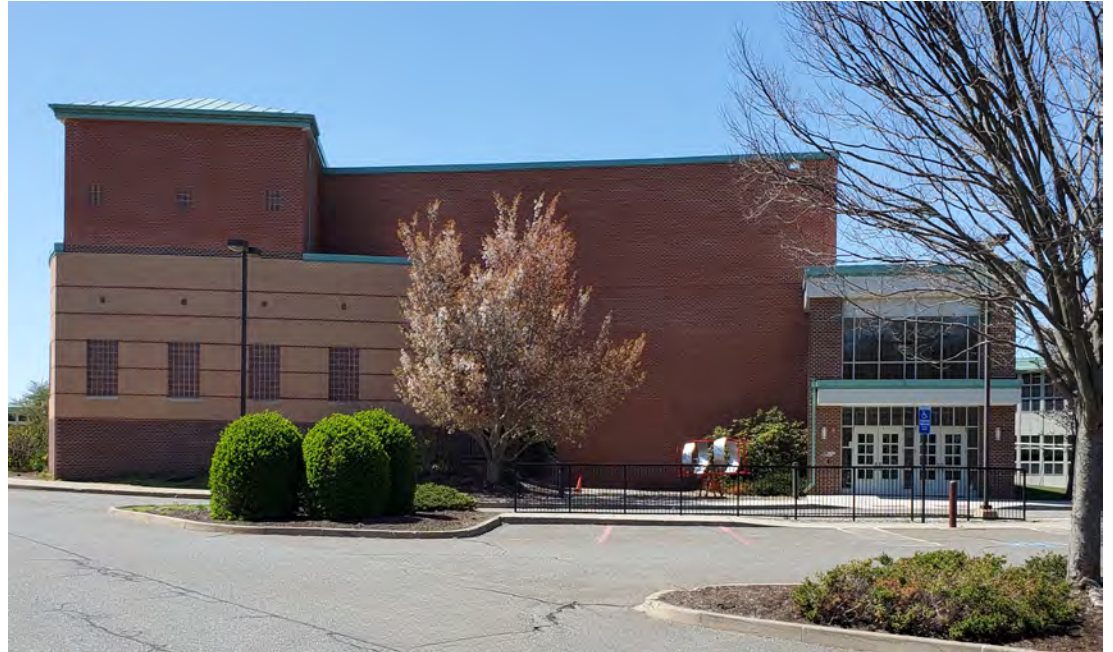
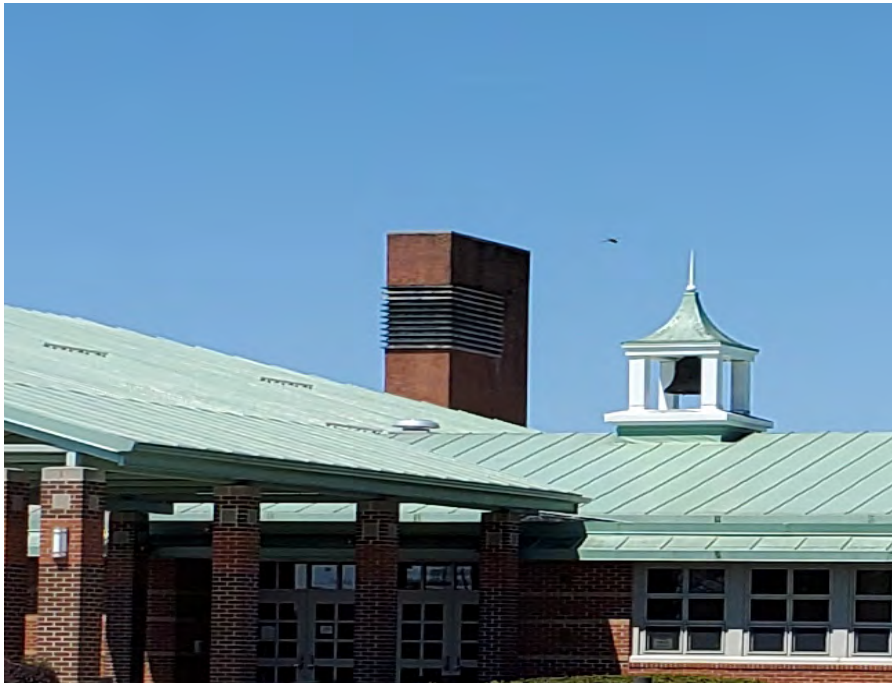
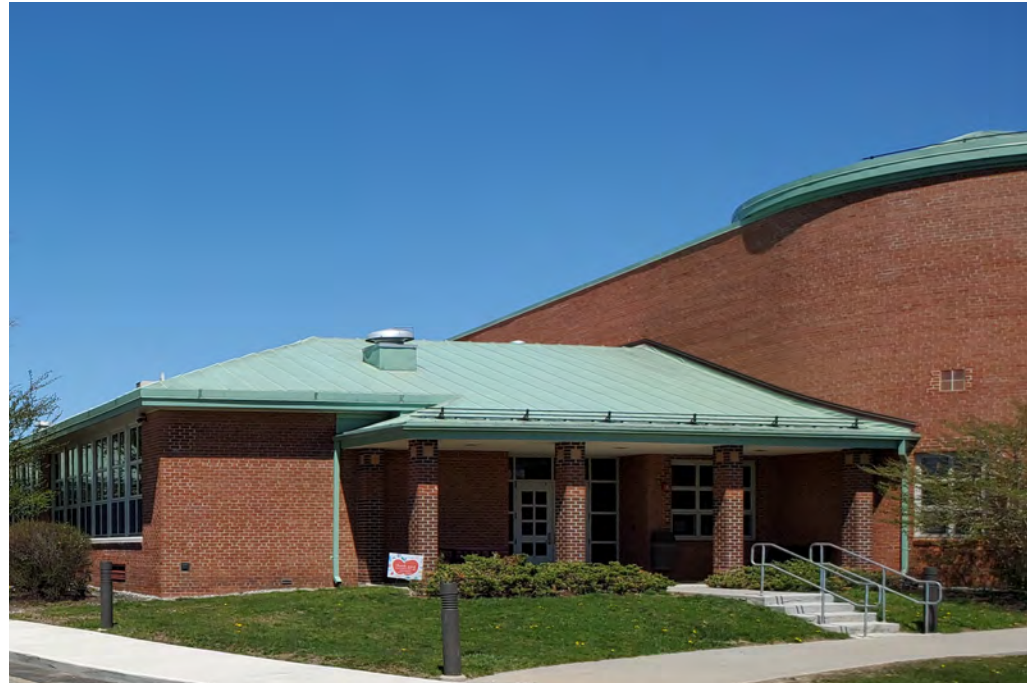
With the exception of the chimney on the 1953 portion, the brick overall appears to be in good condition with little deterioration or effluorecence seen. The chimney is showing signs of deterioration and failure. This area should be investigated further and appropriate repairs made as soon as possible.
