**AGENDA & NOTICE FOR REGION 4 BOARD OF EDUCATION
GROUNDS and BUILDINGS MAINTENANCE & OVERSIGHT COMMITTEE
MEETING**

Athletic Facilities Master Plan

Regional School District No.4

March 2021

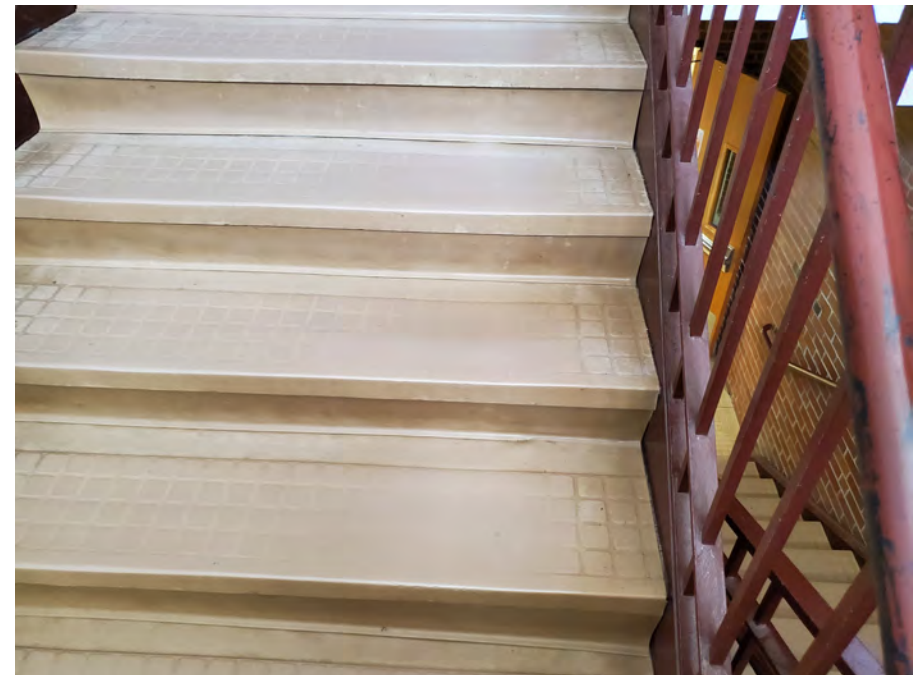
The stairs in the classroom wing have rubber tread covers. These are worn and should be replaced to eliminate potential slipping hazards, especially when the stairs might have water on them. - Lower right hand picture on opposite page.

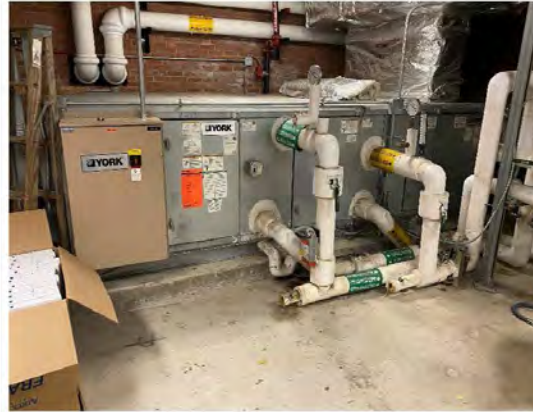
Photo # 1: Indoor air handling unit

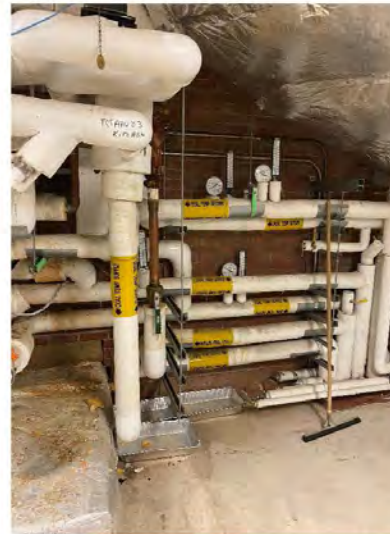
Photo # 3: Existing piping serving kitchen AHU

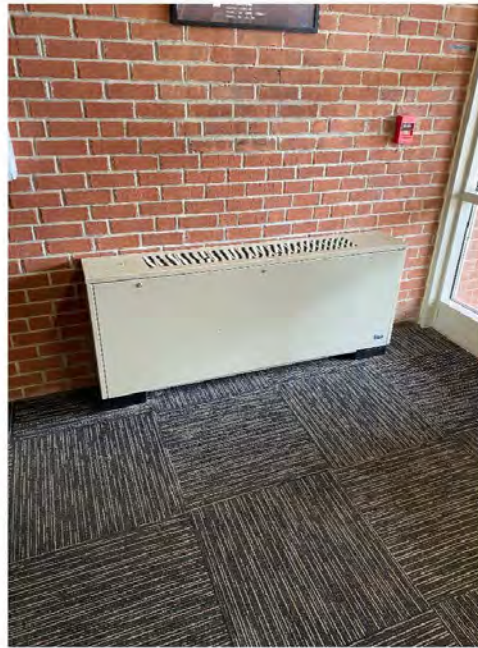
Photo # 5: Existing cabinet unit heater

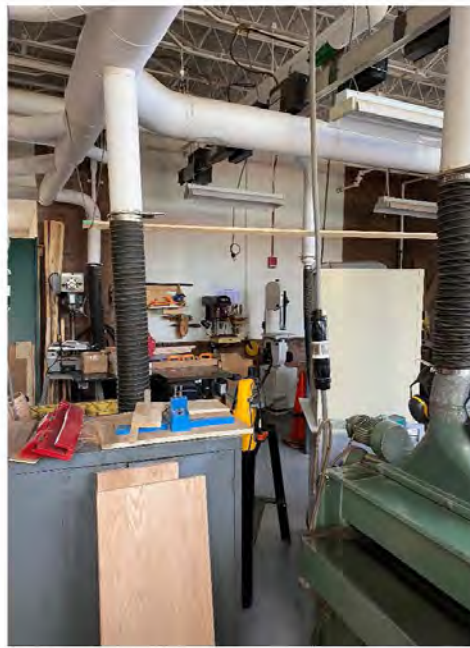
Photo # 6: Wood shop classroom with overhead ductwork to dust collector.

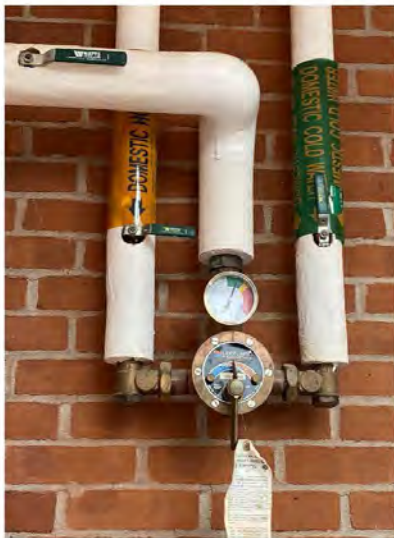
Photo # 7: Mixing valve serving emergency showers.

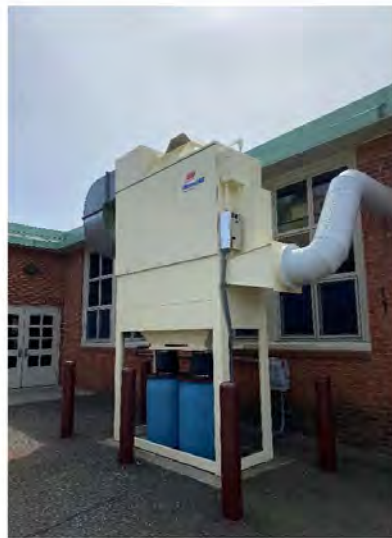
Photo # 8: Exterior dust collector serving wood shop classroom.

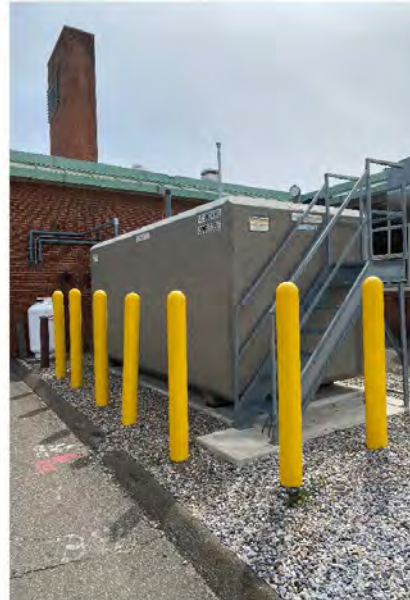
Photo # 9: Exterior, above grade, fuel oil tank

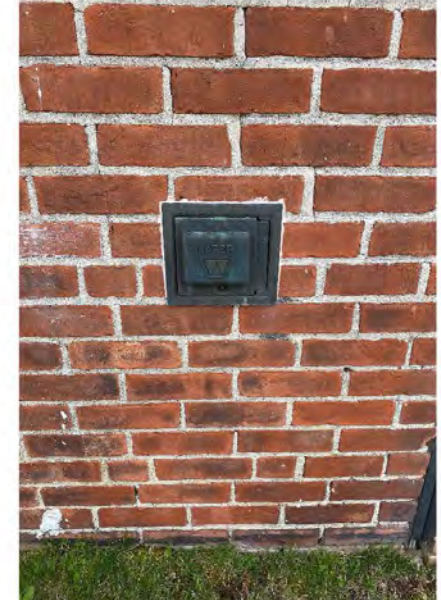
Photo # 10: Exterior hose bib

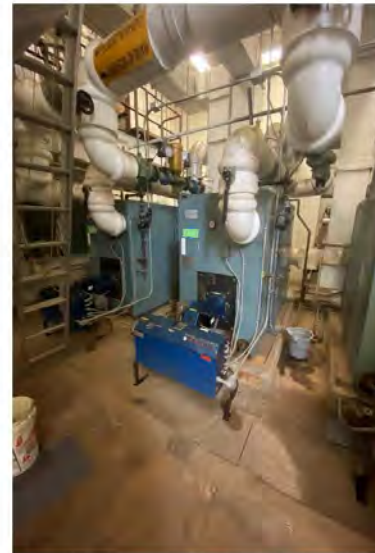
1. Domestic hot water for the building is provided through (2) Weil Mclain "76" hot water boilers. The boilers model number are (#676) and are rated at 355 MBH. The boilers appear to be in fair condition. Though the boilers appear to be operating as designed, they are exceeding their useful life. The (2) hot water boilers provide hot water for (4) Amtrol Boiler mate indirect water heaters. Each indirect water heater has a storage capacity of 41 gallons. All of the indirect water heaters are set for an output of 140°F hot water before they serve the buildings mixing valves to provide tempered water to the building fixtures. The indirect water heaters appear to be in good condition and operating correctly.

Photo # 11: Existing hot water boilers (Total of 3).

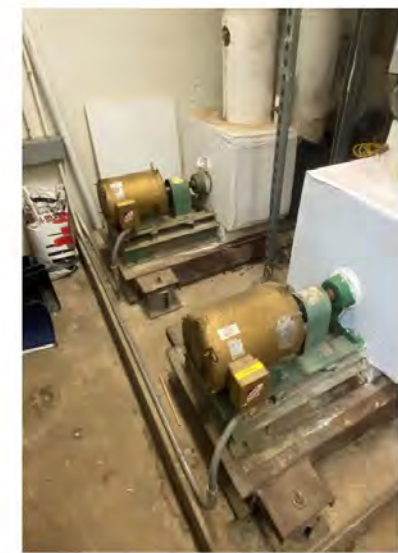
Photo # 12: Existing chilled water pumps

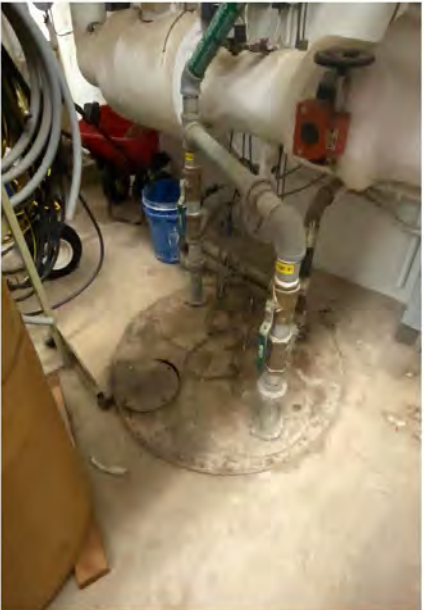
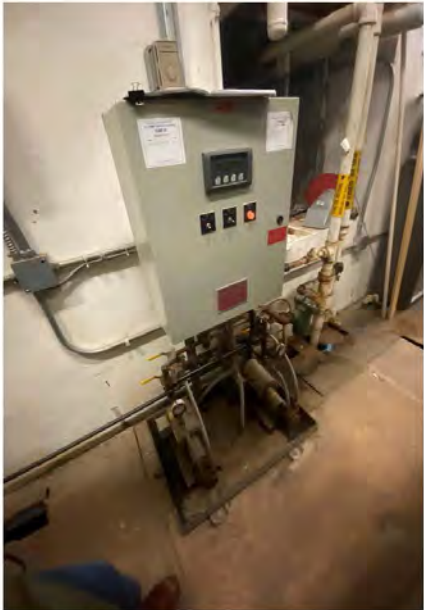
<p>Photo # 13: Existing sump pump in boiler room.</p>	<p>Photo # 14: Fuel oil pump set.</p>

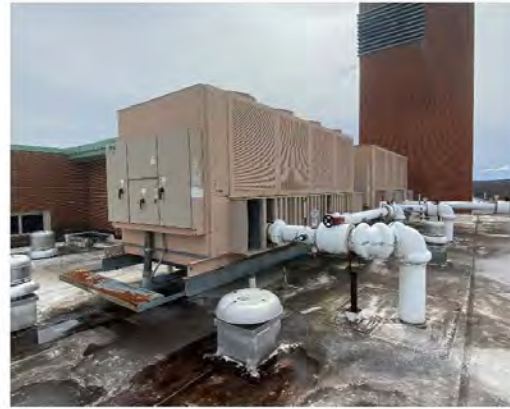
are provided with sound attenuation to reduce the amount of breakout noise from when the units are operating. The units create chilled water for all of the air handling units throughout the building. The chillers are nearing the end of their useful life and should be replaced or upgraded in the near future.

Photo # 17: Roof mounted, air cooled chillers

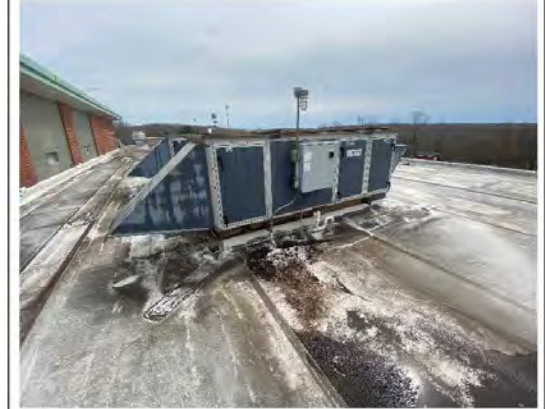
Photo # 18: Existing, roof mounted air handling units

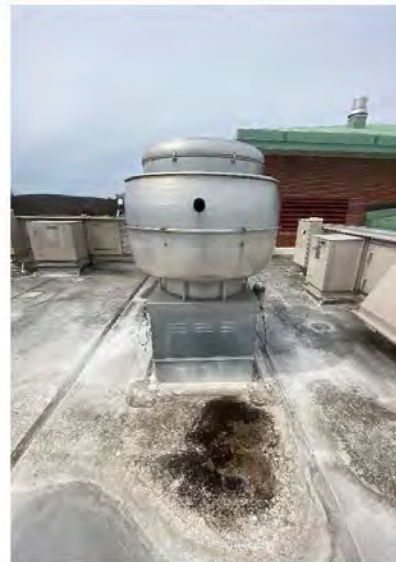
Photo # 19: Kitchen exhaust fan.

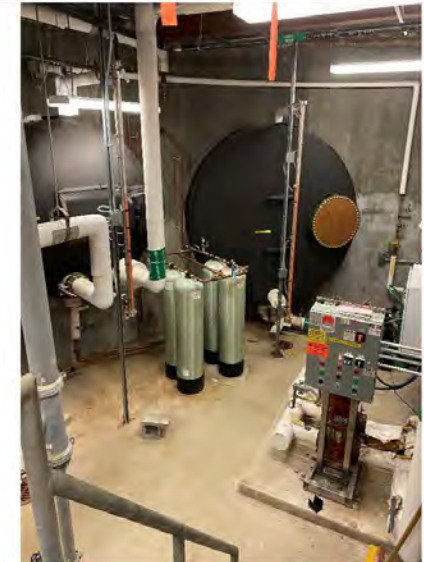
Photo # 20: Domestic water pump room

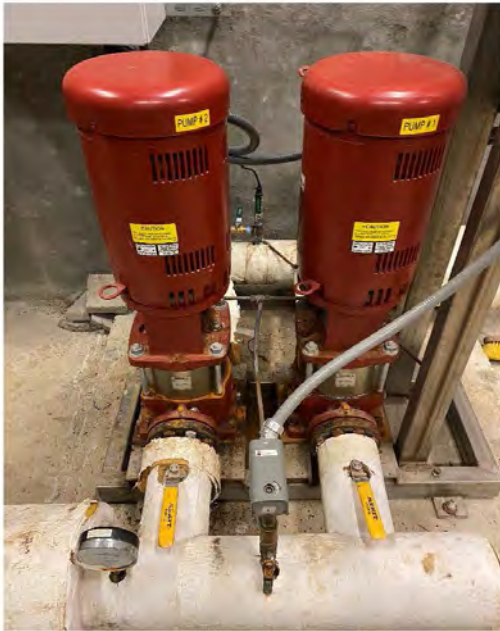
Photo # 21: Domestic water booster pumps.

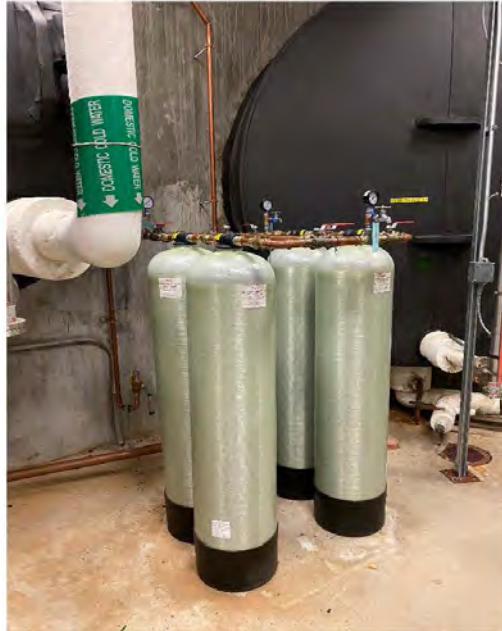
Photo # 22: Domestic water carbon filters

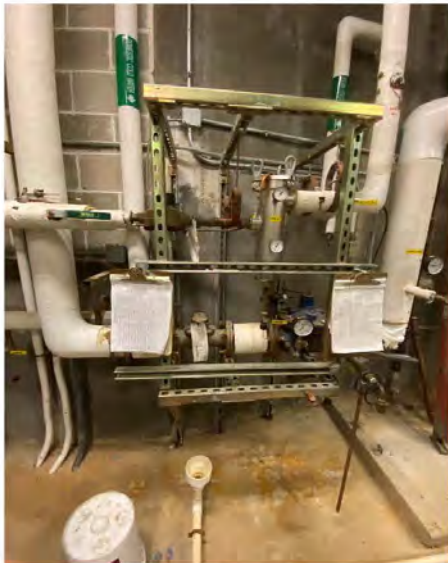
Photo # 23: Domestic water meter assemblies.

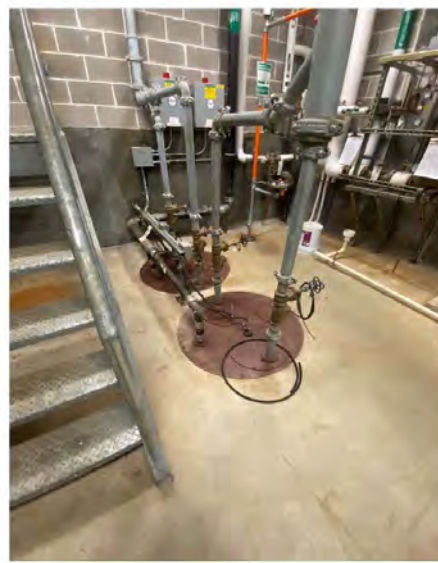
Photo # 24: Sump pumps located in domestic water pump room.

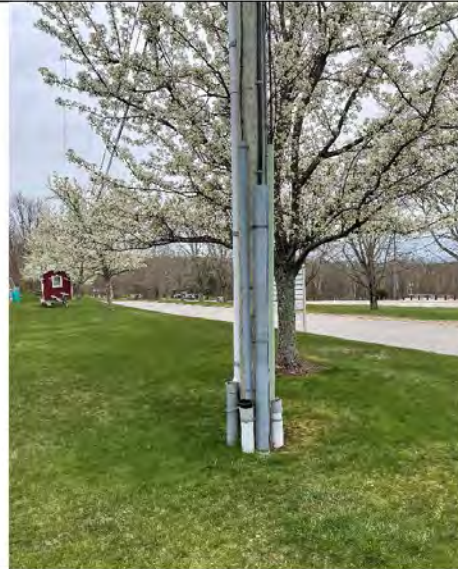
Photo # 25: - Utility Service Pole #1352 on Regional High School Road No.1

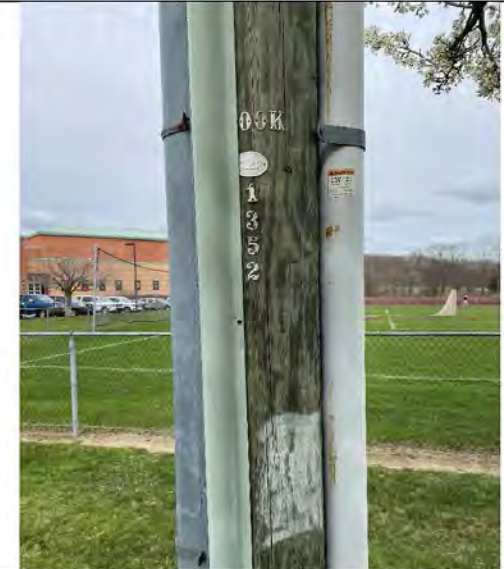
Photo # 26: - Utility Service Pole Primary and Telecommunications

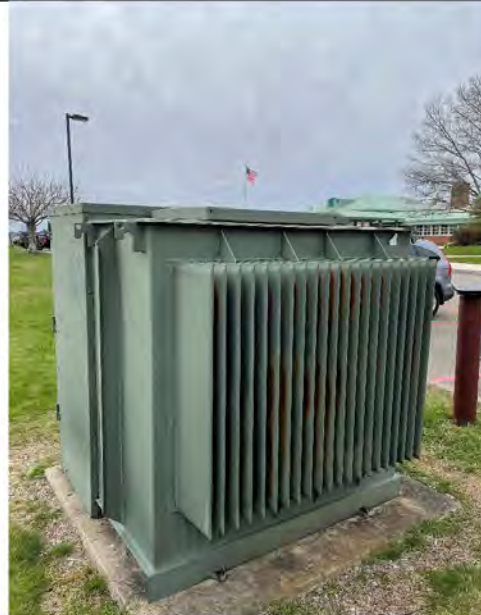
Photo # 27: - Utility Pad Mounted Transformer

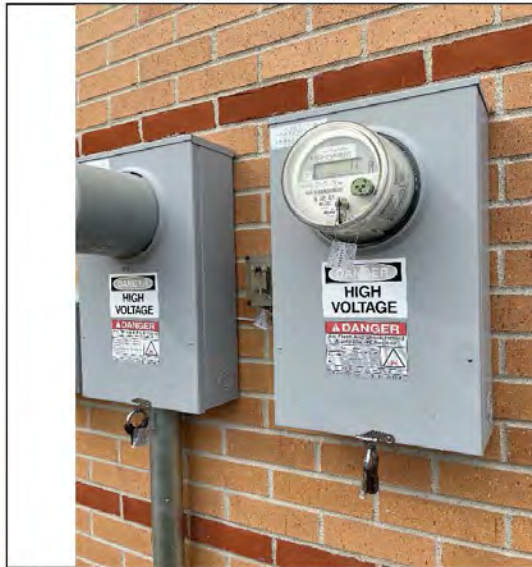
Photo # 29: - Building Utility Meter

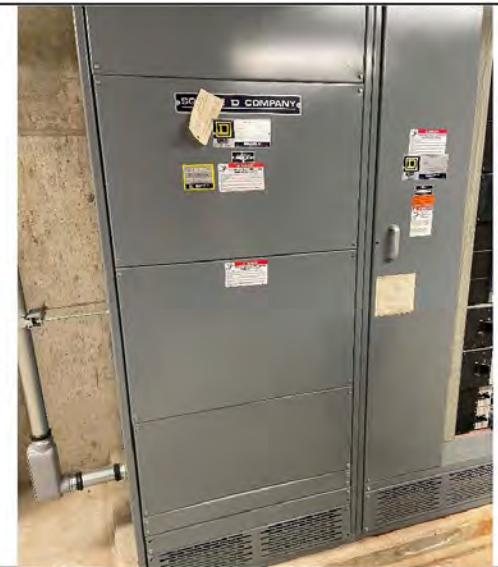
Photo # 30: - Main Distribution Switchboard "MSB-1" in Main Electrical Room

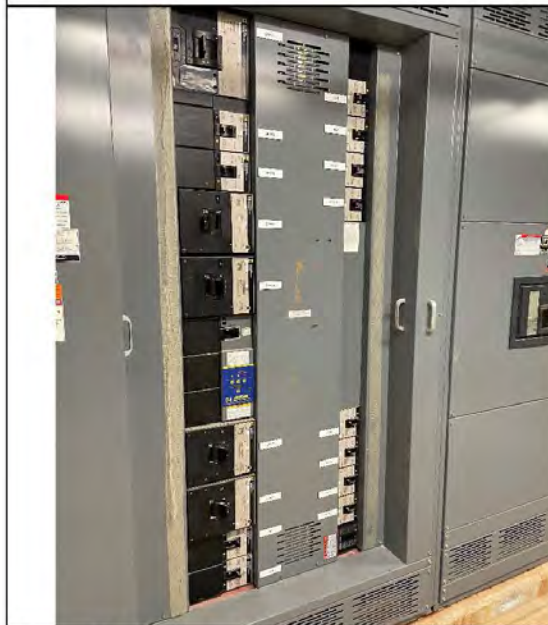
Photo # 31: - Switchboard "MSB-1" Distribution Section and Main Switch

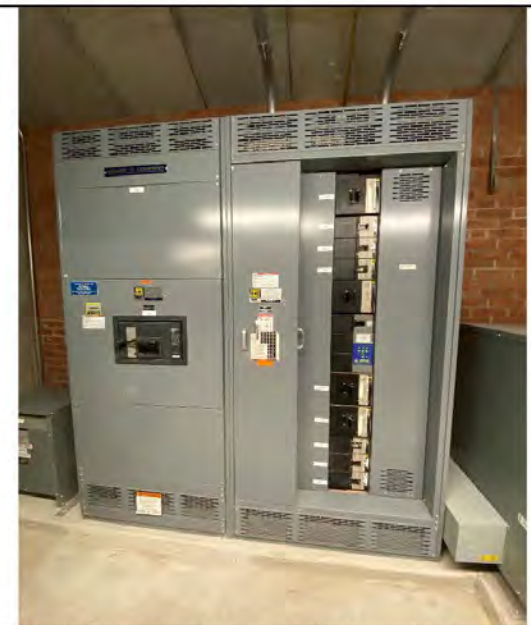
Photo # 32: - Distribution Switchboard "HBDB" in Building Area "B" Electrical Room

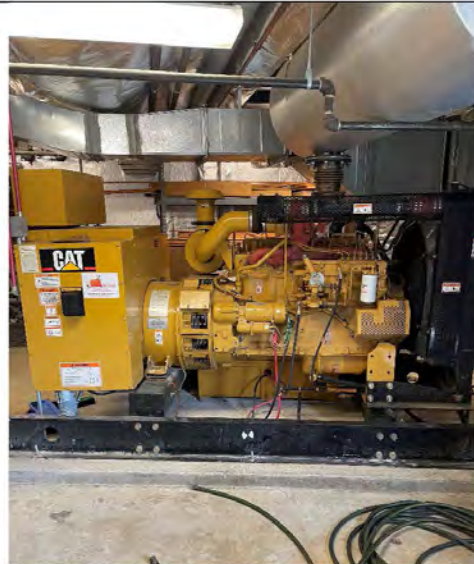
Photo # 40: - 250kVA/313kW Diesel Powered Generator

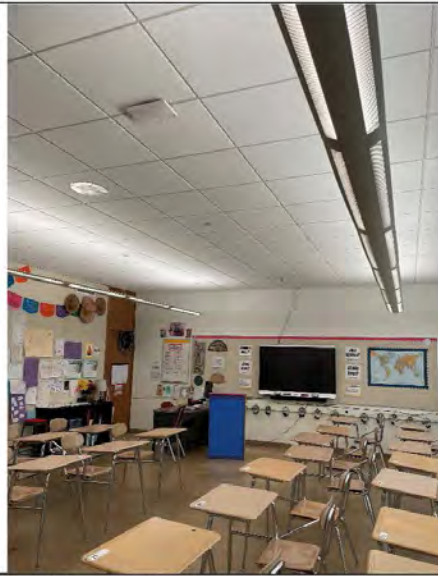
Photo # 46: - Typical Classroom Lighting

No daylighting controls were observed. Suggest replacing the remaining fluorescent troffers with new LED direct/indirect lay-in fixtures and the fluorescent pendants in classrooms with direct/indirect LED pendants for improved light quality. Low voltage wall dimmer switches along with ceiling mounted occupancy/vacancy sensors and daylighting control is recommended in all classrooms and offices to improve efficiency and meet current energy code standards.

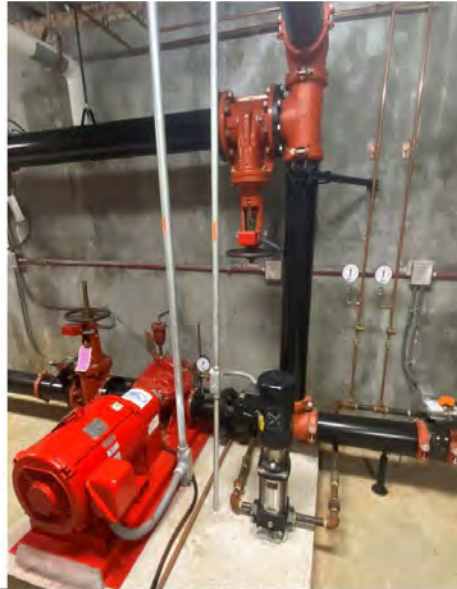
Photo # 54 – Fire Pump

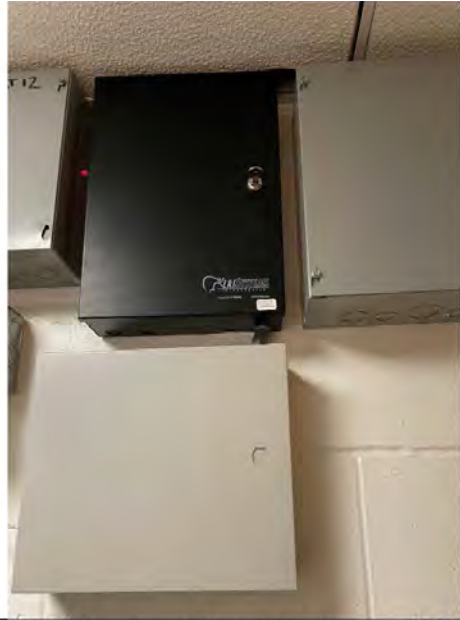
Photo # 61: - Access Control Headend Equipment (KerriSystems)

The existing access control system is recent with no major issues reported. It is recommended that a review of desired access controlled doors and end-user operations be conducted. A full assessment by a qualified technician is recommended to verify that all devices are connected and tested for proper operation.

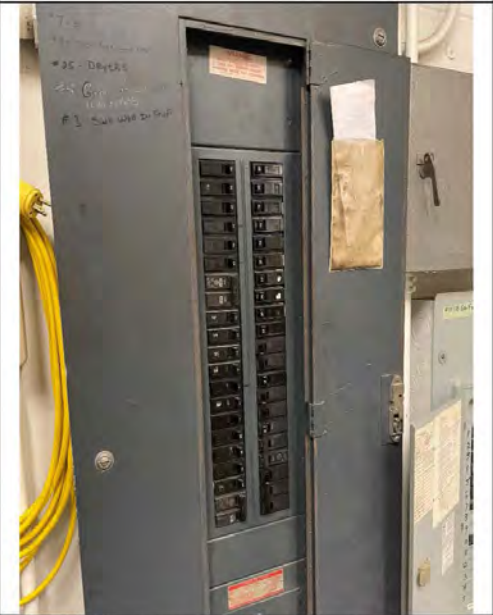
Photo # 68: - 200A Distribution Panel

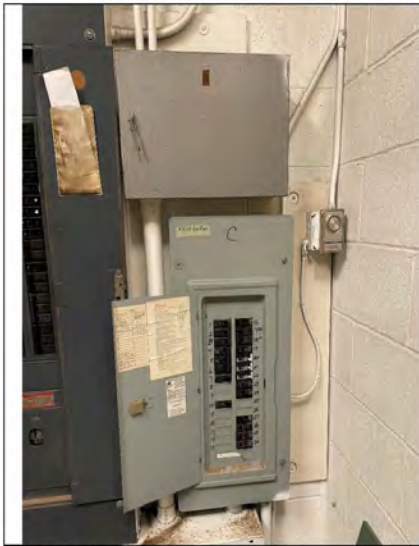
Photo # 69: - GE Load Center Panel

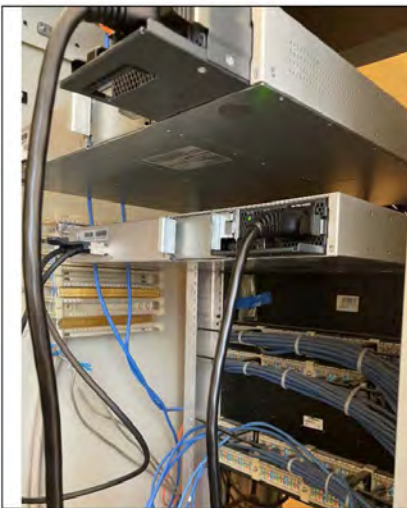
Photo # 65: - Telecommunications Rack Equipment

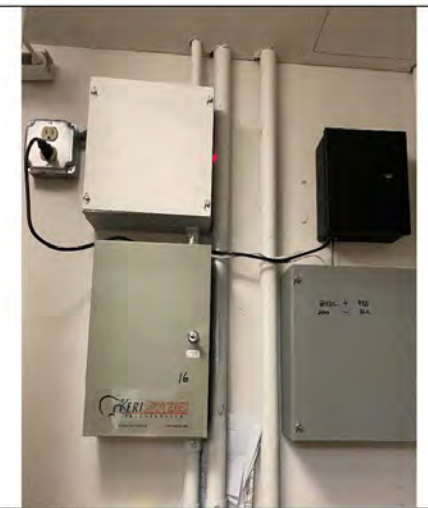
Photo # 66: - Access Control Headend

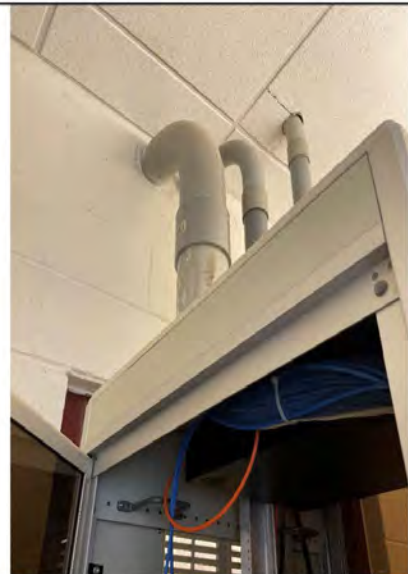
Photo # 72: - Telecommunications Conduits into Rack

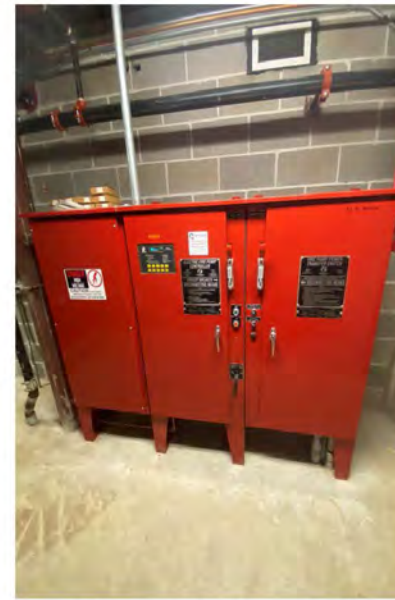
Photo # 67: Electric fire pump control panels.

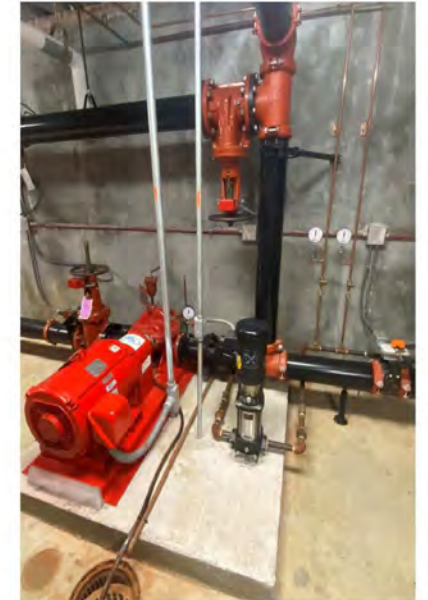
Photo # 68: Electric fire pump and jockey pump.

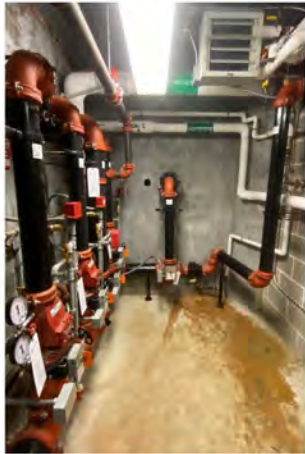
Photo # 69: Fire protection riser assemblies.

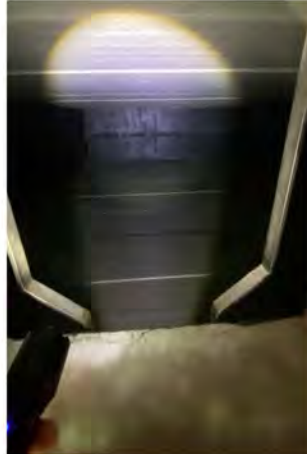
Photo # 70: Fire Protection water storage tank

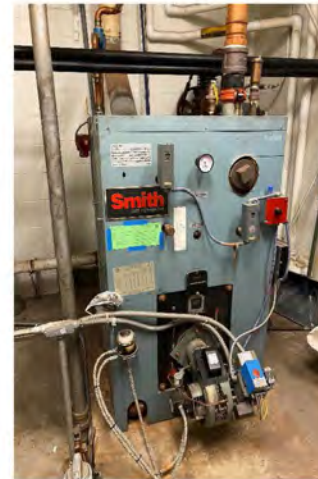
Photo # 73: Tech Ed: Existing HB Smith boiler.

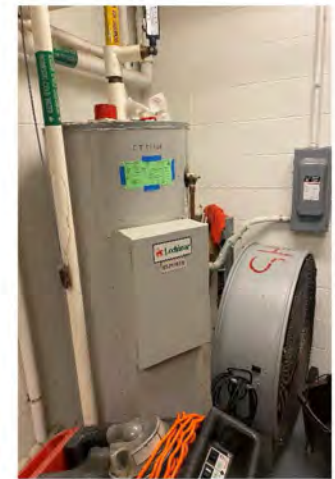
Photo # 74: Tech Ed: Existing electric domestic water heater.

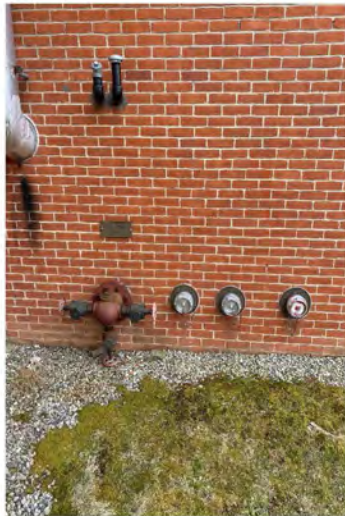
Photo # 71: Fire protection test header and fire department connection.

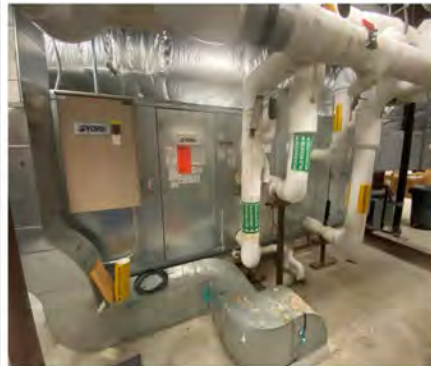
Photo # 72: Existing air handling units in mezzanine.

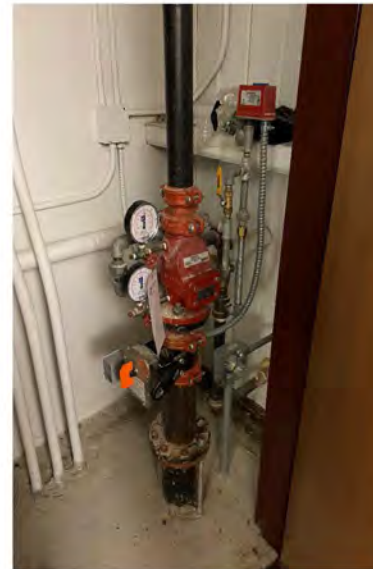
Photo # 75: Tech Ed: Fire Protection riser assembly.
